**TECHNICAL STUDY  
FOR REHABILITATION  
ON PRAMBANAN TEMPLE COMPOUND  
AFTER EARTHQUAKE**

**BY  
TECHNICAL STUDY TEAM  
ARCHAEOLOGICAL OFFICE OF YOGYAKARTA**

**DEPARTMENT OF CULTURE AND TOURISM  
2007**

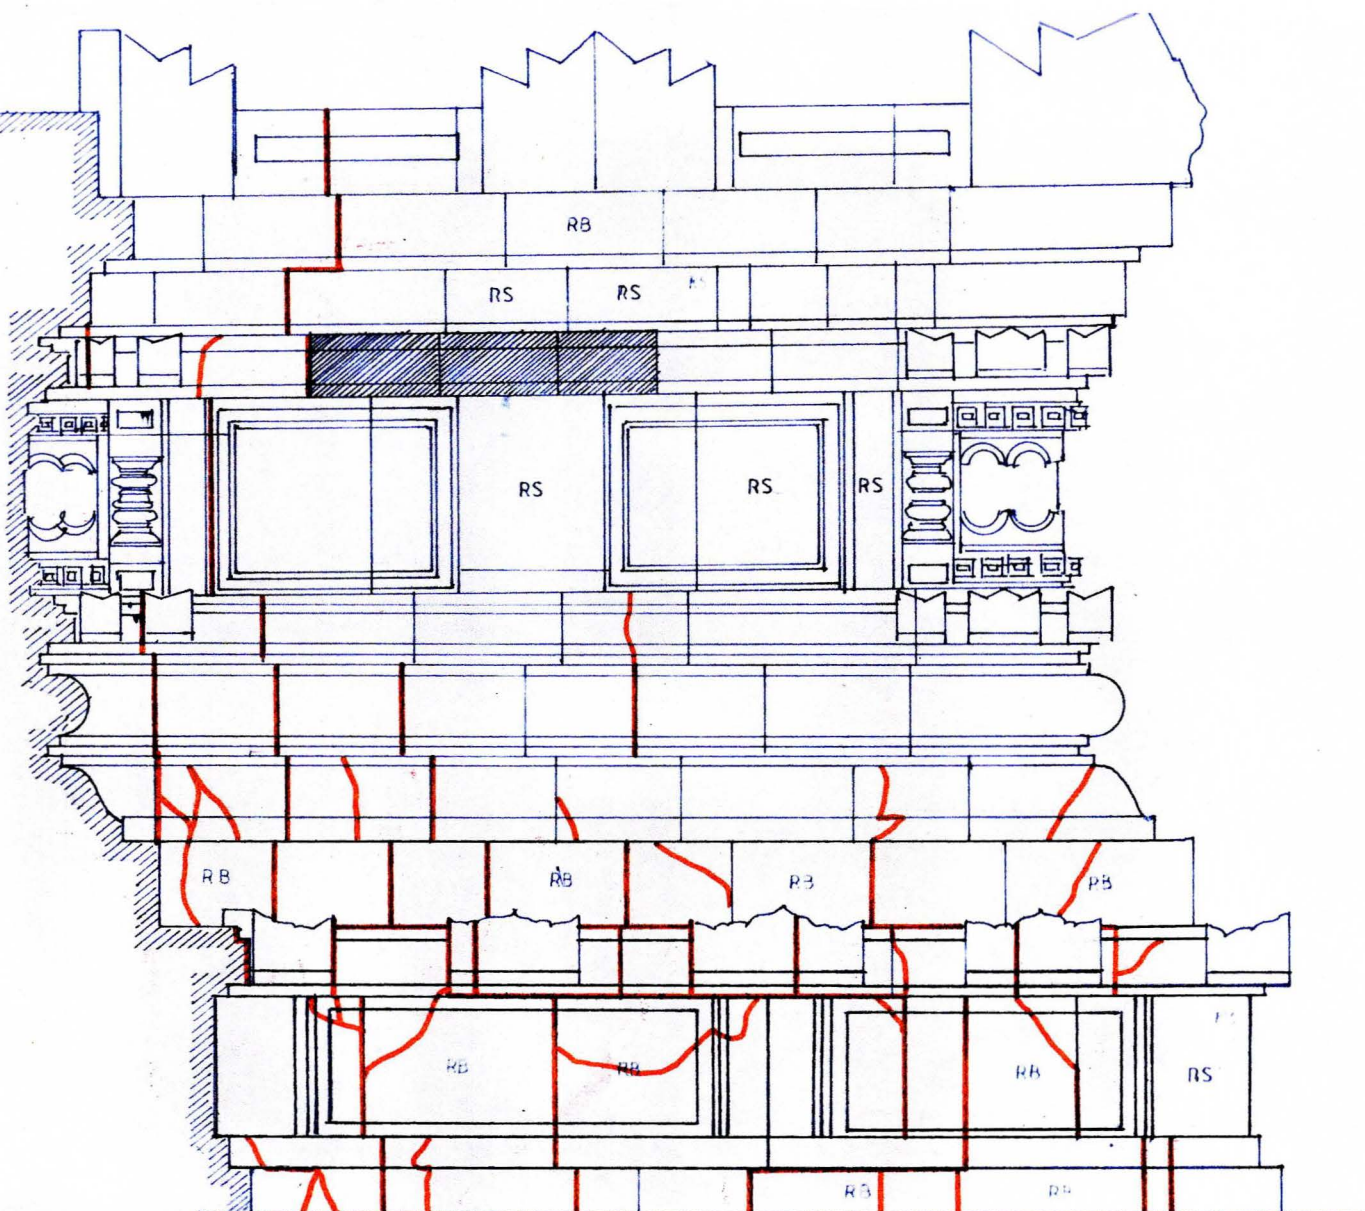
## Area 4

— Cracking and open joint stone

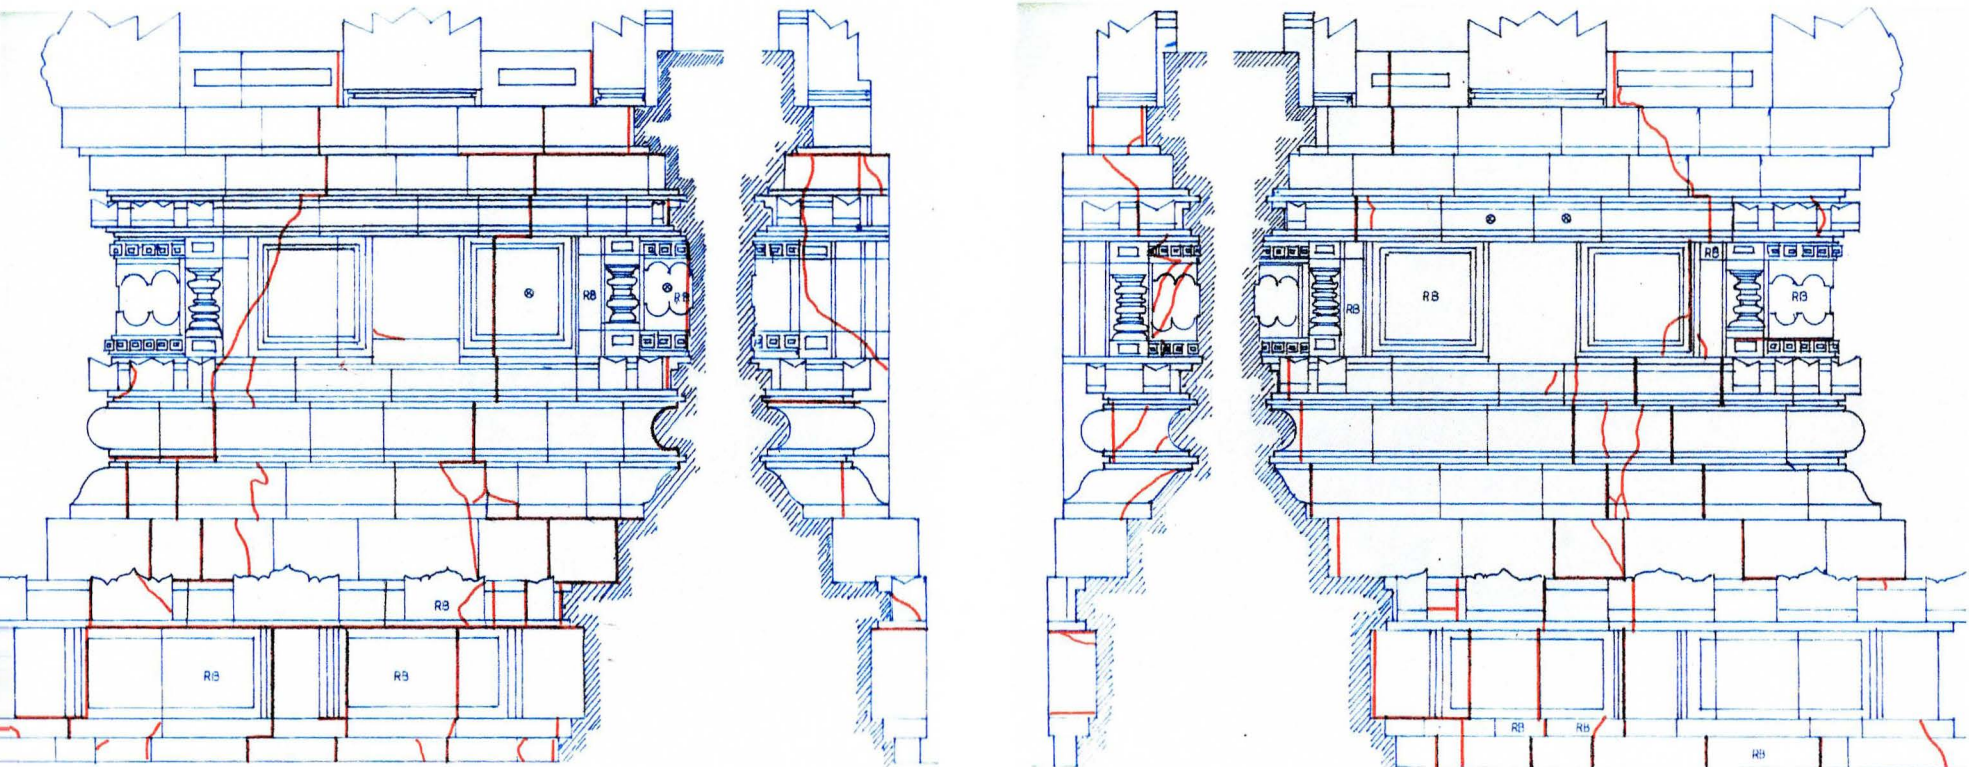
Area XVI

— Cracking and open joint stone

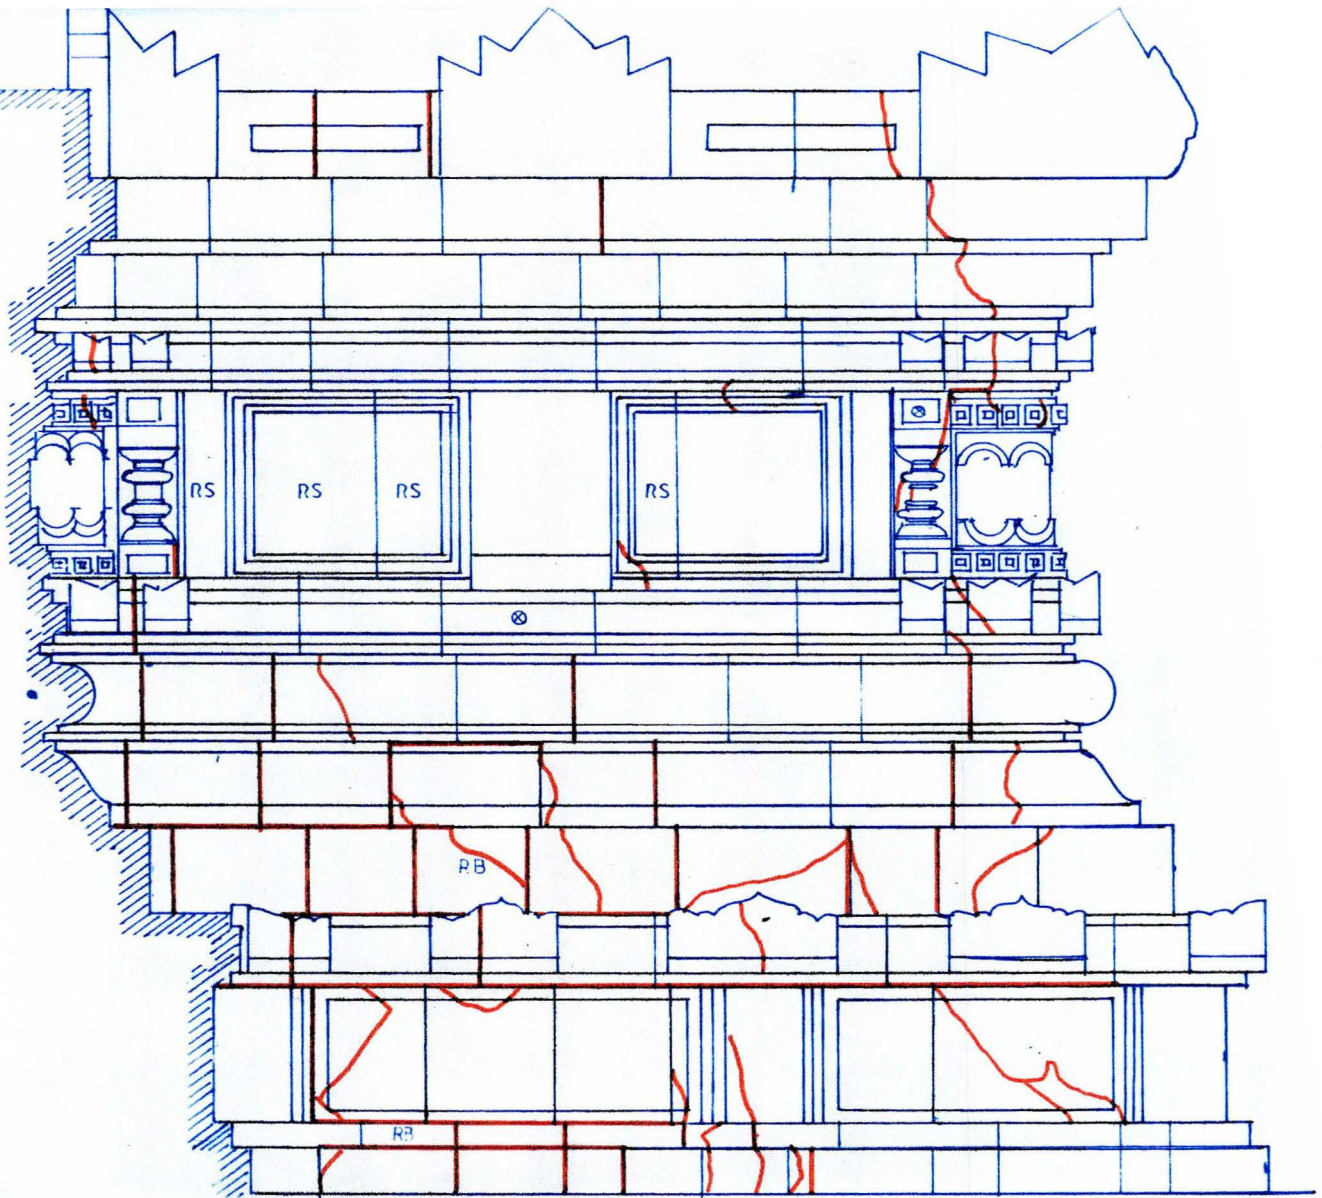
Area 19

— Craking and open joint stone
