**TECHNICAL STUDY
FOR REHABILITATION
ON PRAMBANAN TEMPLE COMPOUND
AFTER EARTHQUAKE**

**BY
TECHNICAL STUDY TEAM
ARCHAEOLOGICAL OFFICE OF YOGYAKARTA**

**DEPARTMENT OF CULTURE AND TOURISM
2007**

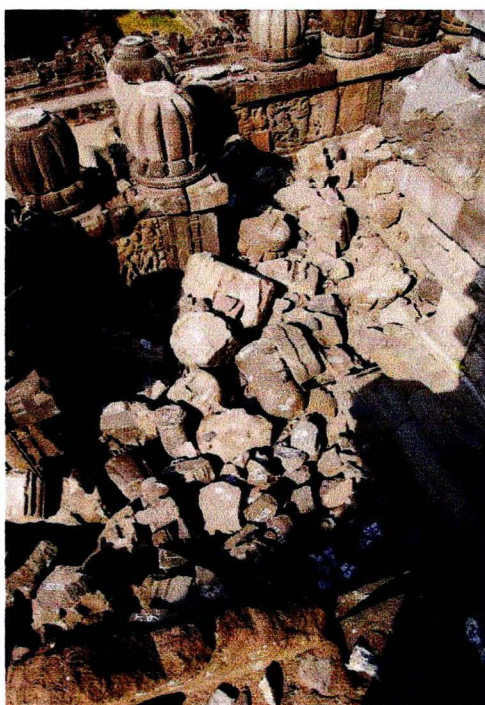
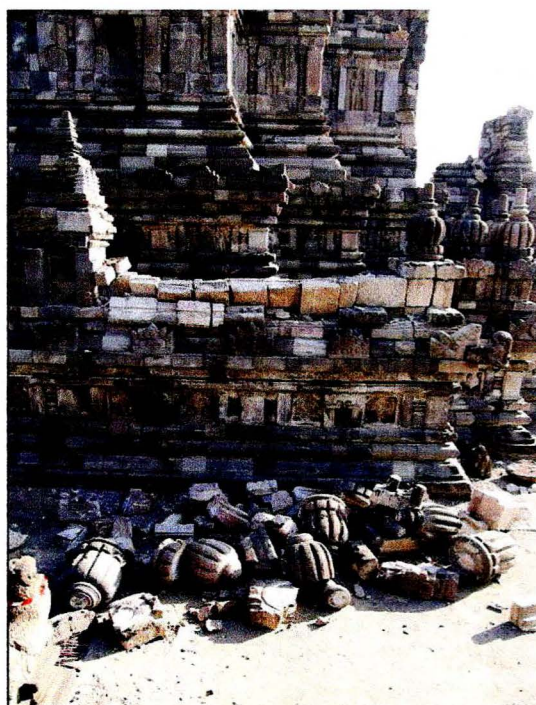
Generally the damage on the stone blocks are: cracks, broken but still in situ, and fragmented. The object of the observation are: the fallen components of the temples, either on the courtyard, on the floor of the balustrade or the still-in-situ stone blocks. It turns out that the heaviest damage on the building material occurs in Brahma temple. There are many components of the roof which fell down and are broken. On Brahma and Wisnu temples many stone blocks are broken, because stoneblocks from the upper stages fell on them. On the other hand the damage on the building material of Siwa temple are mostly cracks on the stone. It seems because the space among the stoneblocks were filled with cement, they became monolithic structure.

Material damage on Brahma and Wisnu temple

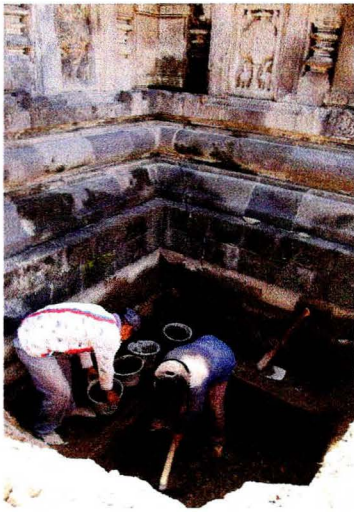
Excavation on Brahma Temple

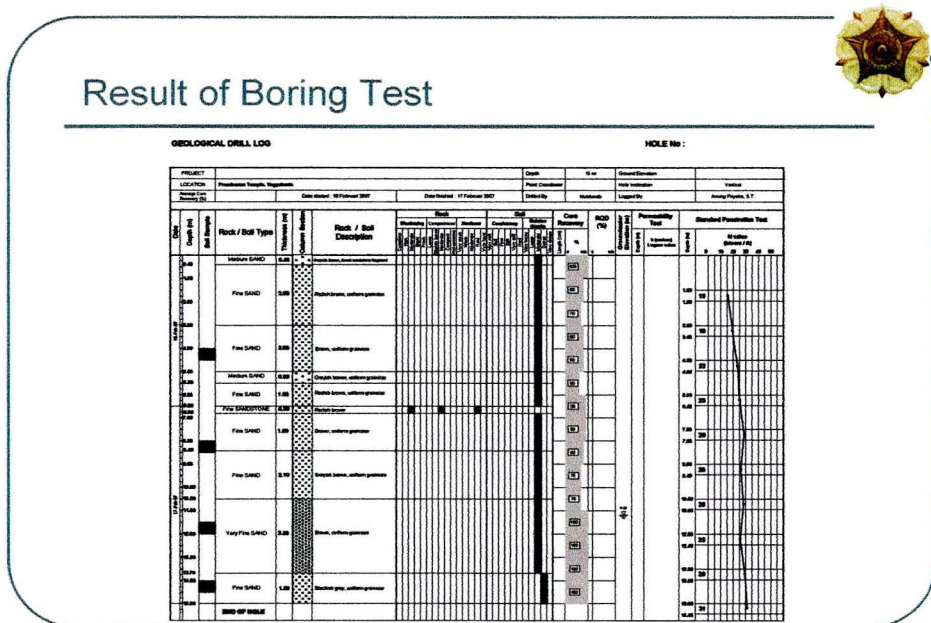
Result of Boring Test (Location: Front of Çiwa Temple)

- From bor log and value of N_{SPT} can be interpreted as following
 - Soil at test location is embankment soil, with relative density fair & uniform from depth of $\pm 0,00 - 15,00$ m.
 - Original ground elevation is located at depth of $14,00 - 15,00$ m.
 - Occur change of soil composition at depth $15,00$ m, and also value of N_{SPT} .
 - Ground water level is observed at depth of $11,20$ m.

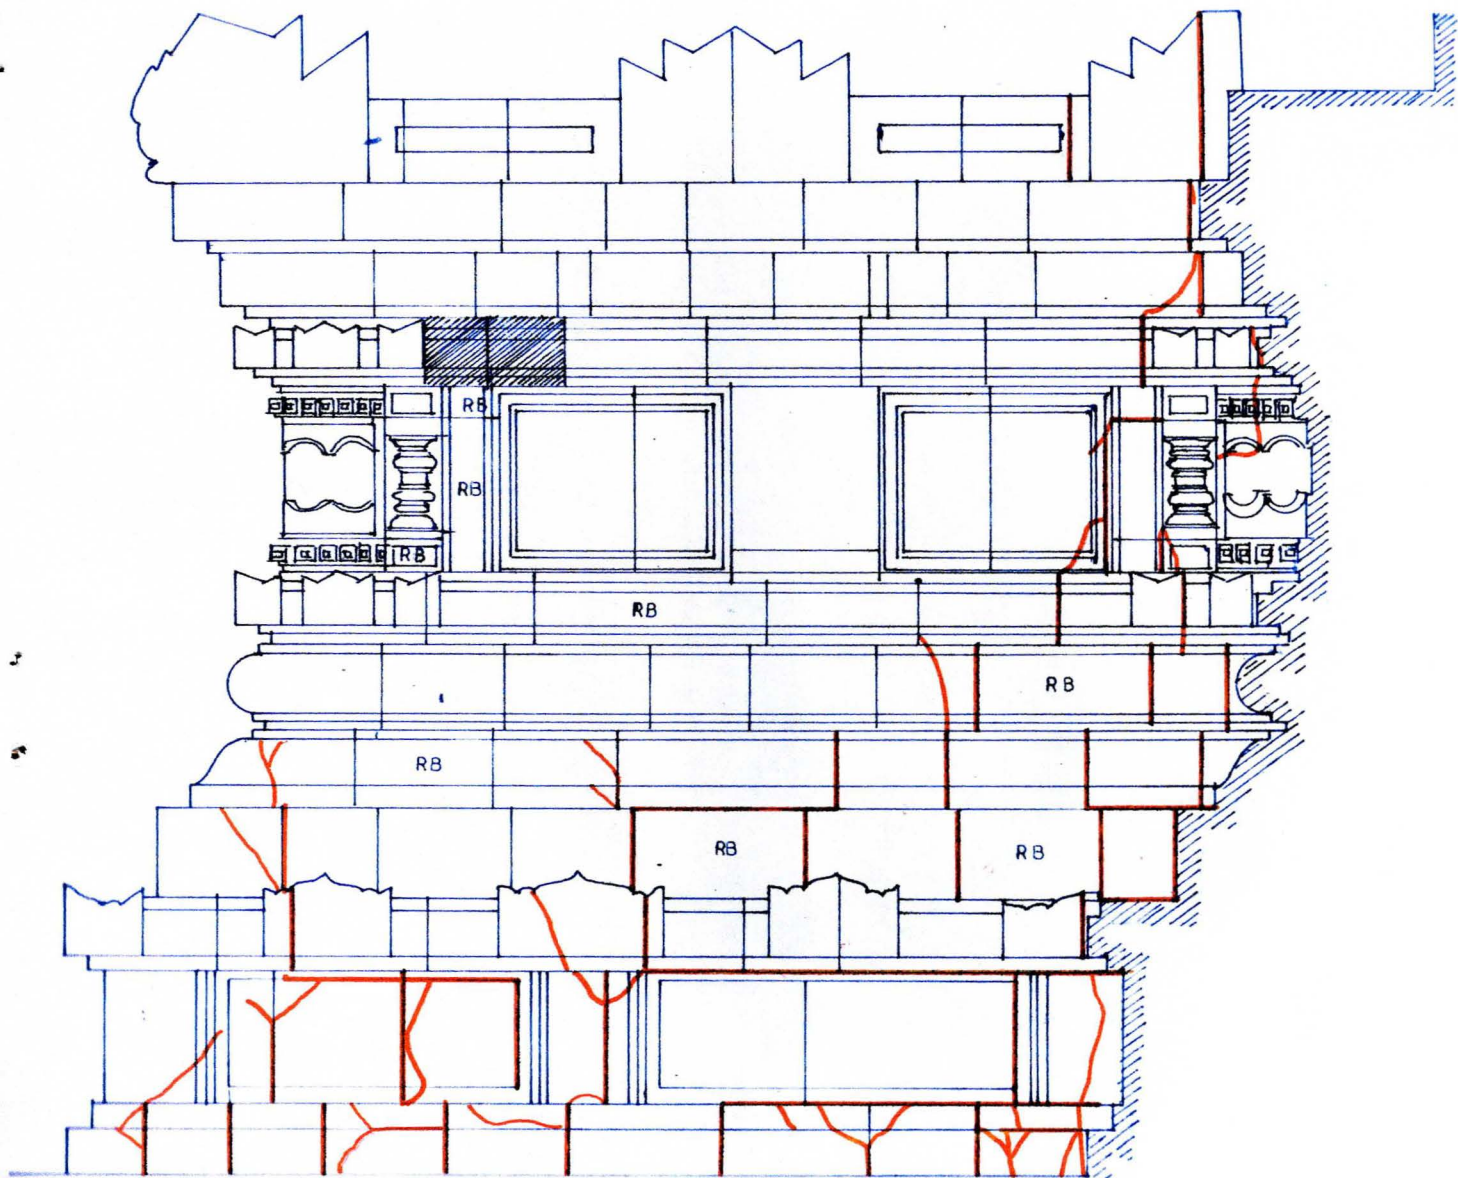
Area 3

— Cracking and open joint stone

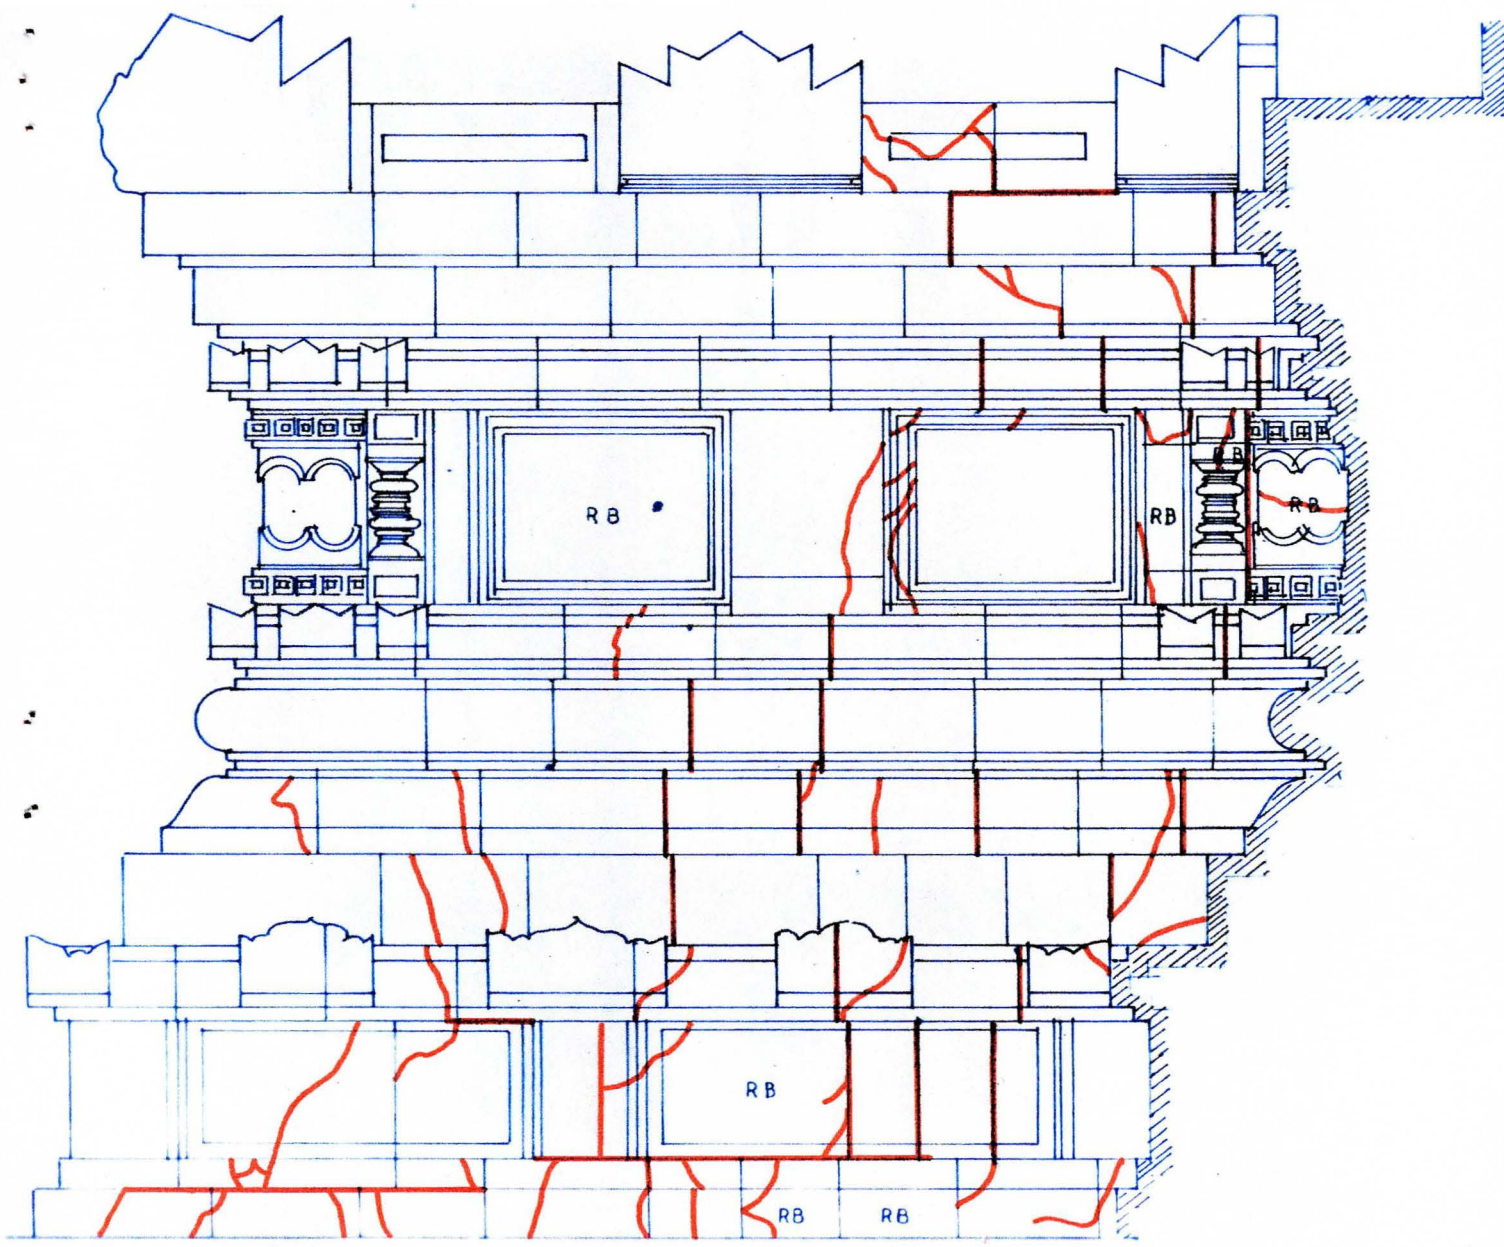
Area 10

— Cracking and open joint stone

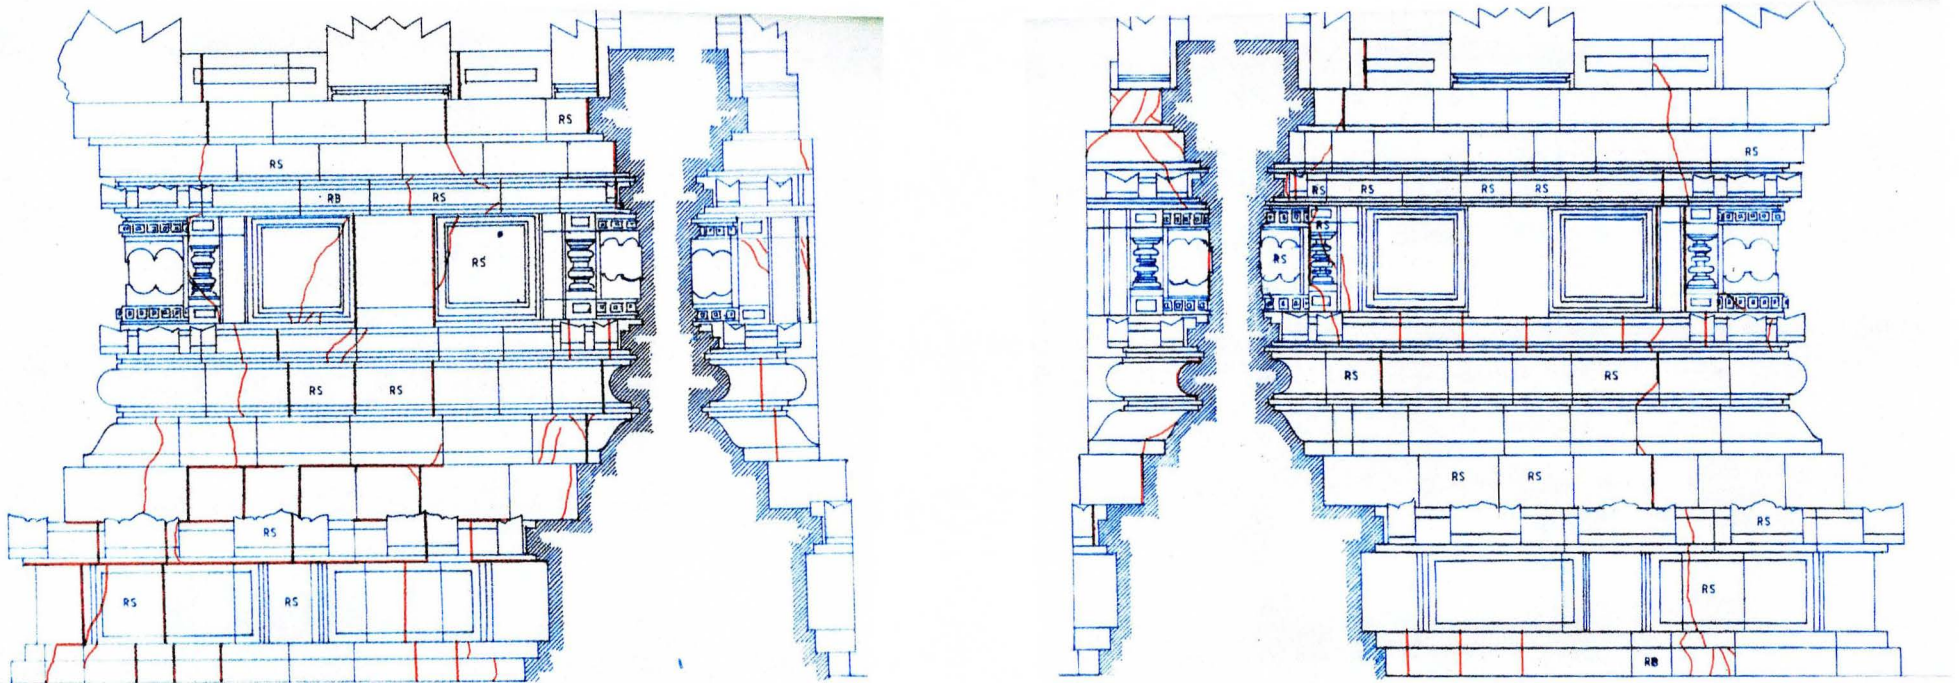
Area11

Cracking and open joint stone

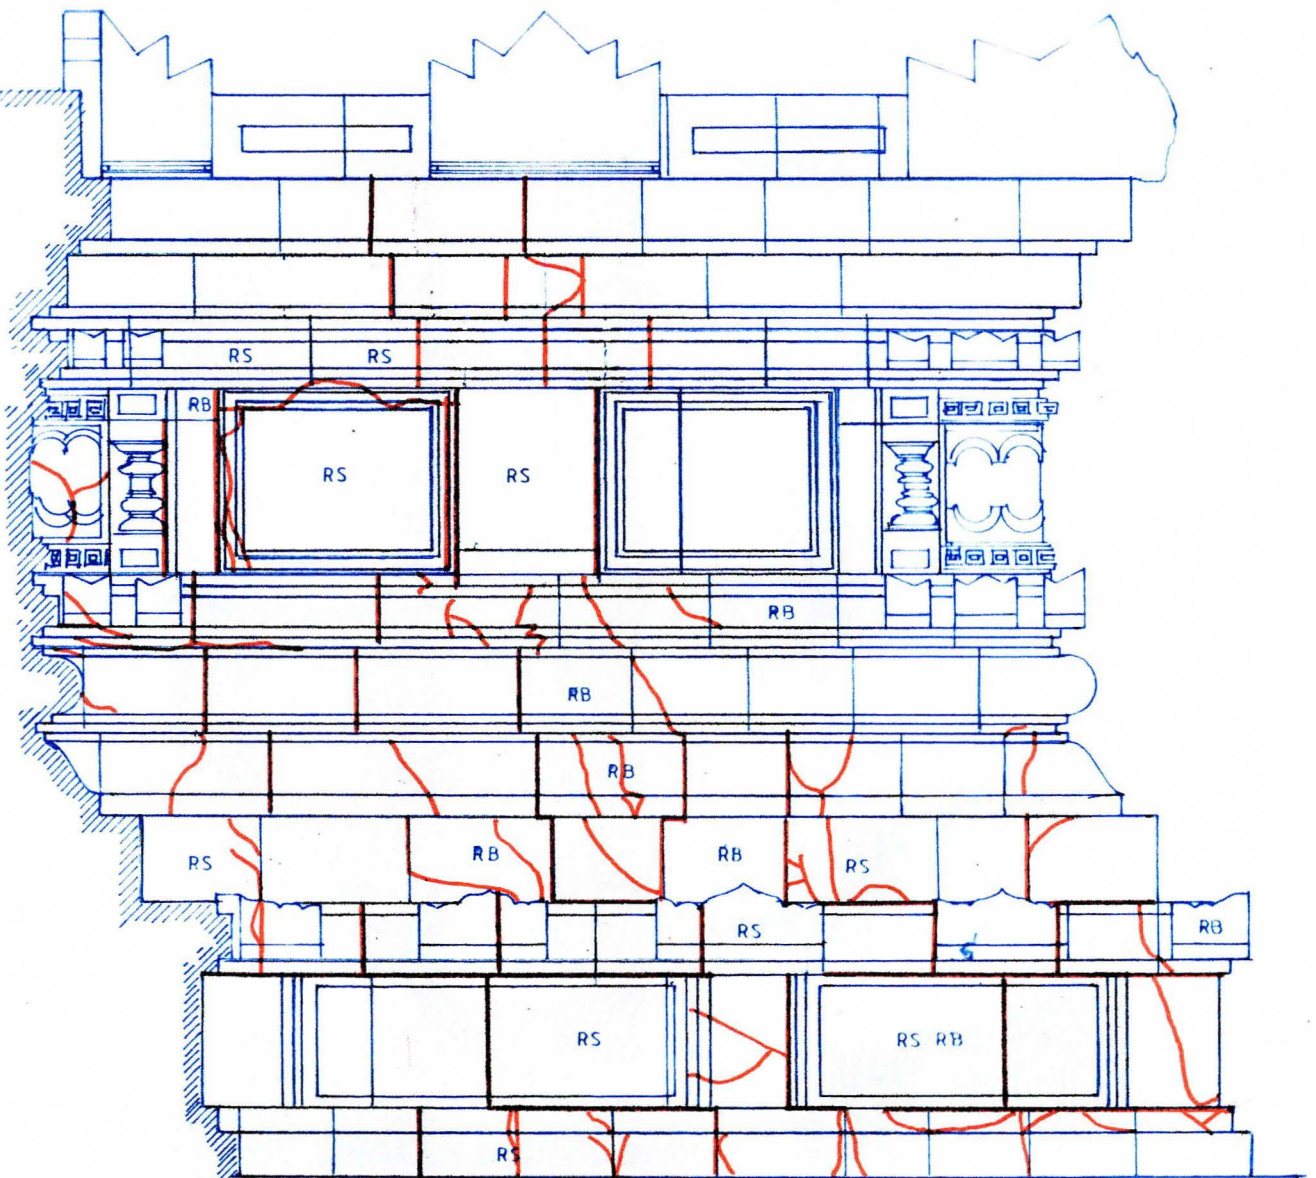
Area 12

— Cracking and open joint stone

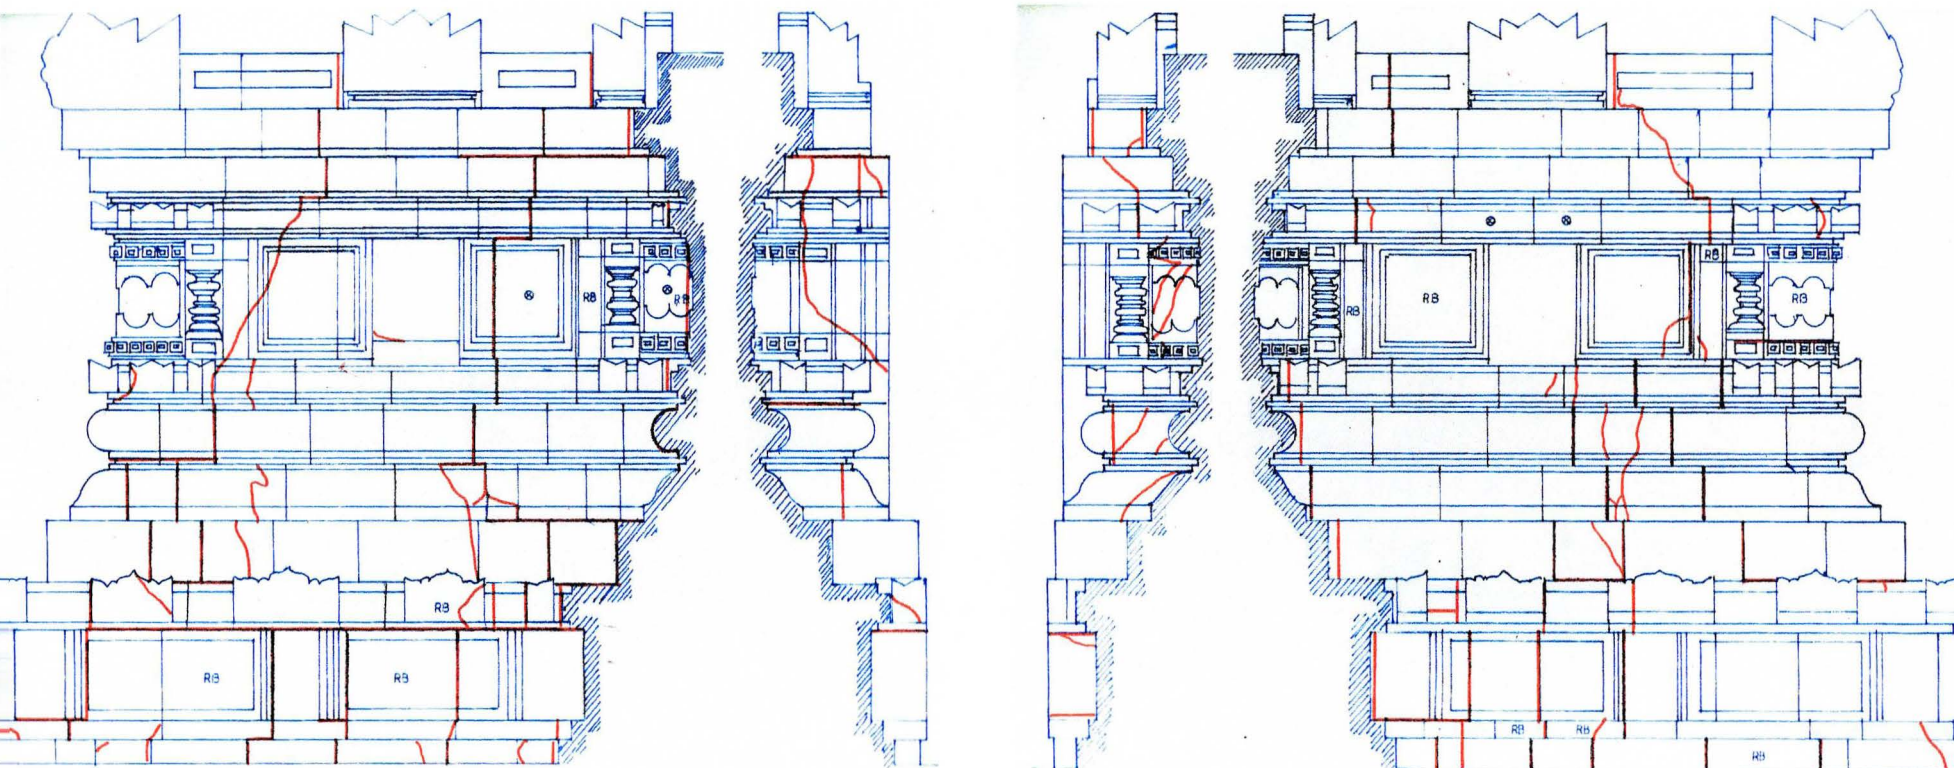
Area XVI

— Cracking and open joint stone

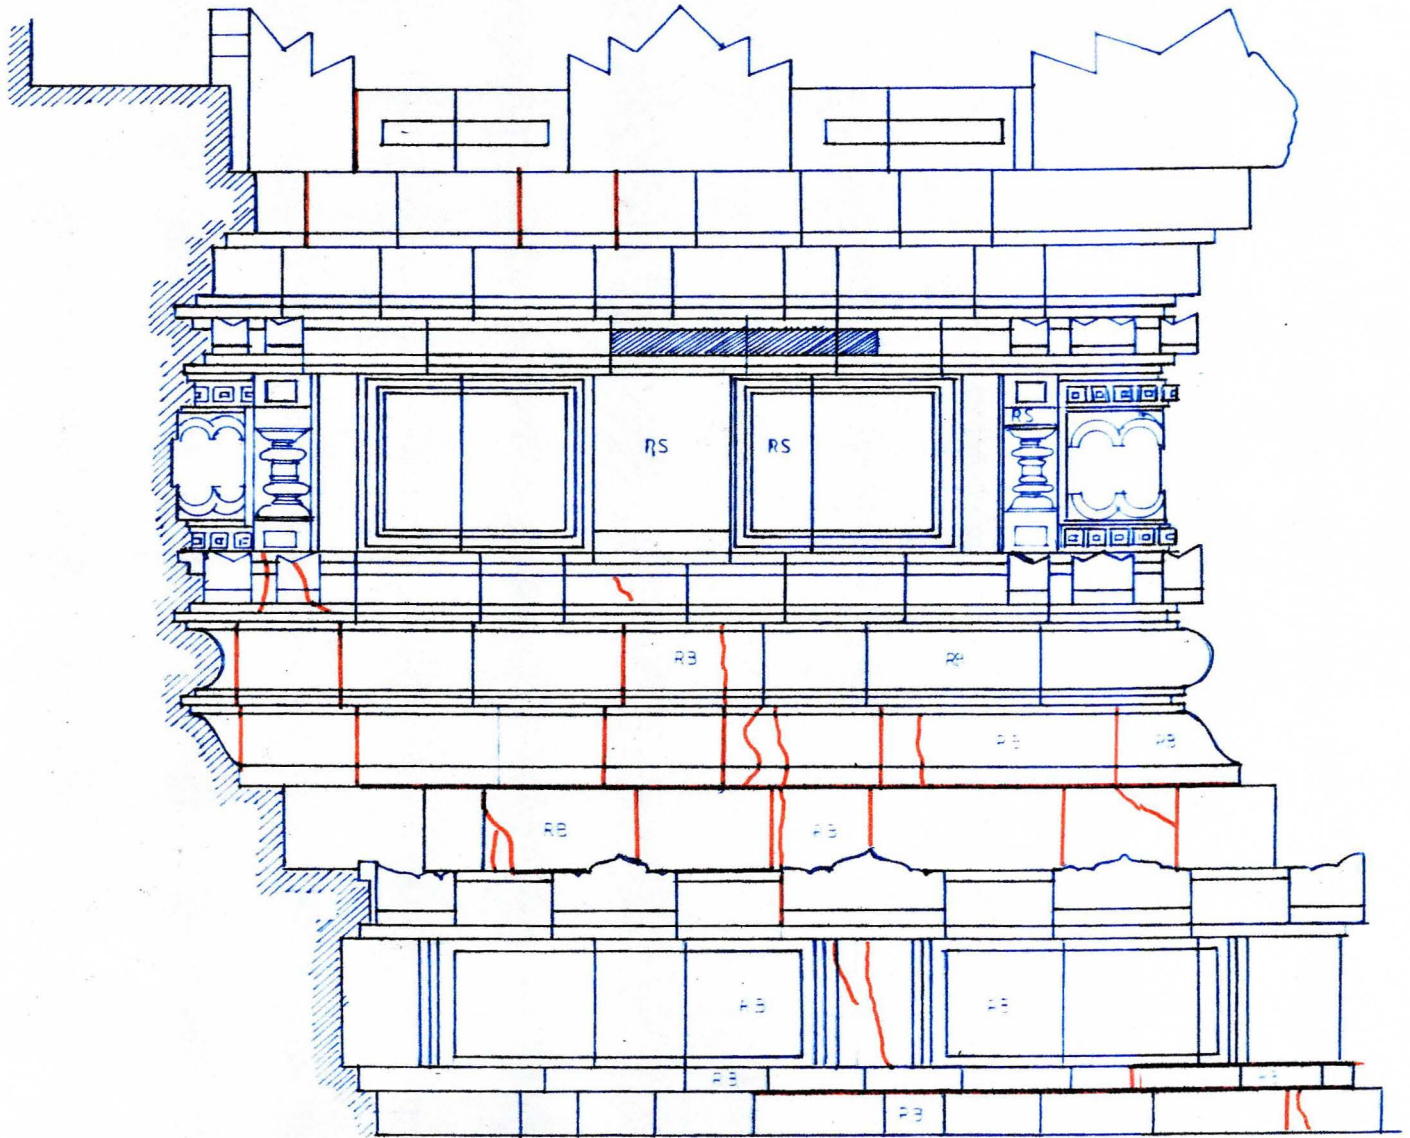
Area 17

— Craking and open joint stone

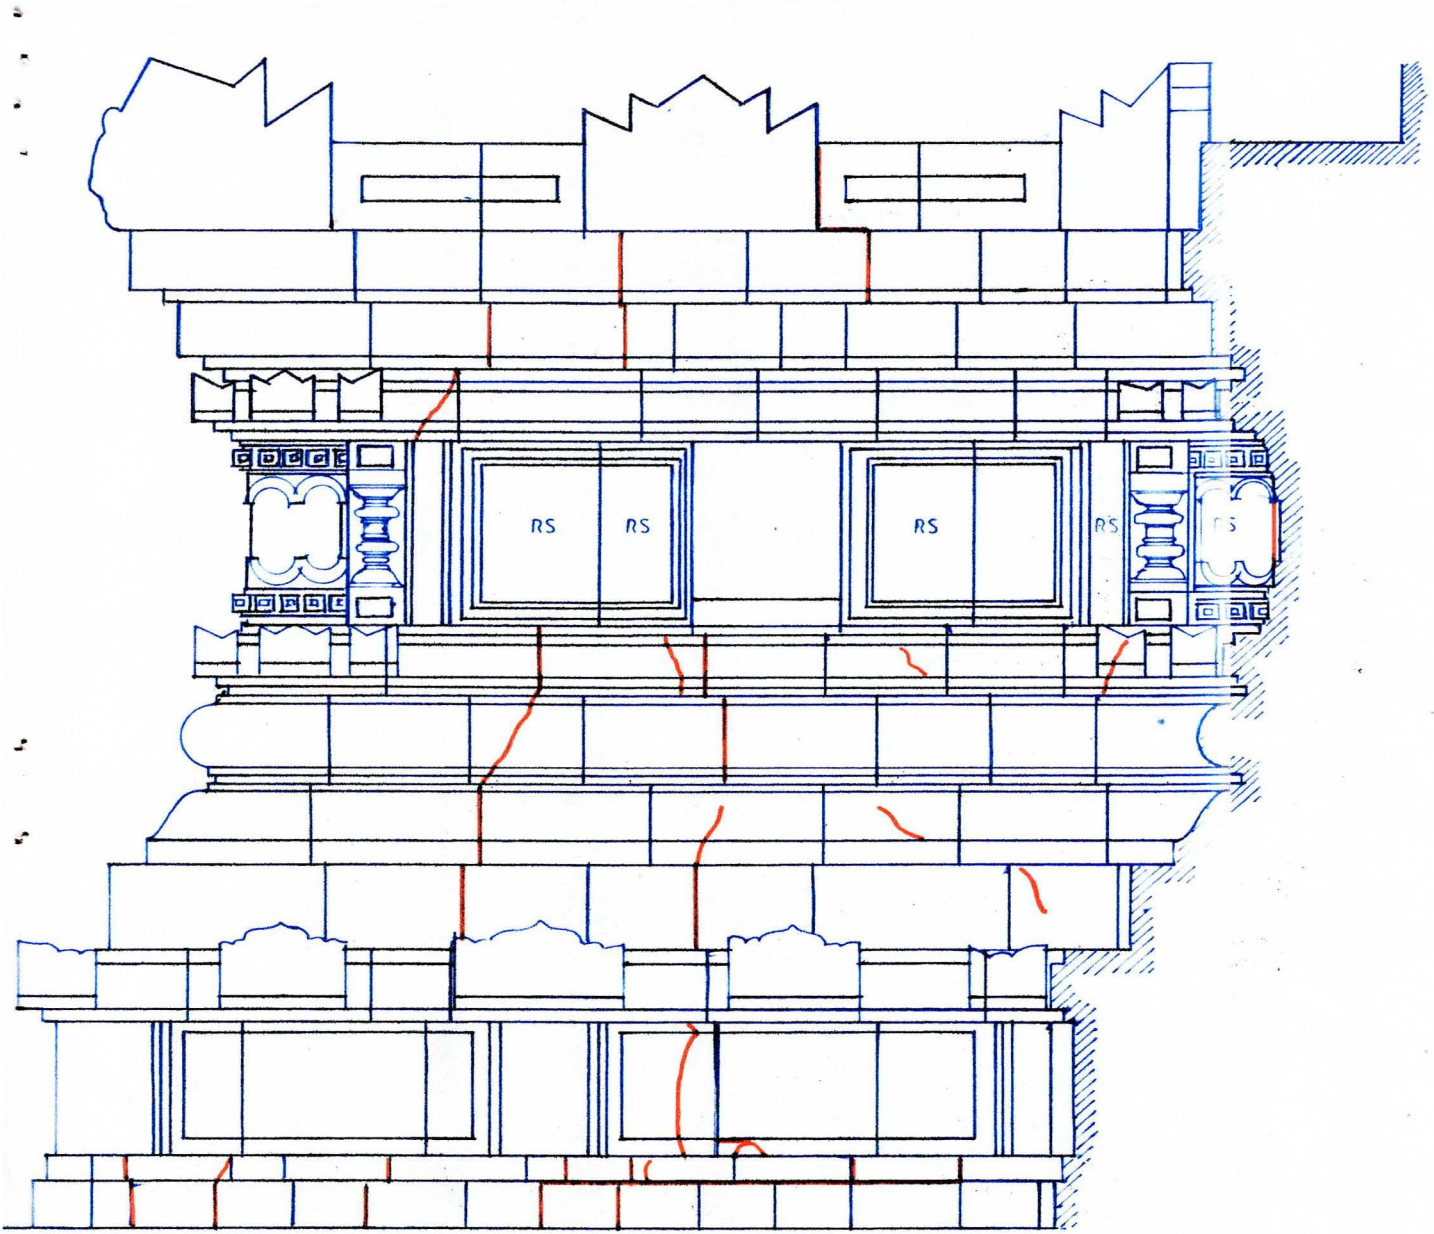
Area18

— Craking and open joint stone

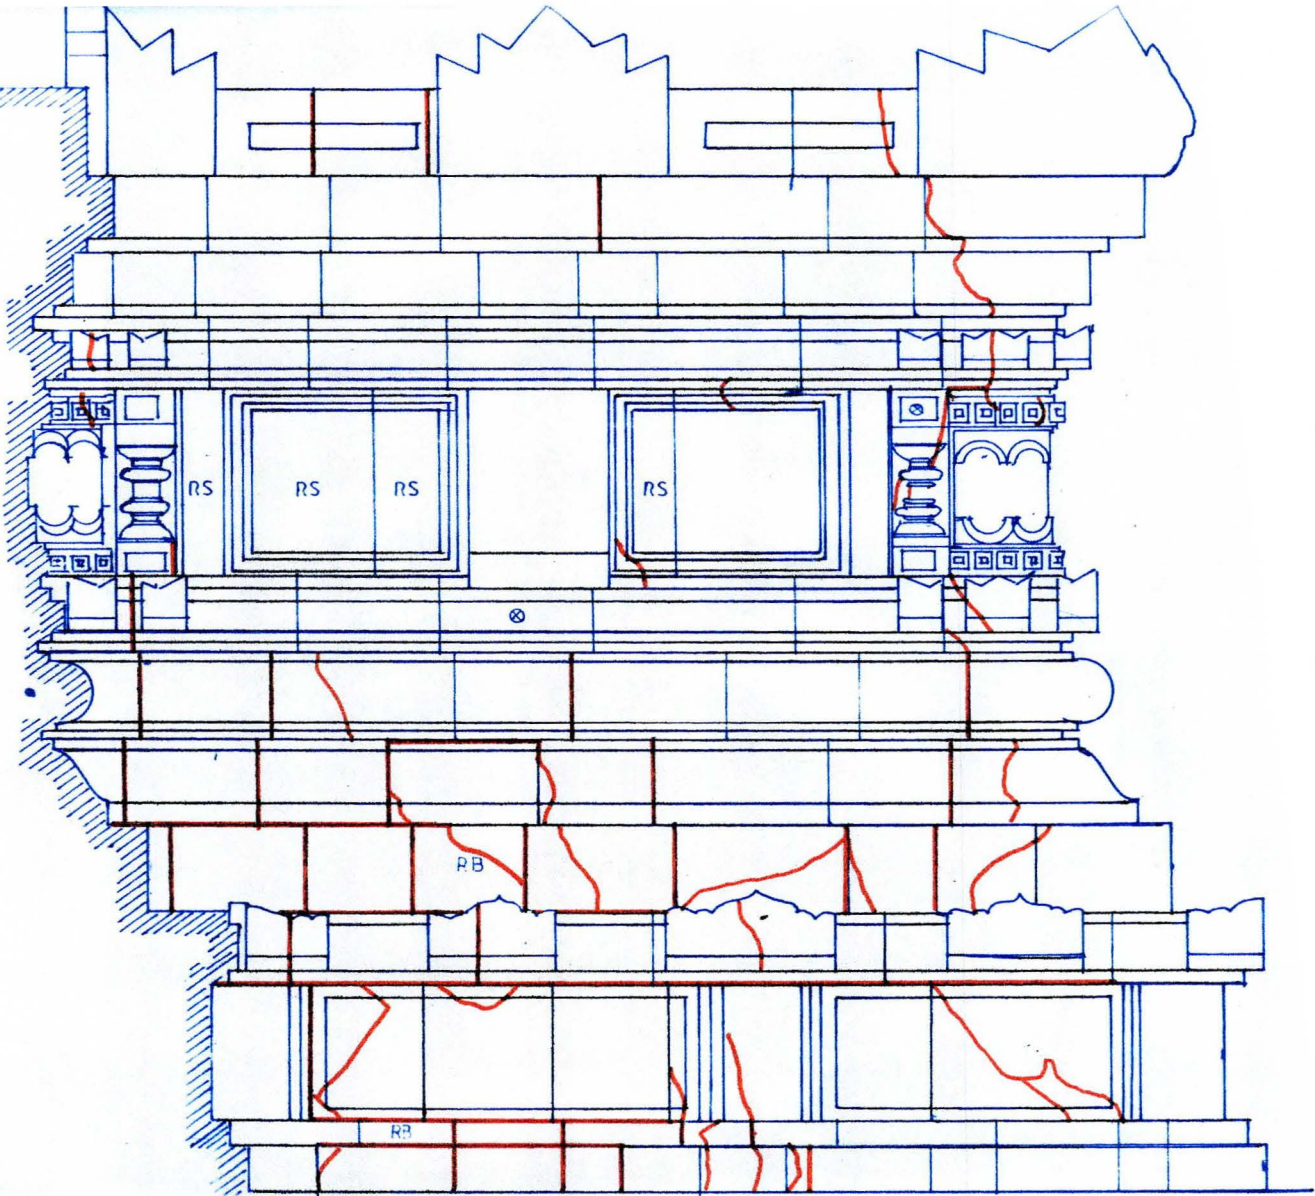
Area 19

— Craking and open joint stone

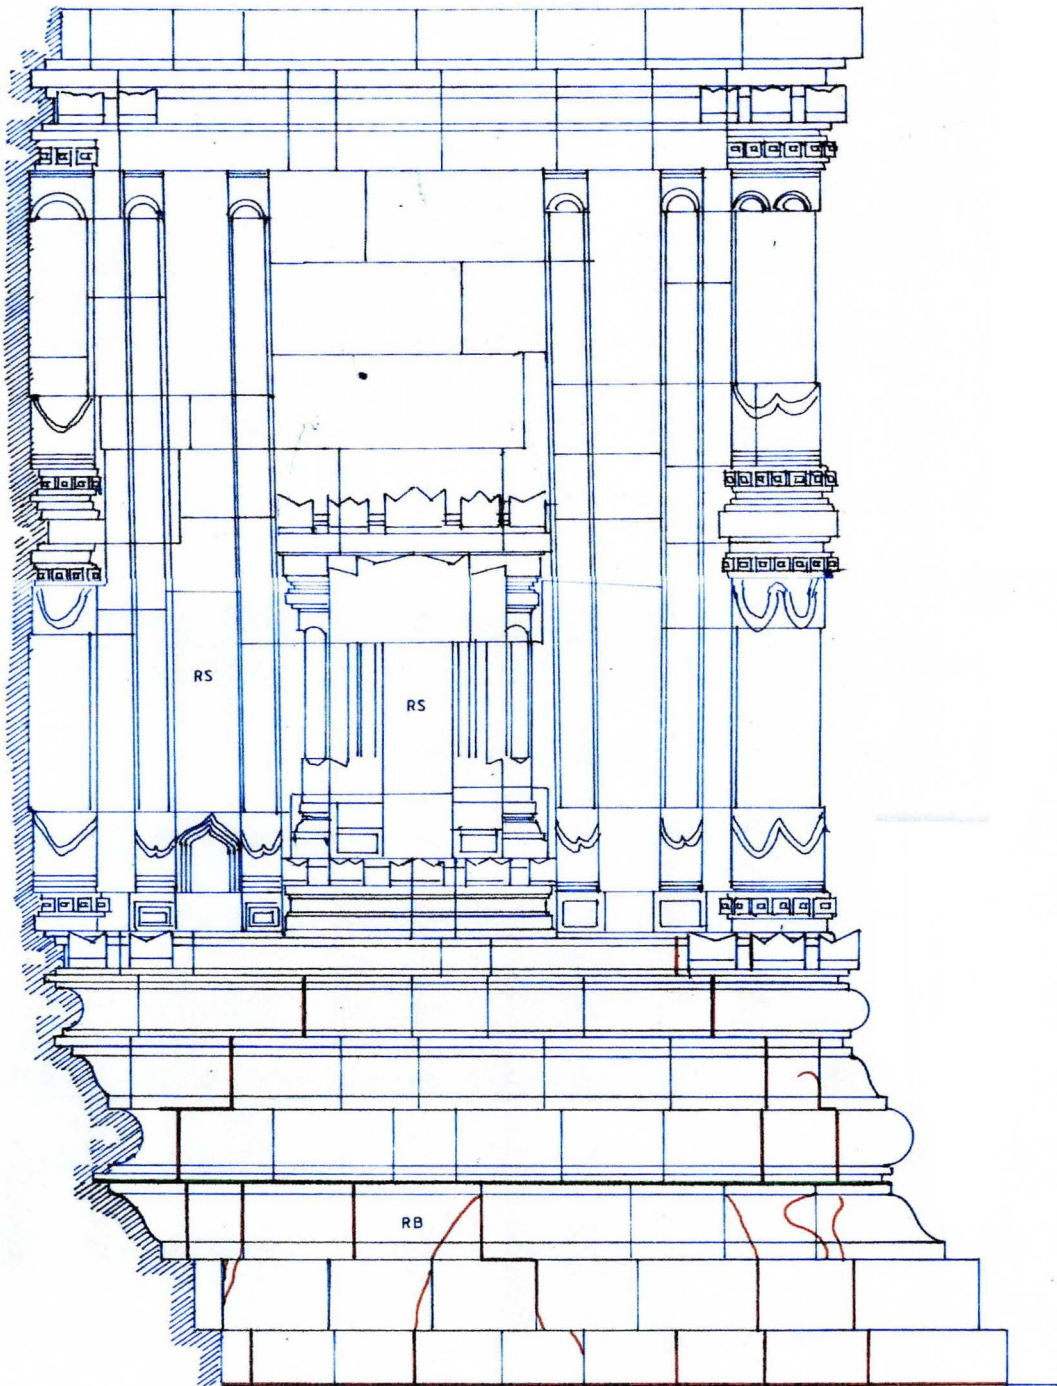
Area II

— Cracking and open joint stone

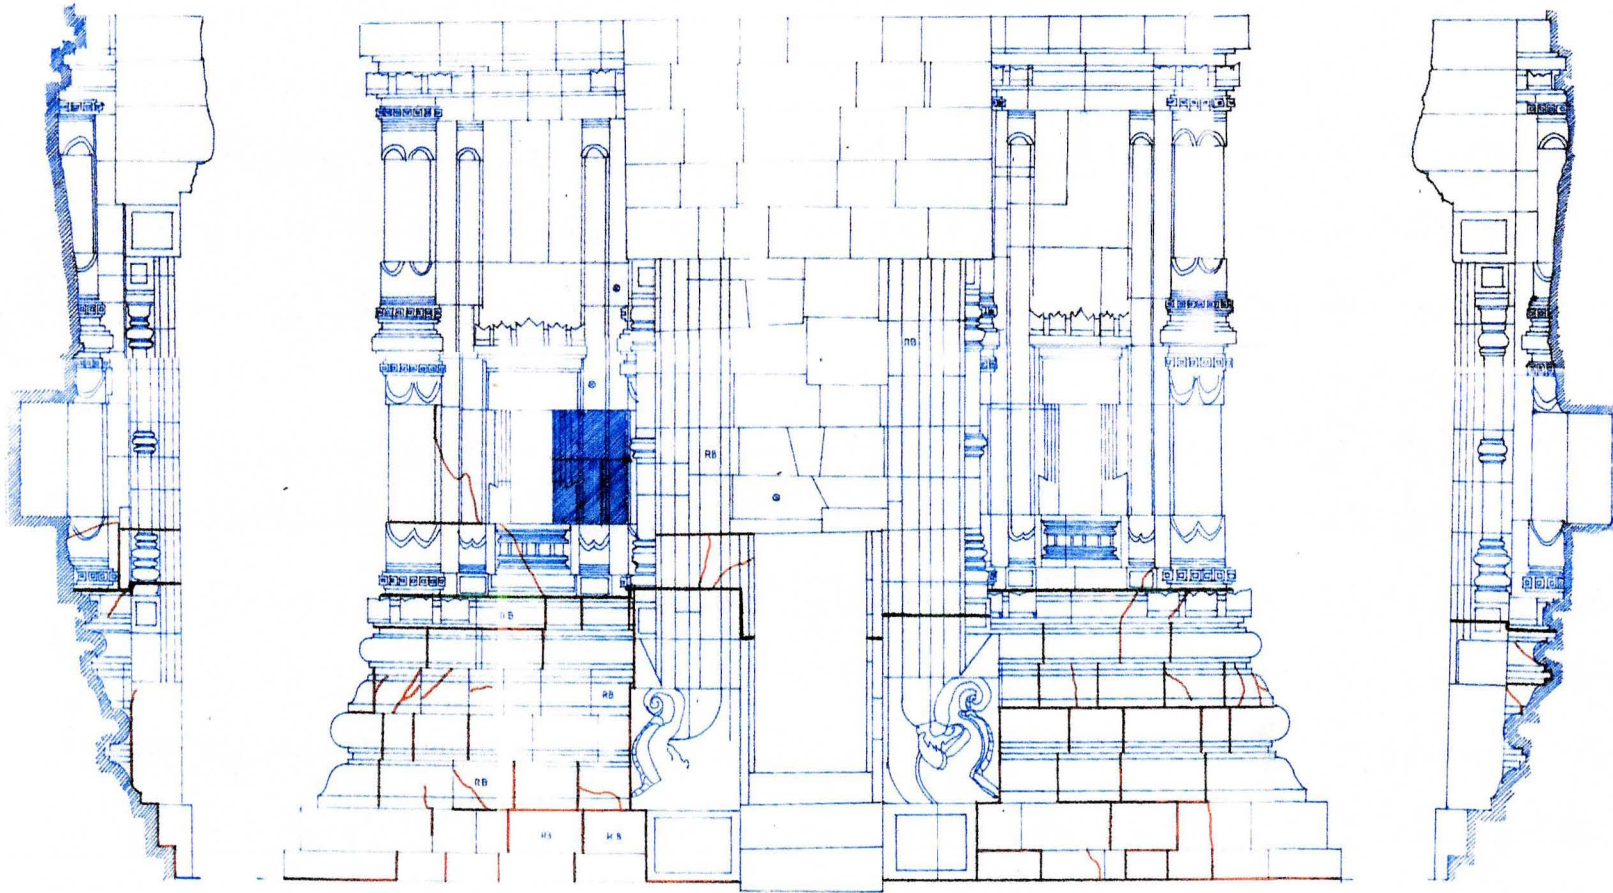
— Cracking and open joint stone

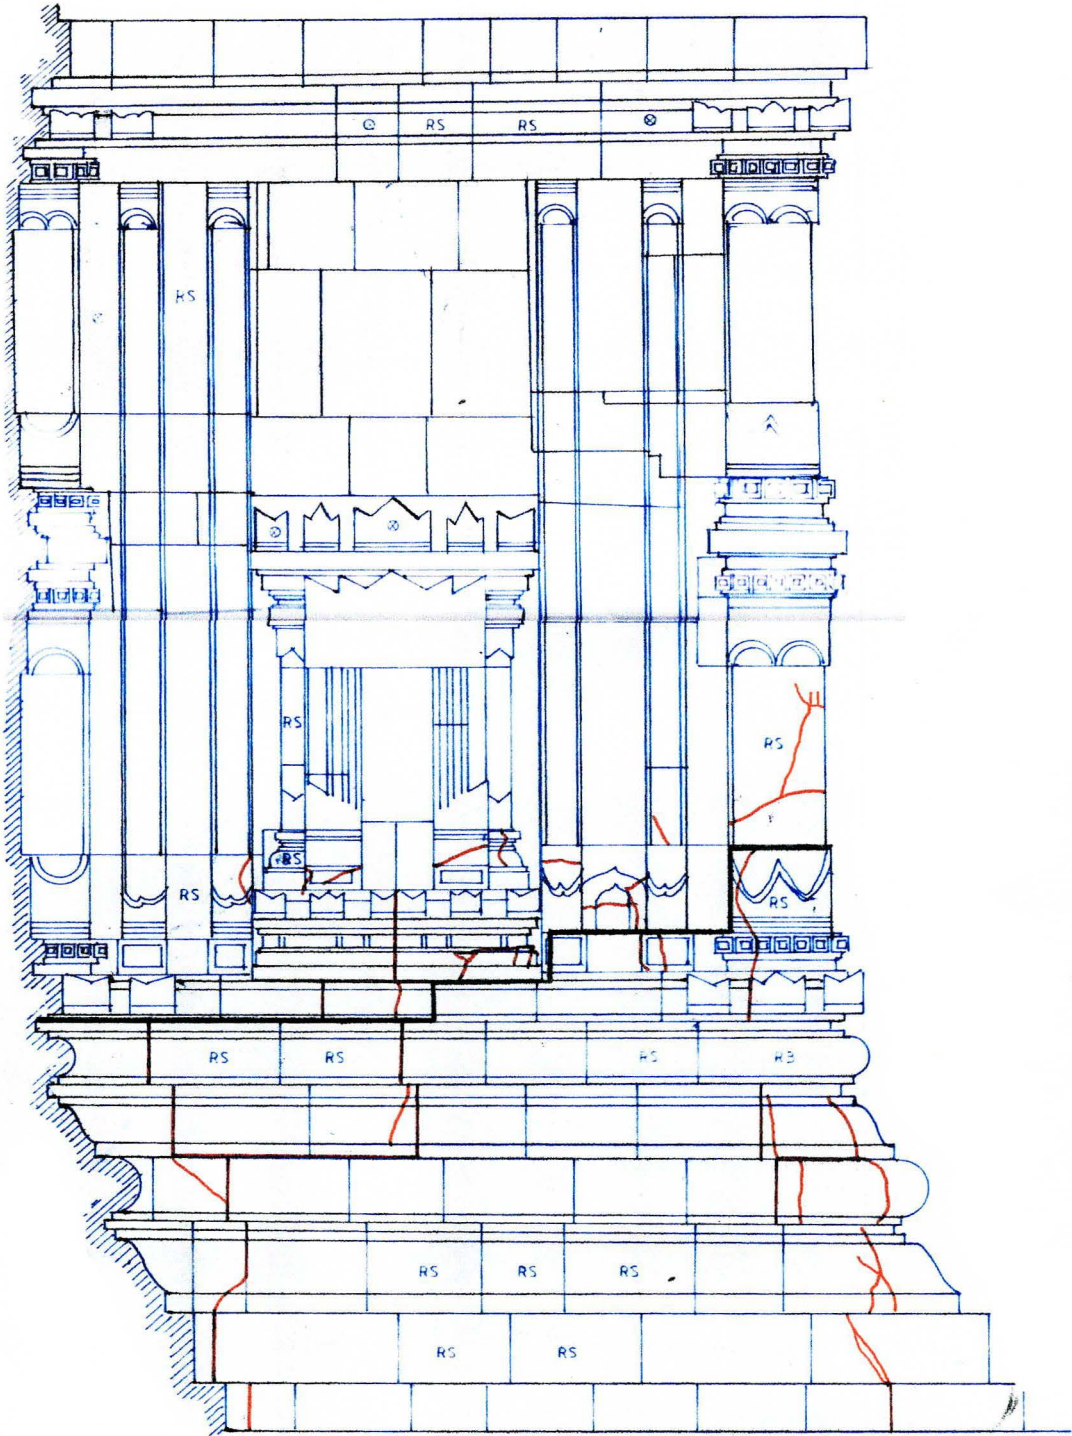
Area 9

— Craking and open joint stone

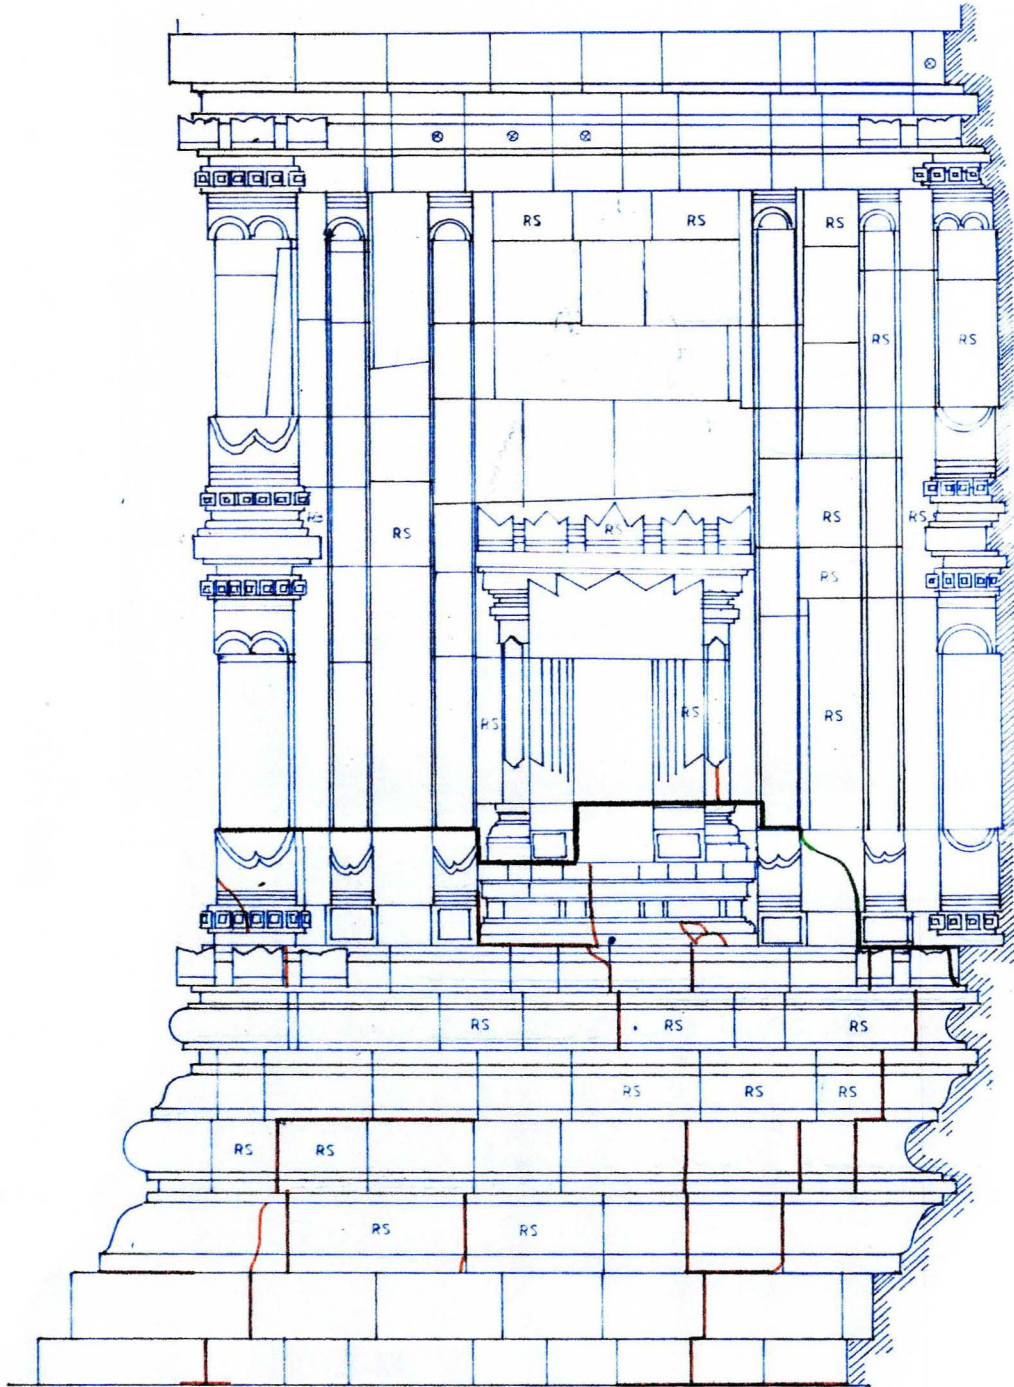
Area X

Craking and open joint stone

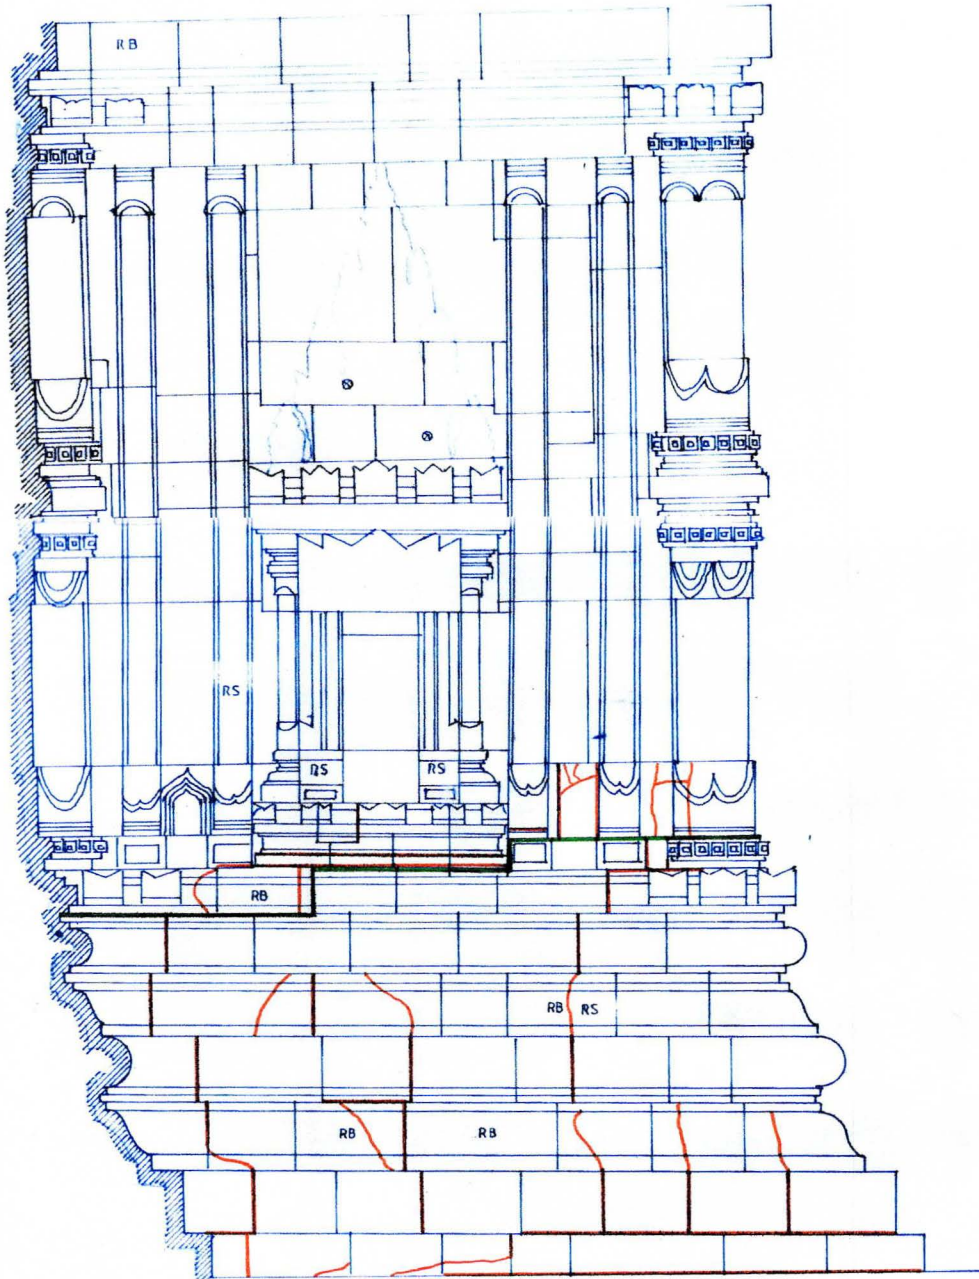
Area XVII

— Cracking and open joint stone
