TECHNICAL STUDY

FOR REHABILITATION ON PRAMBANAN TEMPLE COMPOUND AFTER EARTHQUAKE

BY
TECHNICAL STUDY TEAM
ARCHAEOLOGICAL OFFICE OF YOGYAKARTA

DEPARTMENT OF CULTURE AND TOURISM
2007

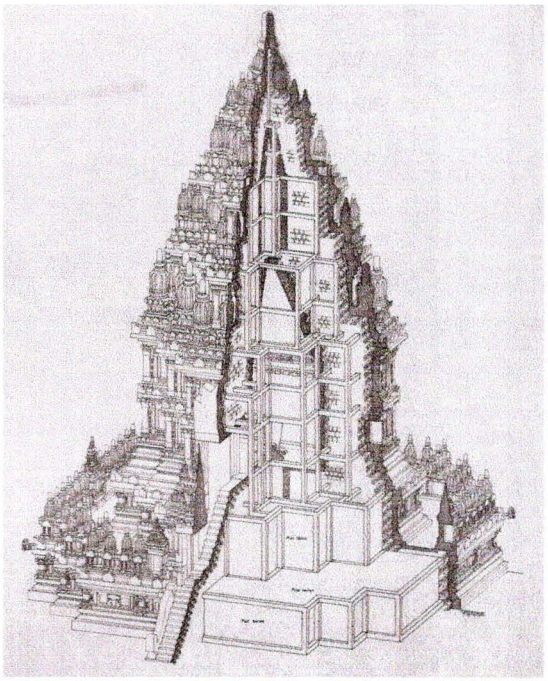
Reinforced concrete construction on Siwa temple

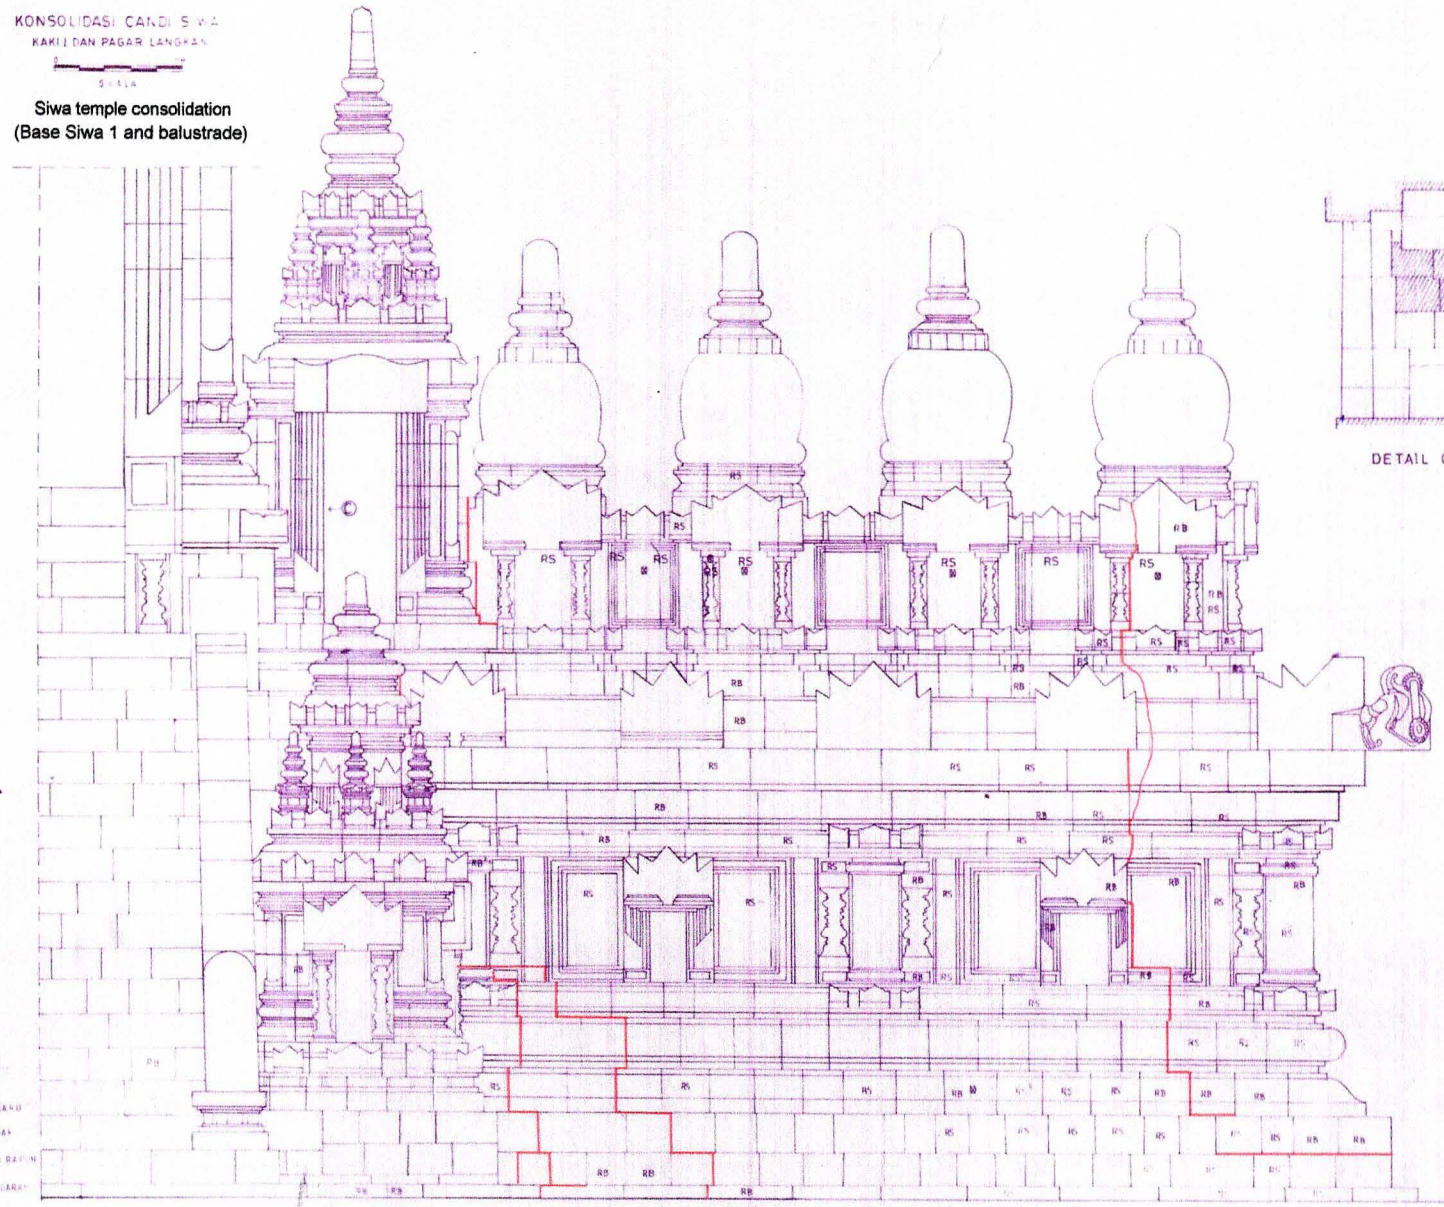
(Section 1)

Siwa temple consolidation
(Base Siwa 1 and balustrade)

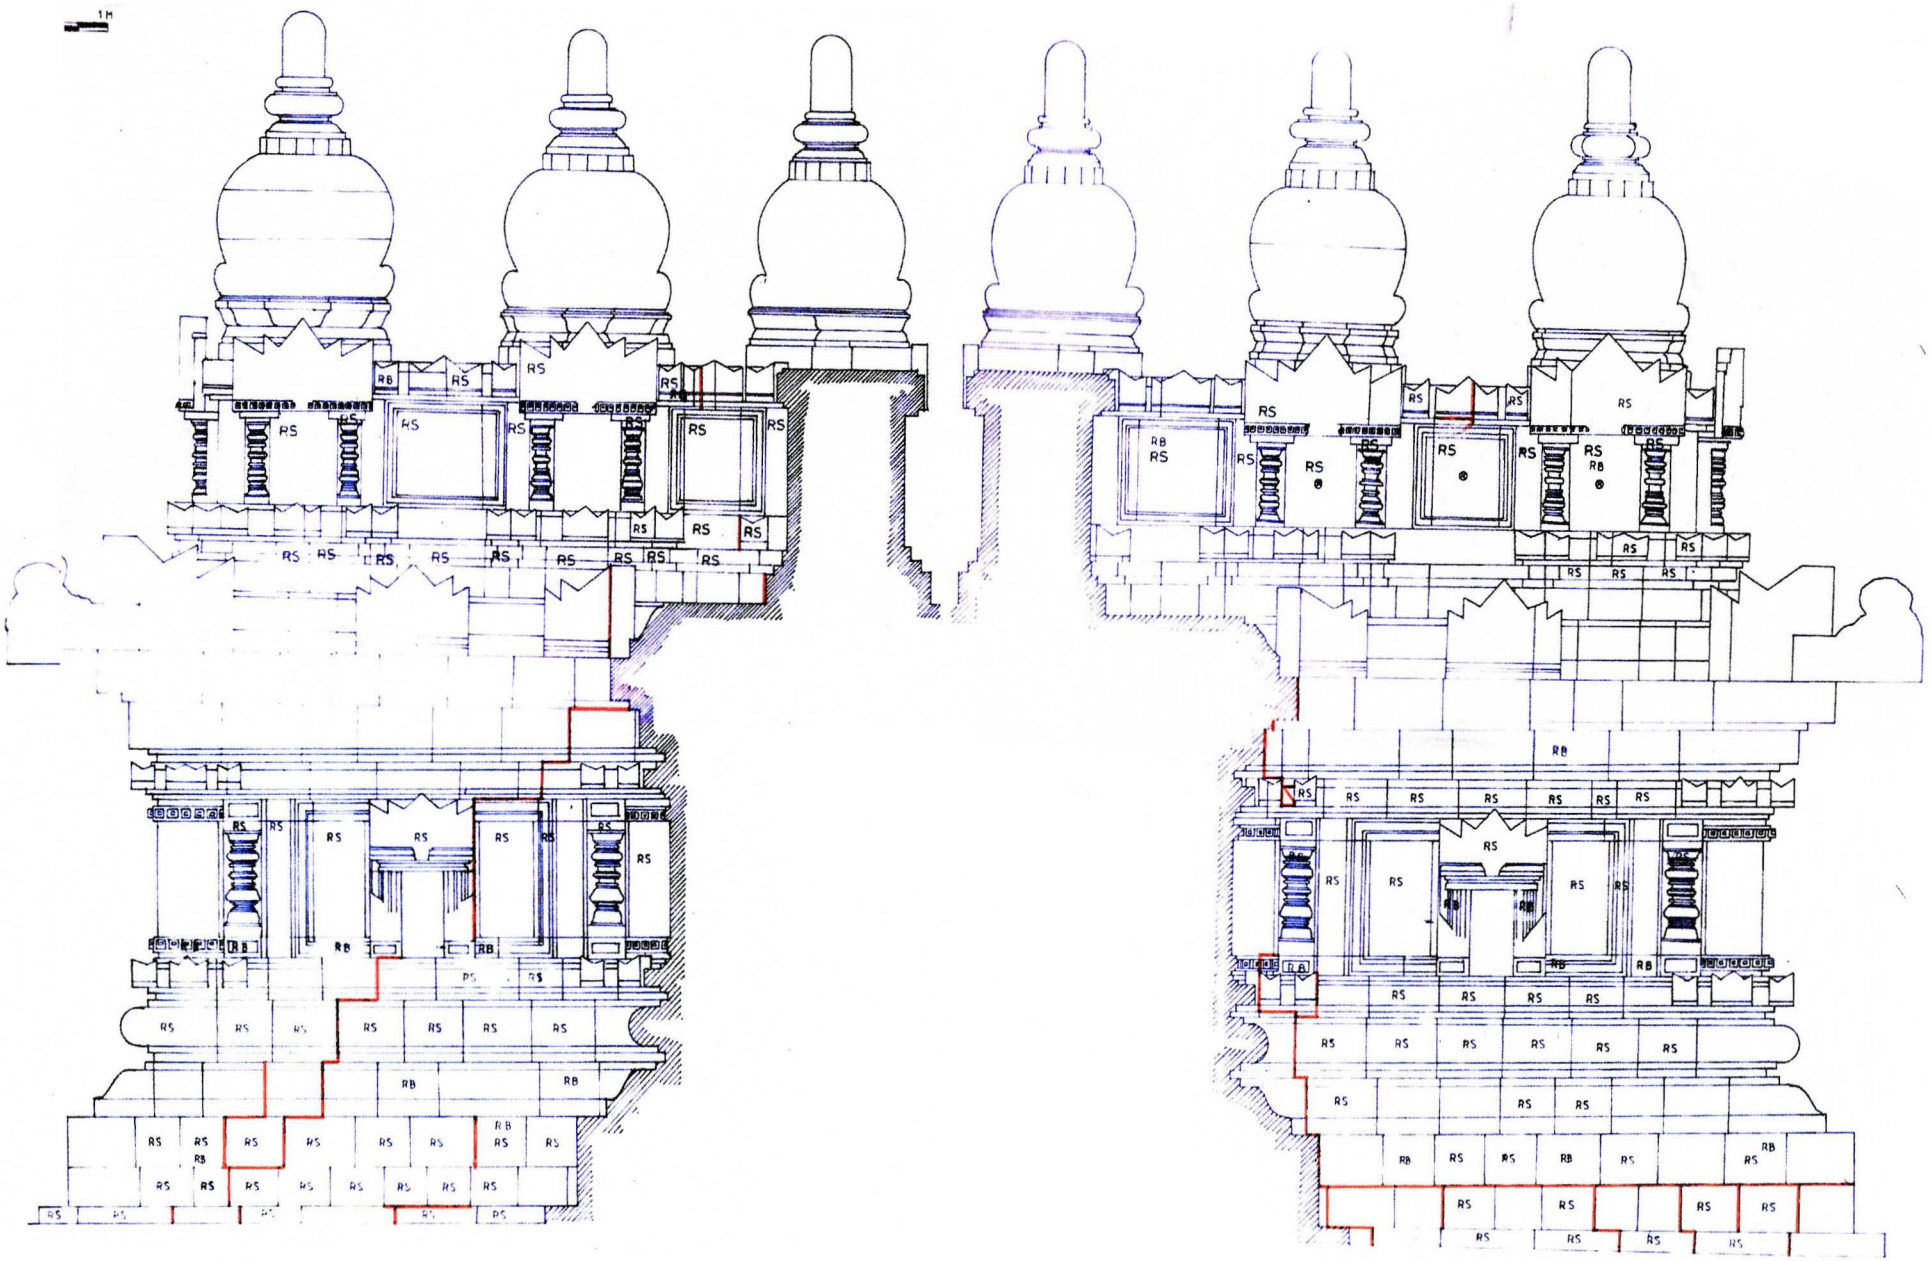
Bidang 3
(Section 3)

Candi Siwa
Kaki I dan Pagar Langkan
(Base Siwa 1 and balustrade)

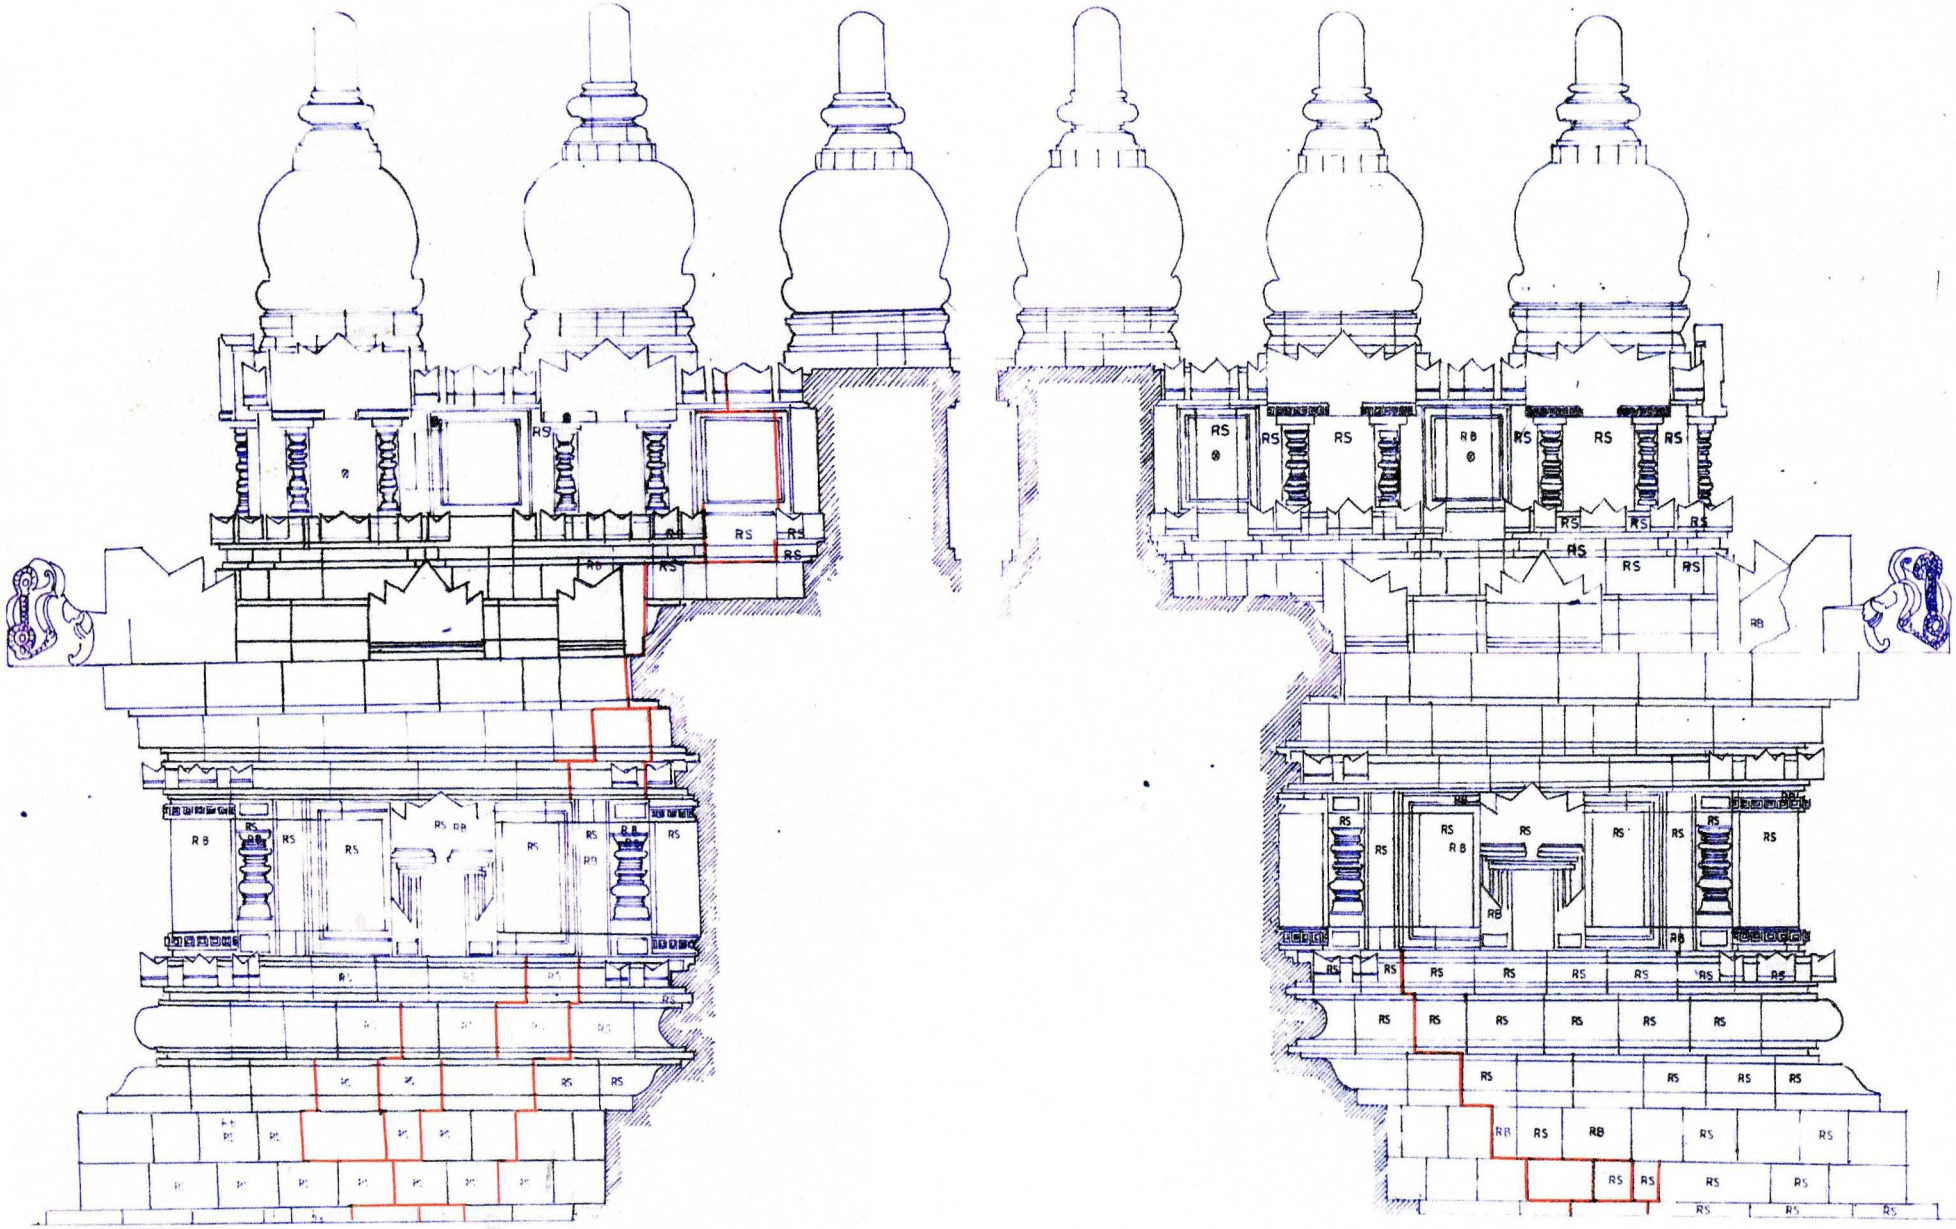
Bidang 5
(Section 5)

Candi Siwa
Kaki I dan Pagar Langkan
(Base I and balustrade of Siwa temple)

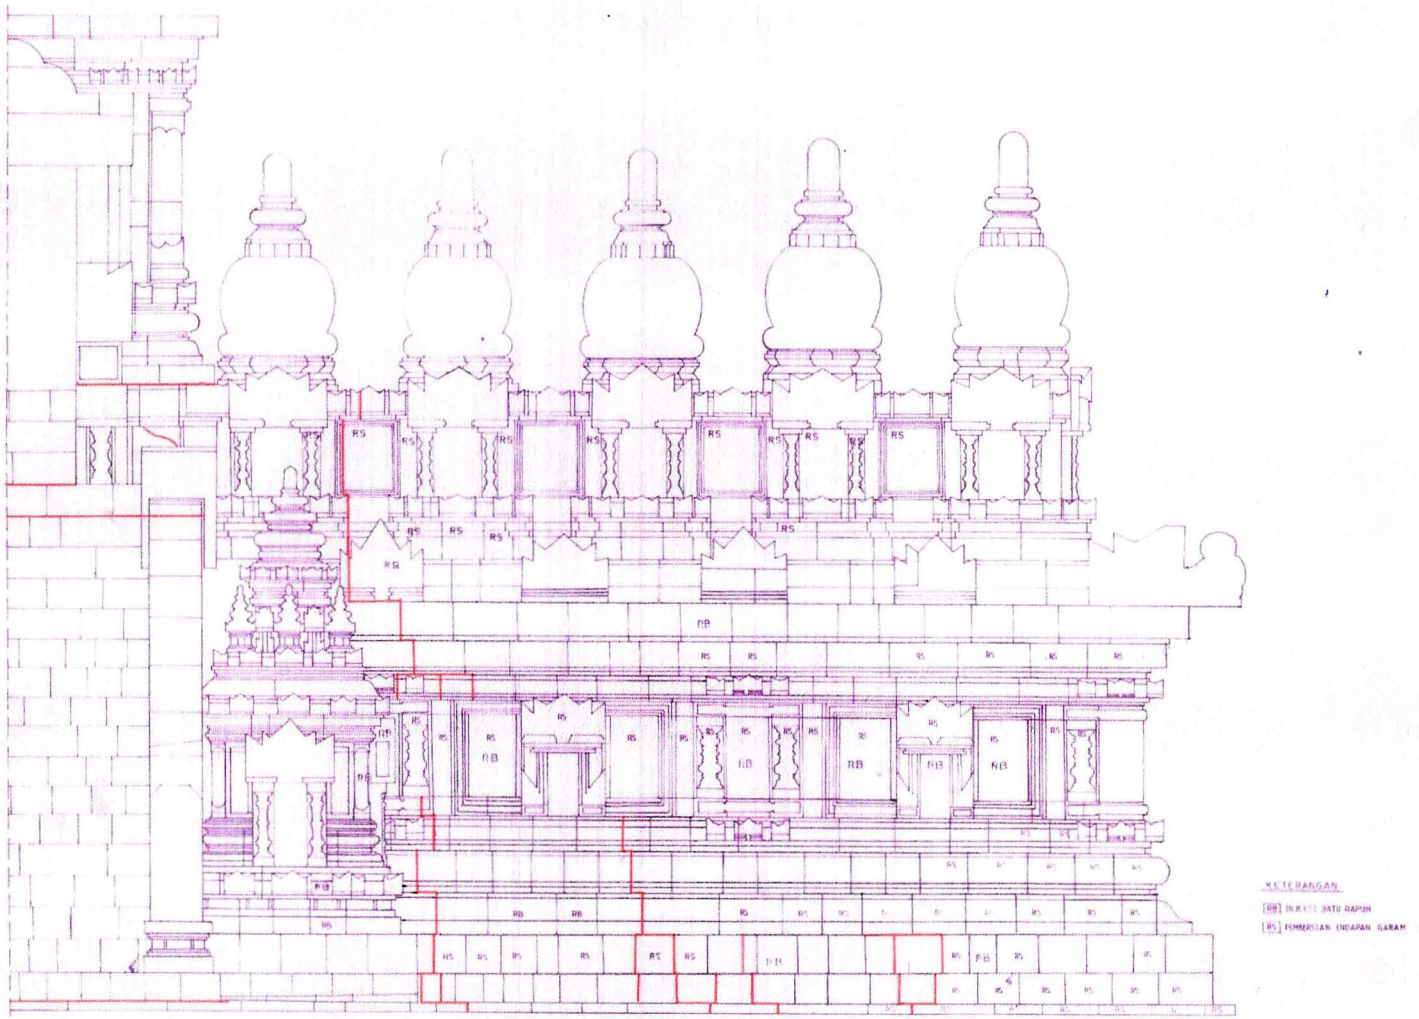
BIDANG 6
Section 6

Siwa temple consolidation
Base Siwa 1 and Balustrade

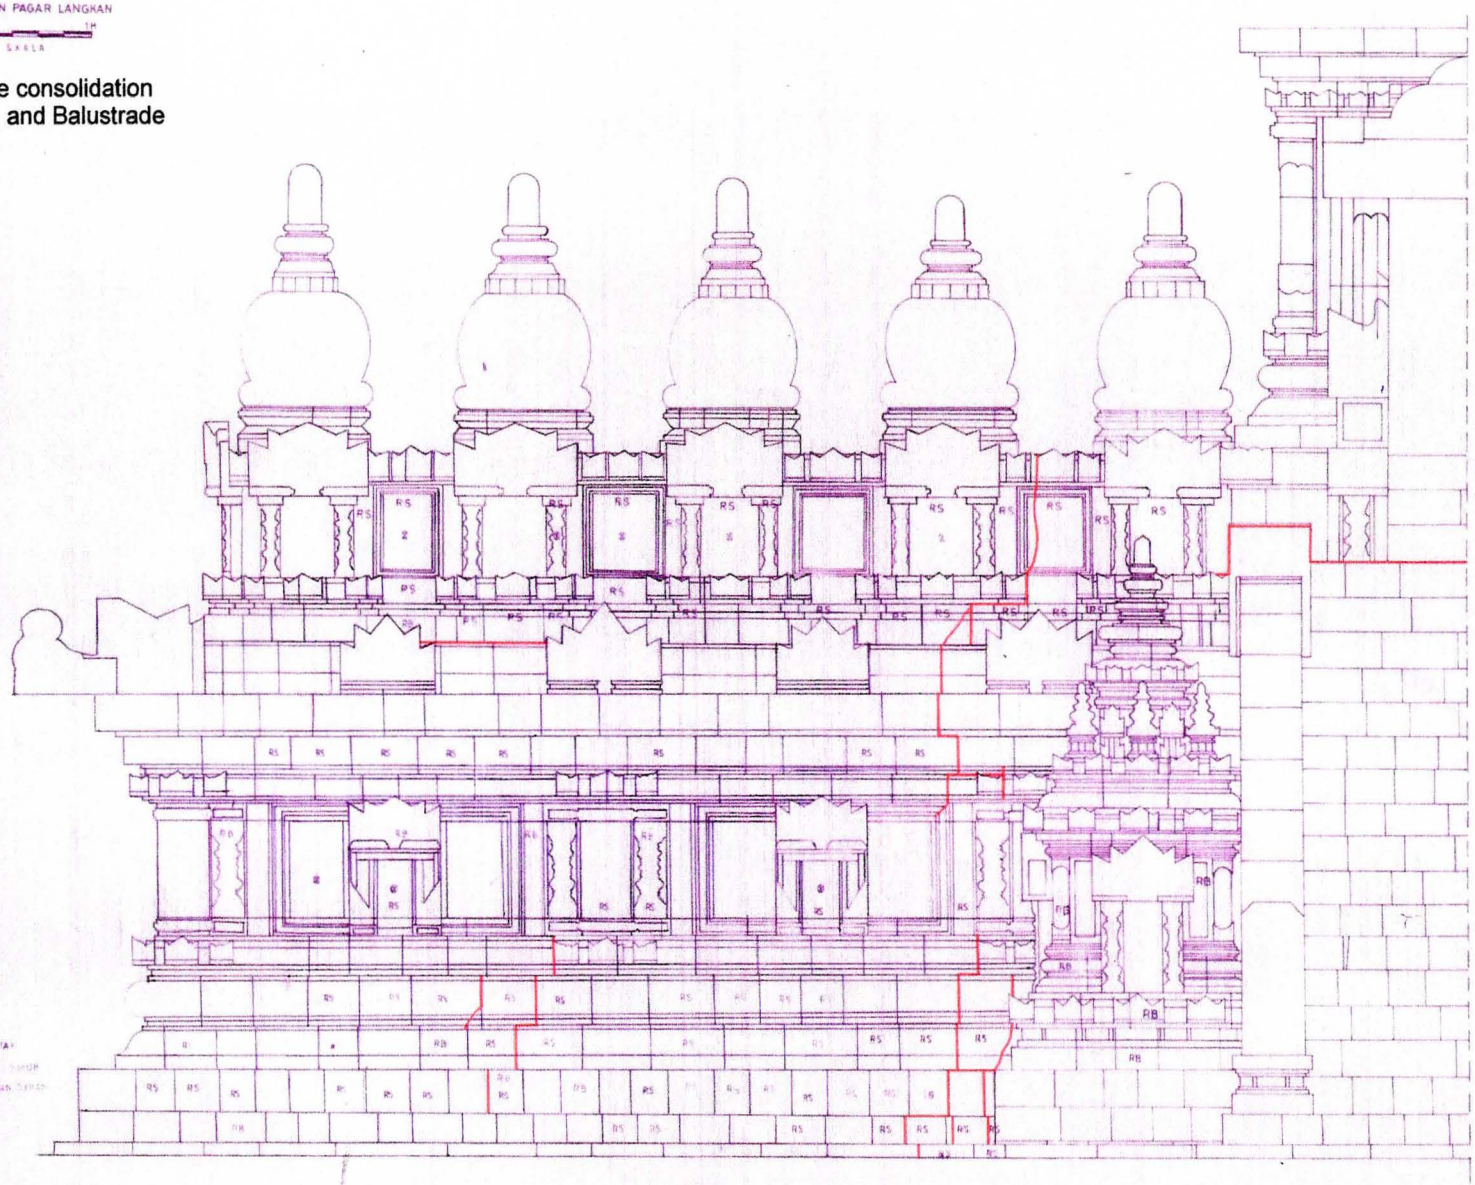
BIDANG 6

Siwa temple consolidation
Base Siwa 1 and Balustrade

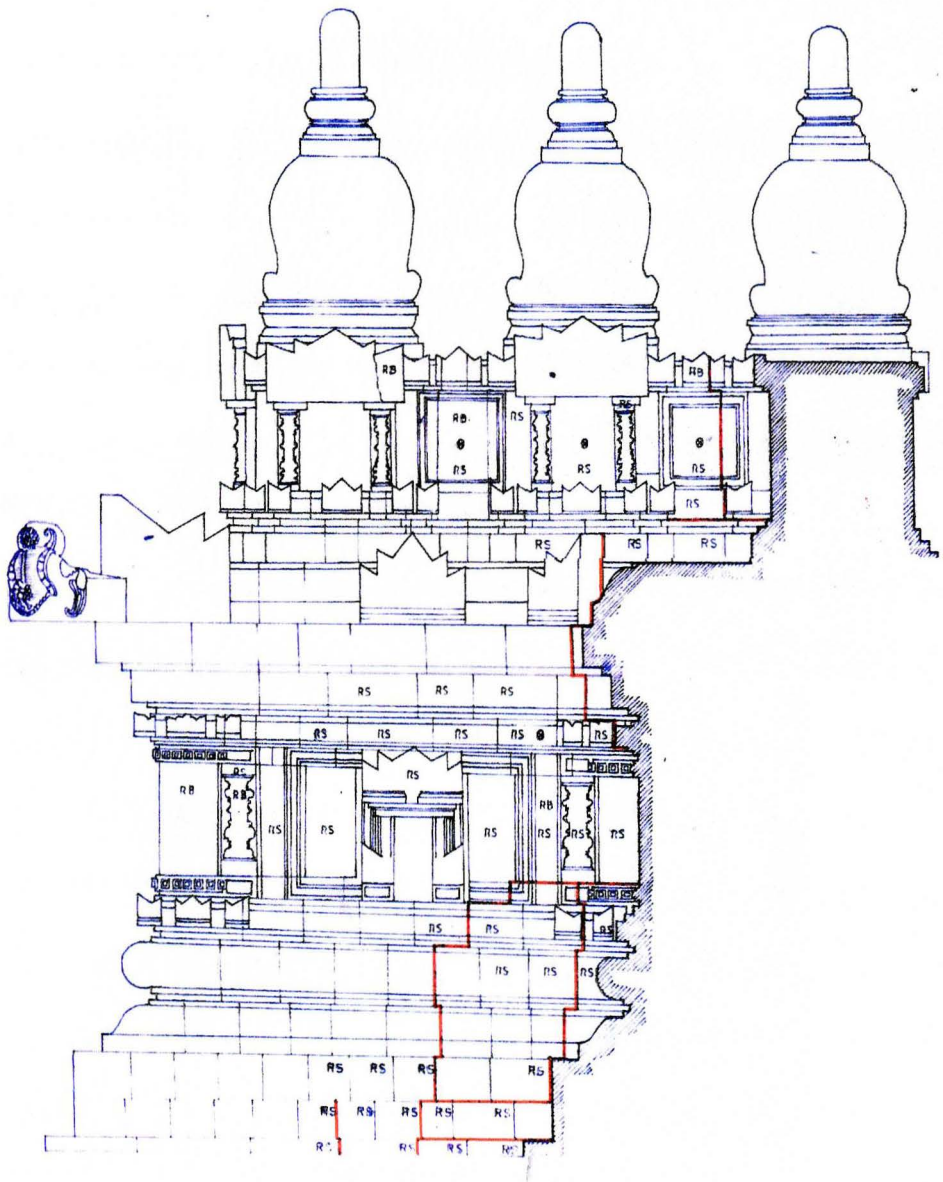
Bidang 8
(Section 8)

(Base Siwa 1 and balustrade)

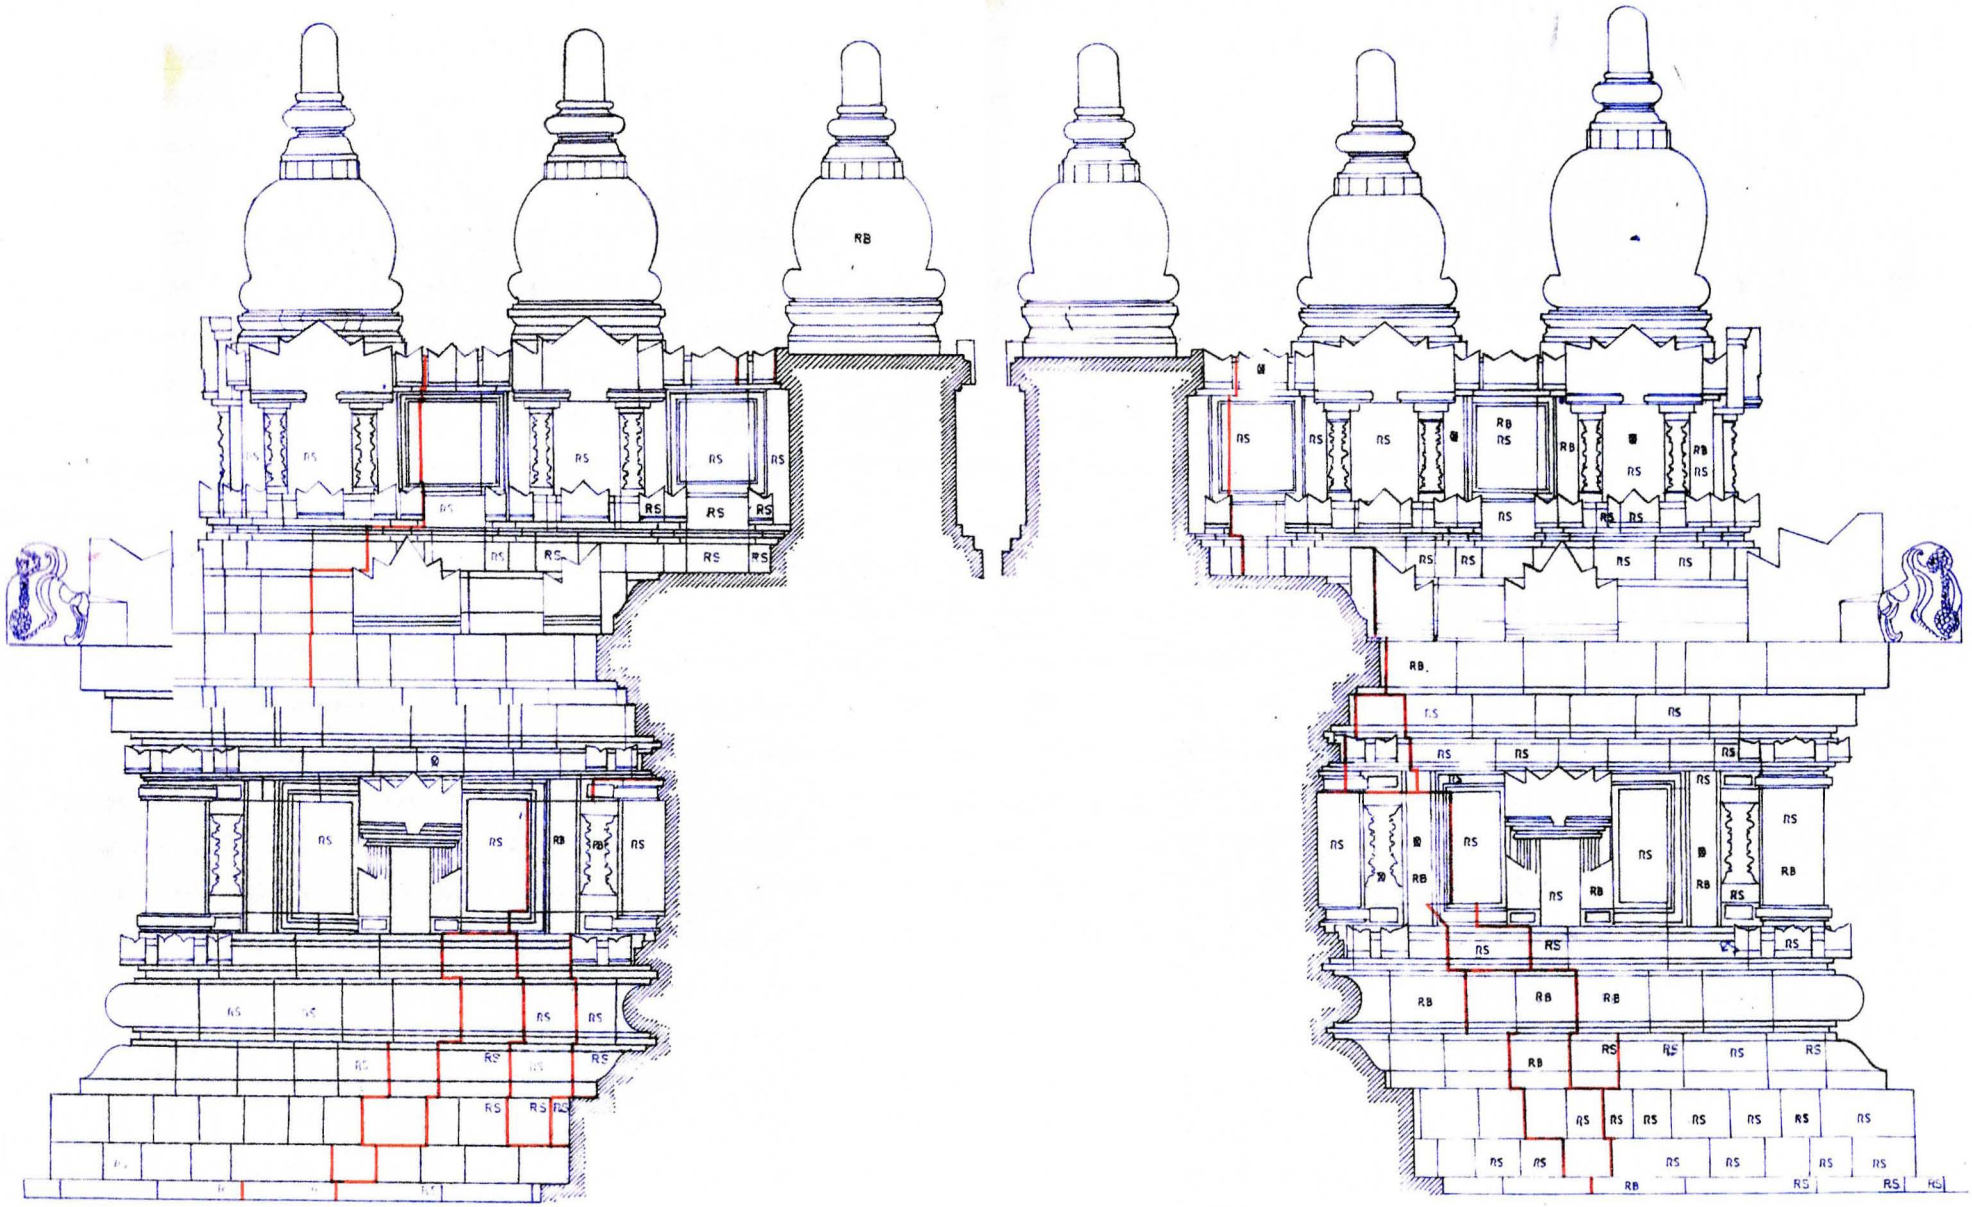
Bidang 10
(Section 10)

Candi Siwa
Kaki I dan Pagar Langkan
(Basement 1 and balustrade of Siwa temple)

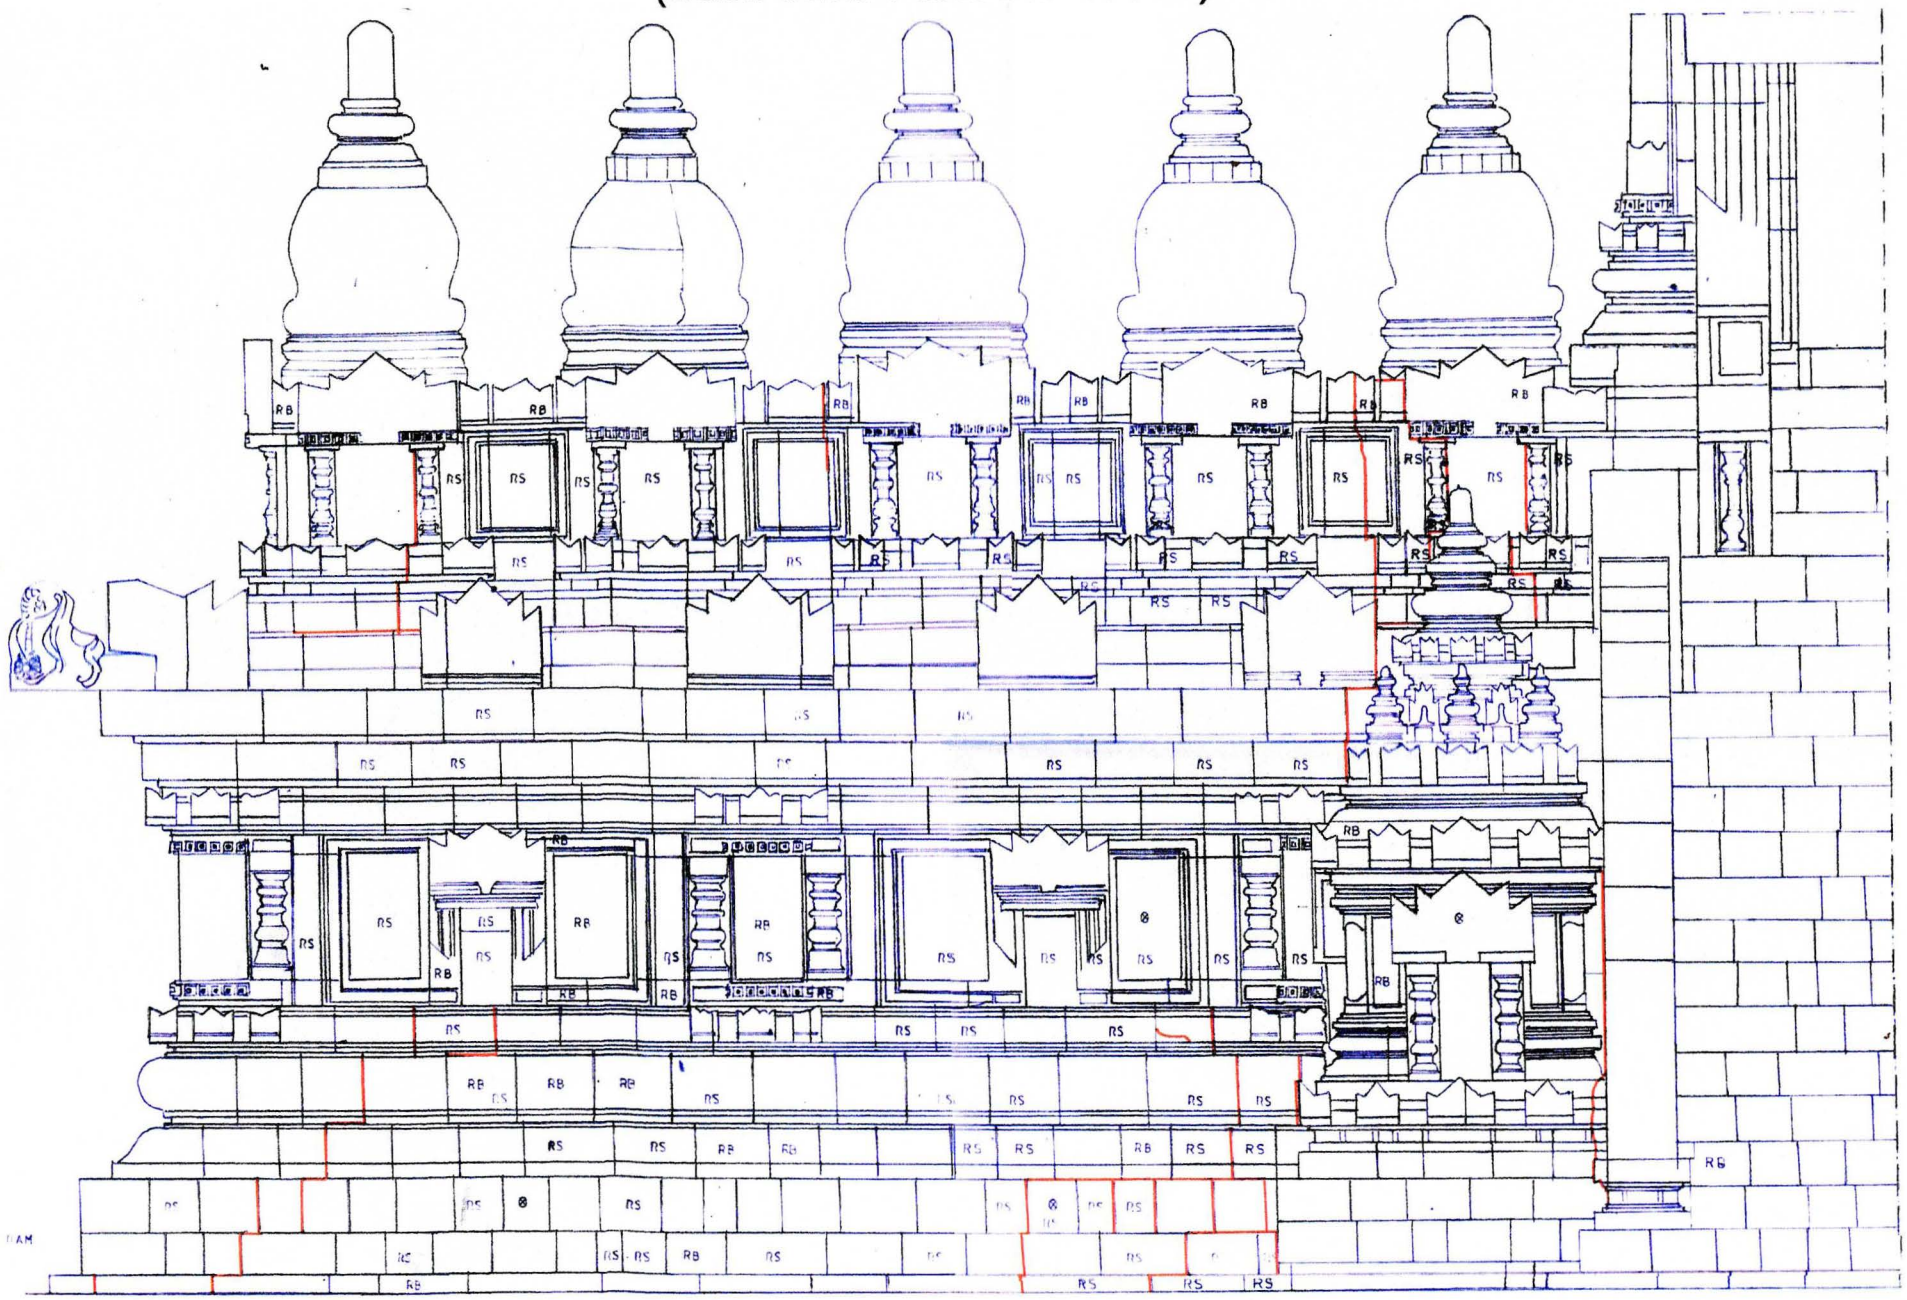
Bidang 11

(Base Siwa 1 and balustrade)

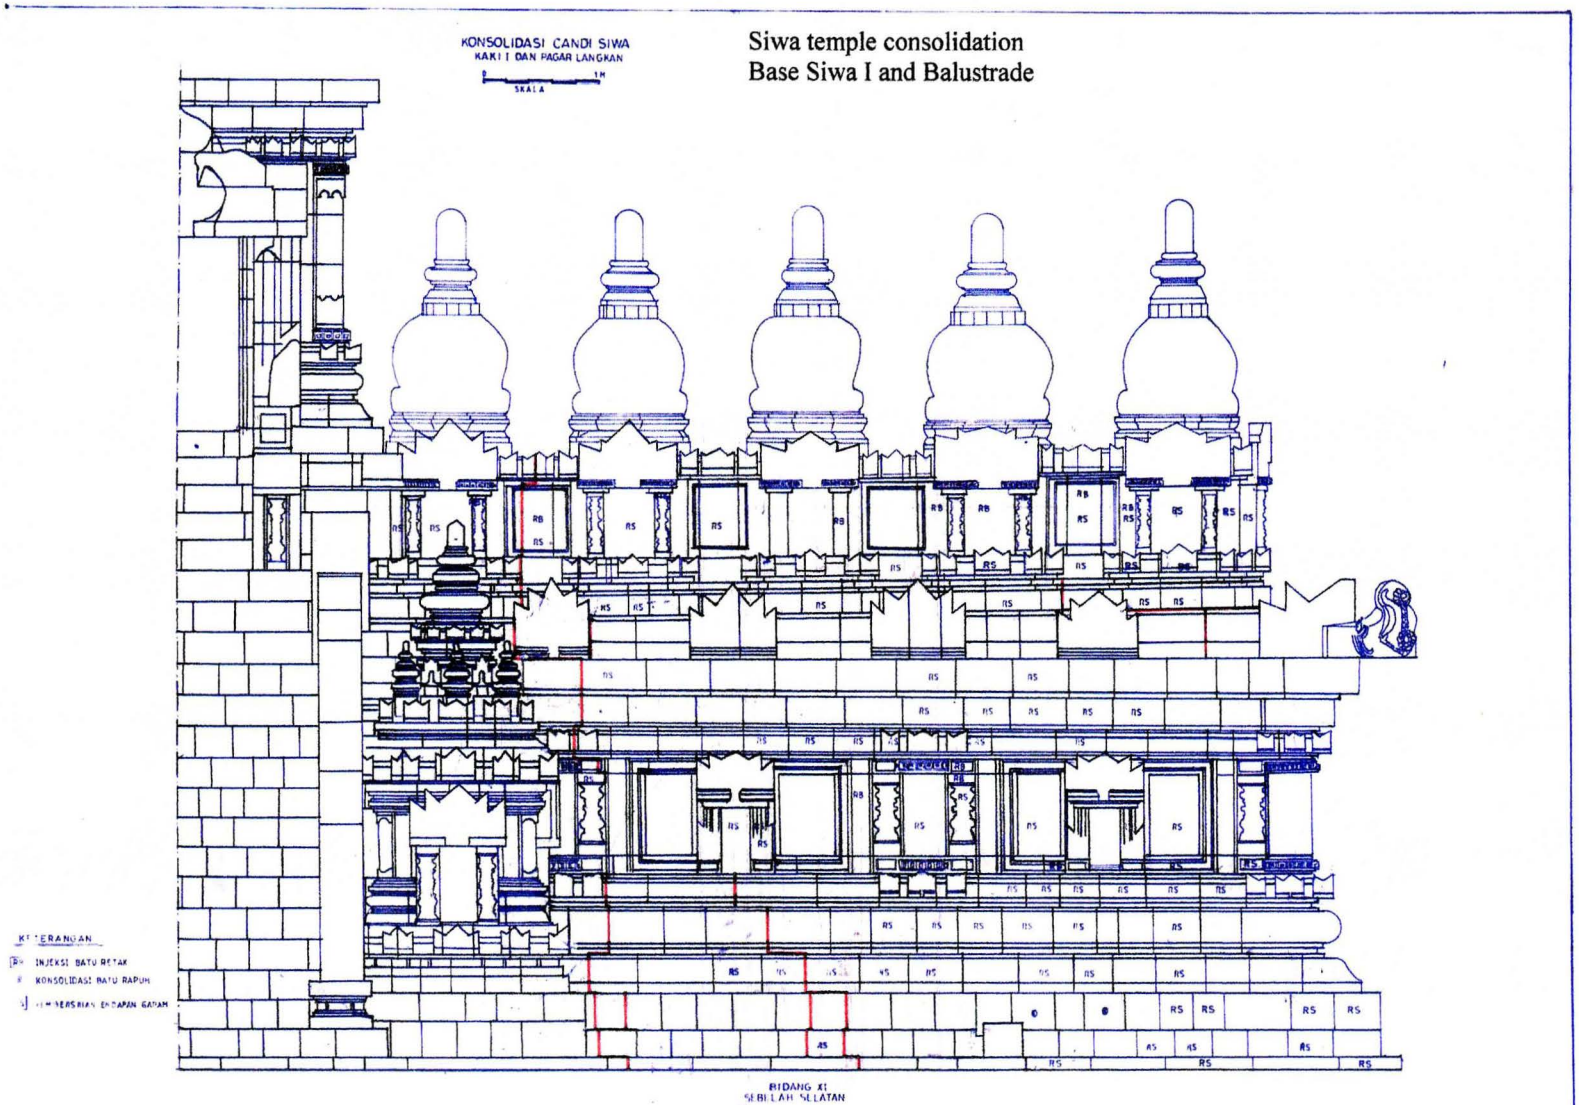
Section 11

Siwa temple consolidation
Base Siwa I and Balustrade

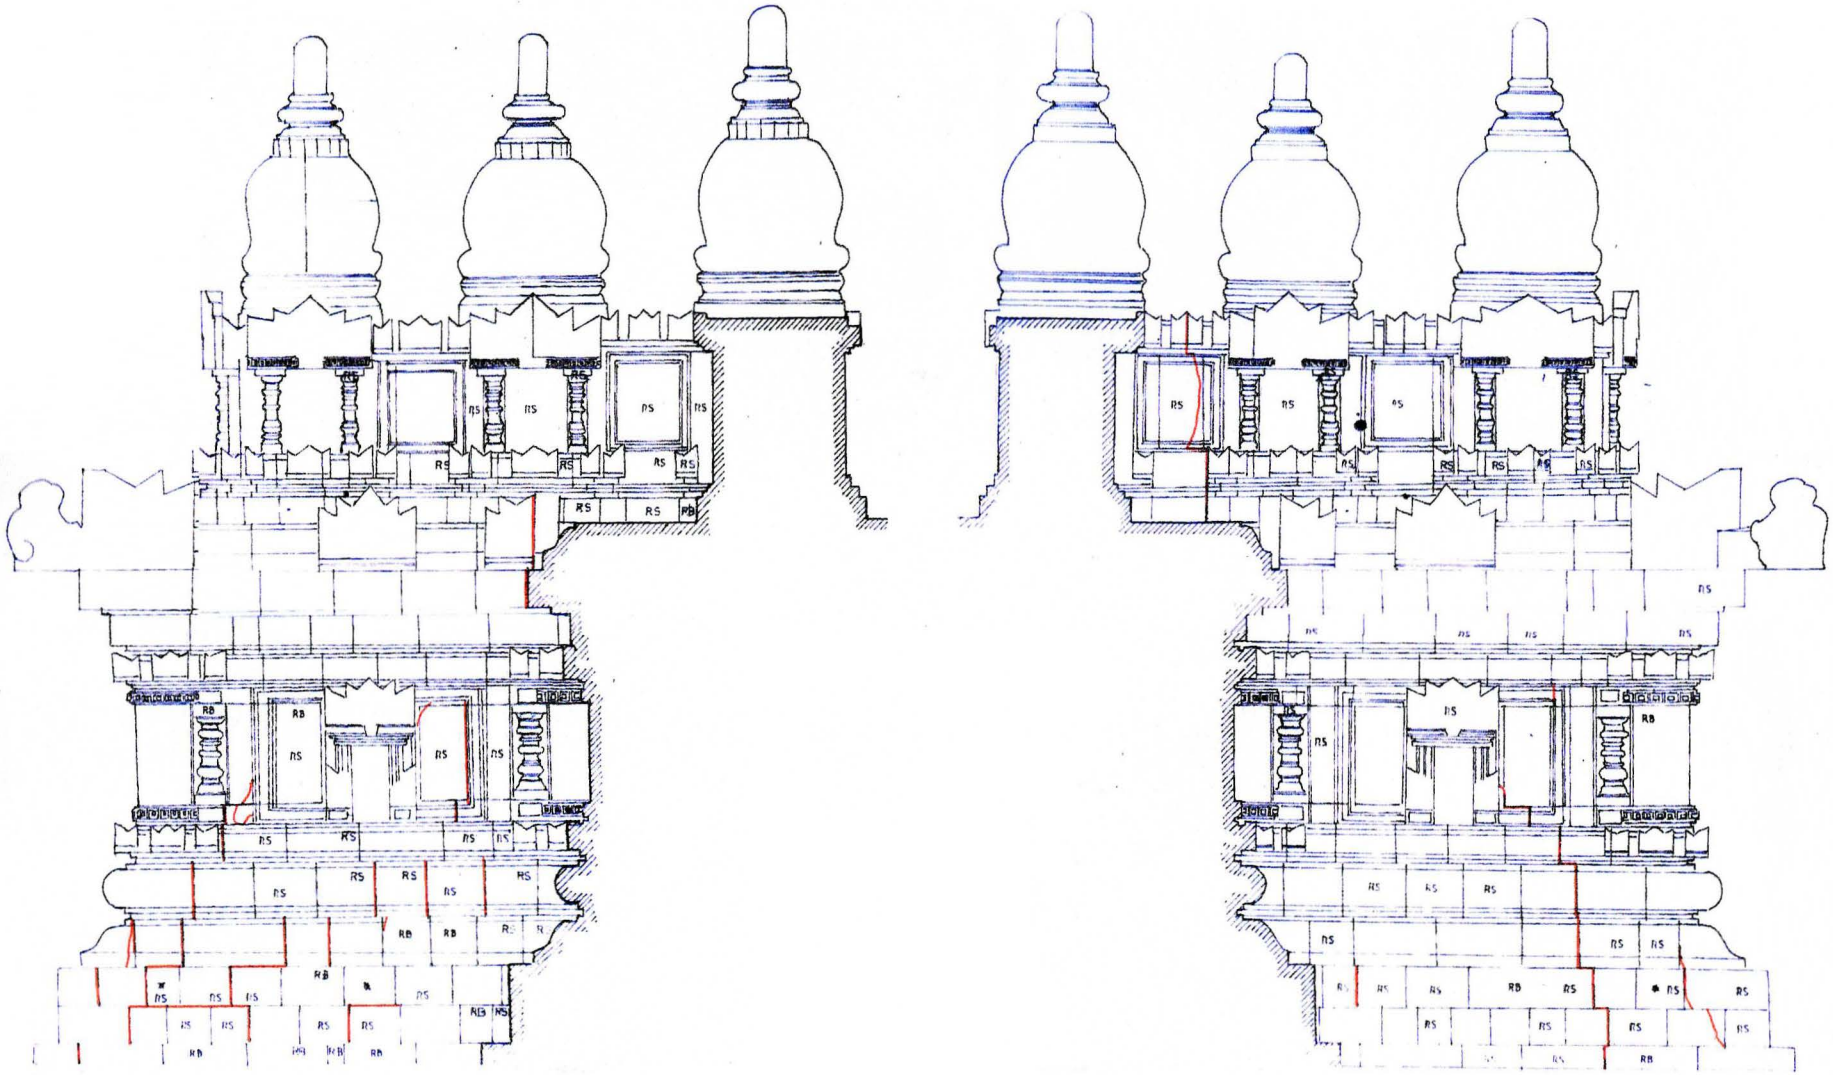
Bidang 13
(Section 13)

Candi Siwa
Kaki I dan Pagar Langkan
(Base 1 and balustrade of Siwa temple)

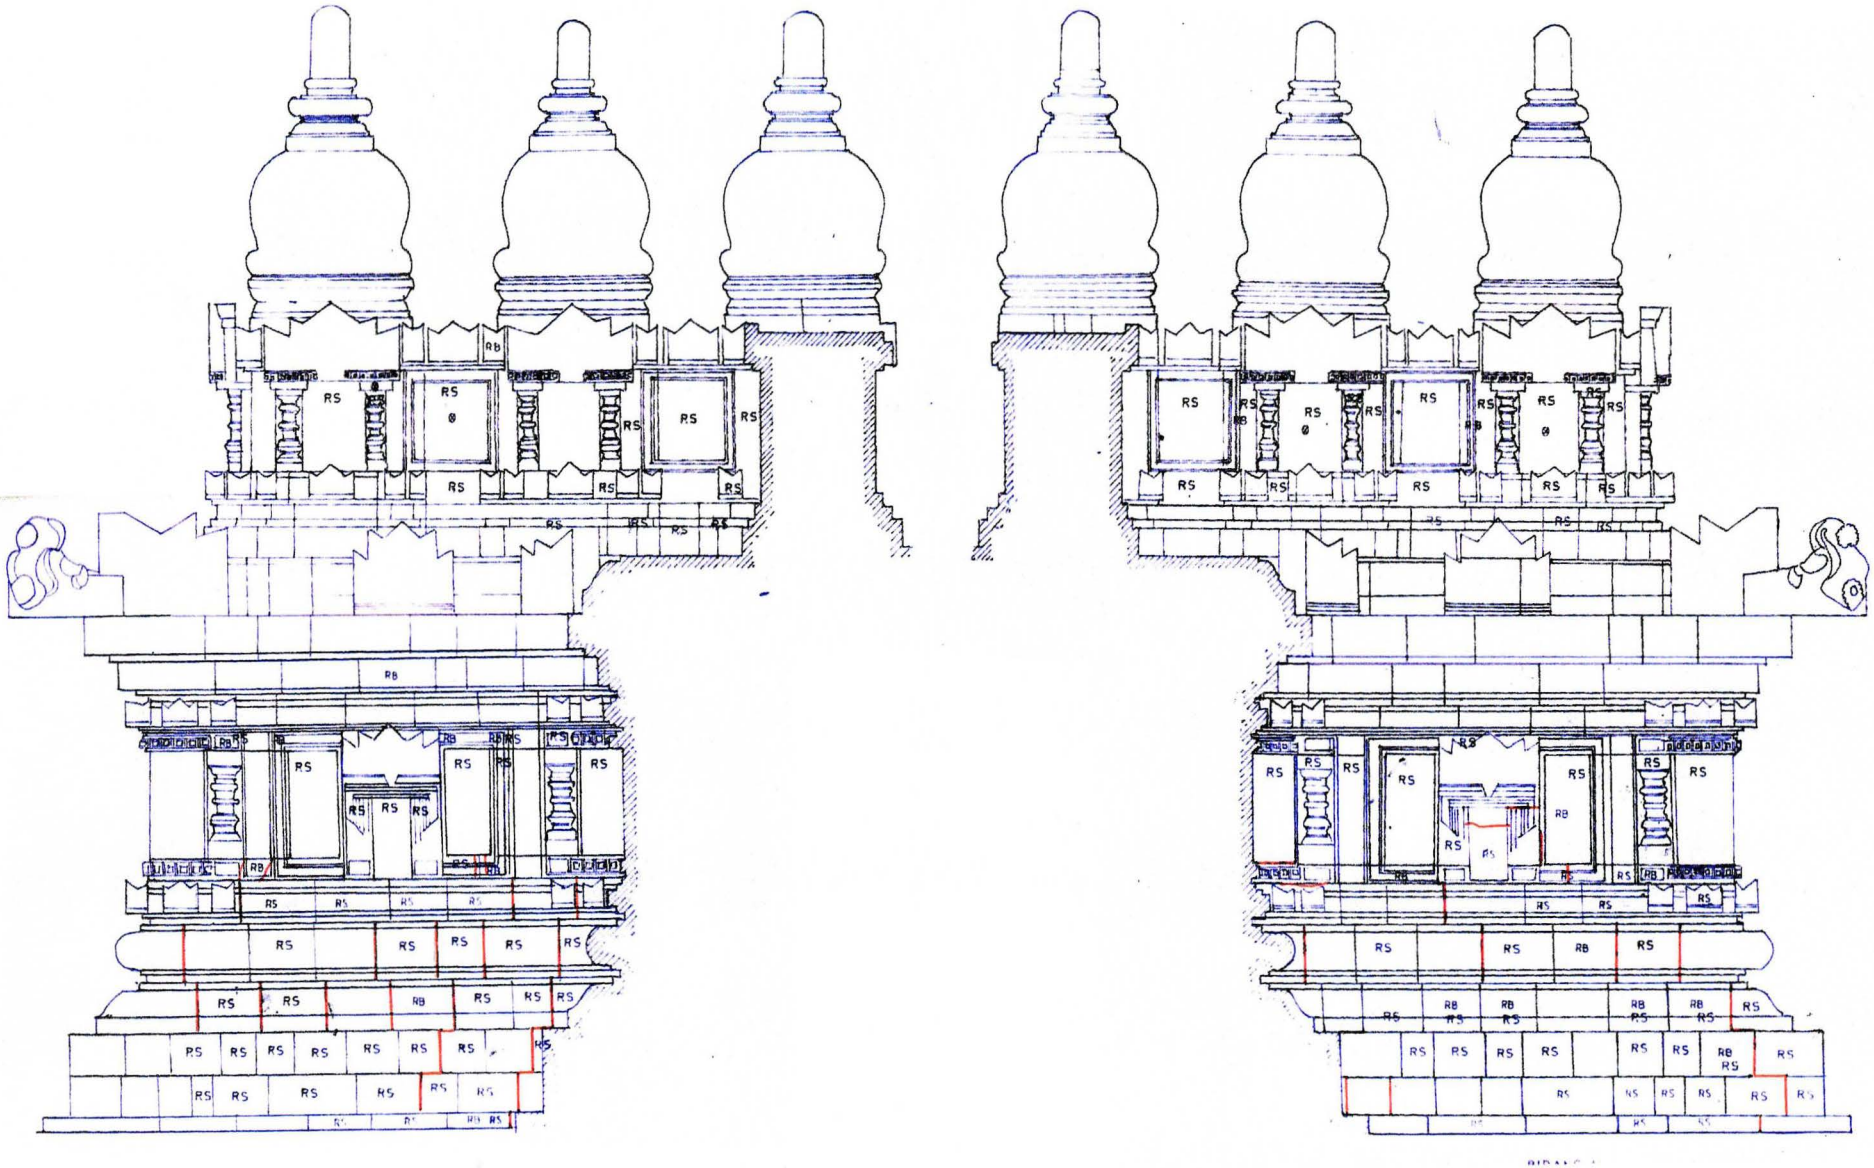
Bidang 15
(Section 15)

Candi Siwa
Kaki I dan Pagar Langkan
(Base 1 and balustrade of Siwa temple)
