TECHNICAL STUDY

FOR REHABILITATION ON PRAMBANAN TEMPLE COMPOUND AFTER EARTHQUAKE

BY
TECHNICAL STUDY TEAM
ARCHAEOLOGICAL OFFICE OF YOGYAKARTA

DEPARTMENT OF CULTURE AND TOURISM
2007

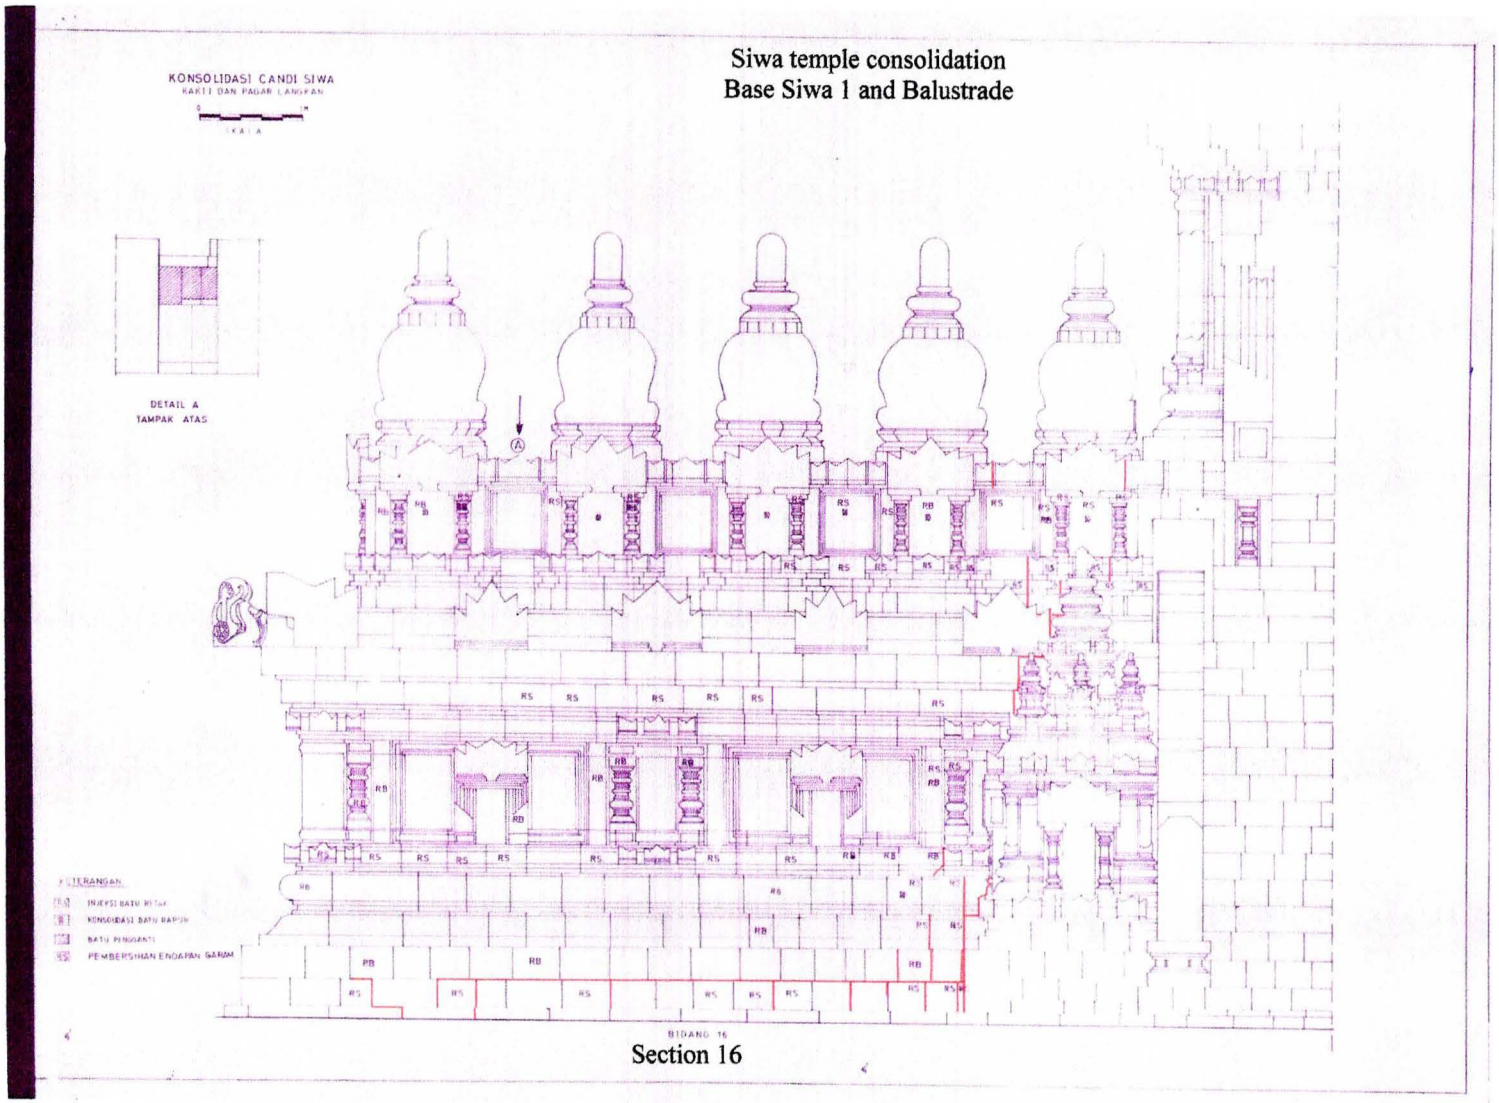
Section 16

Siwa temple consolidation
Base Siwa 1 and Balustrade

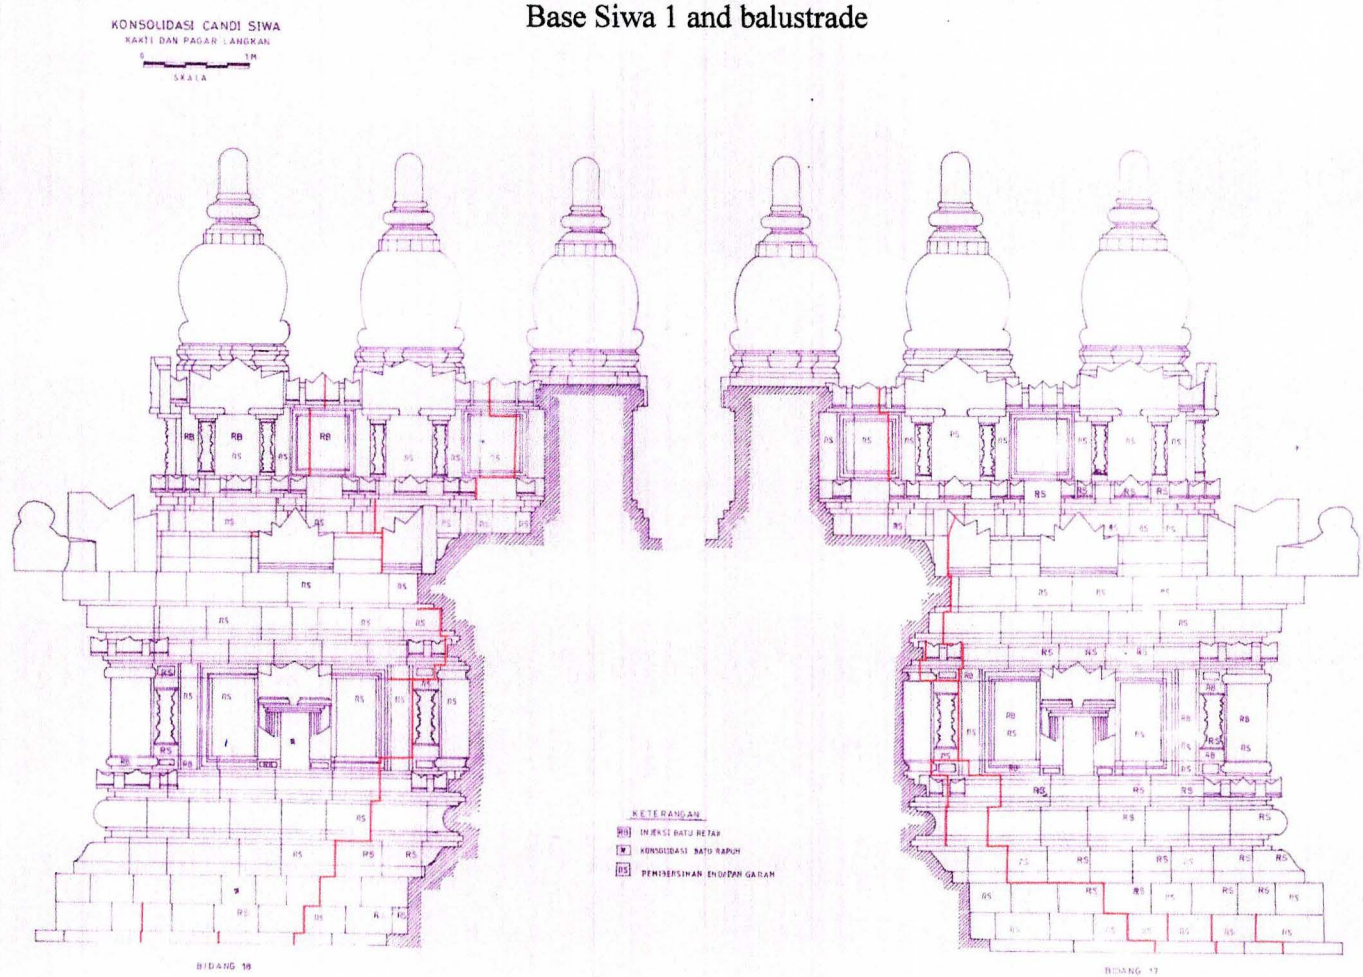
Section 18

Siwa Temple Consolidation
Base Siwa 1 and balustrade

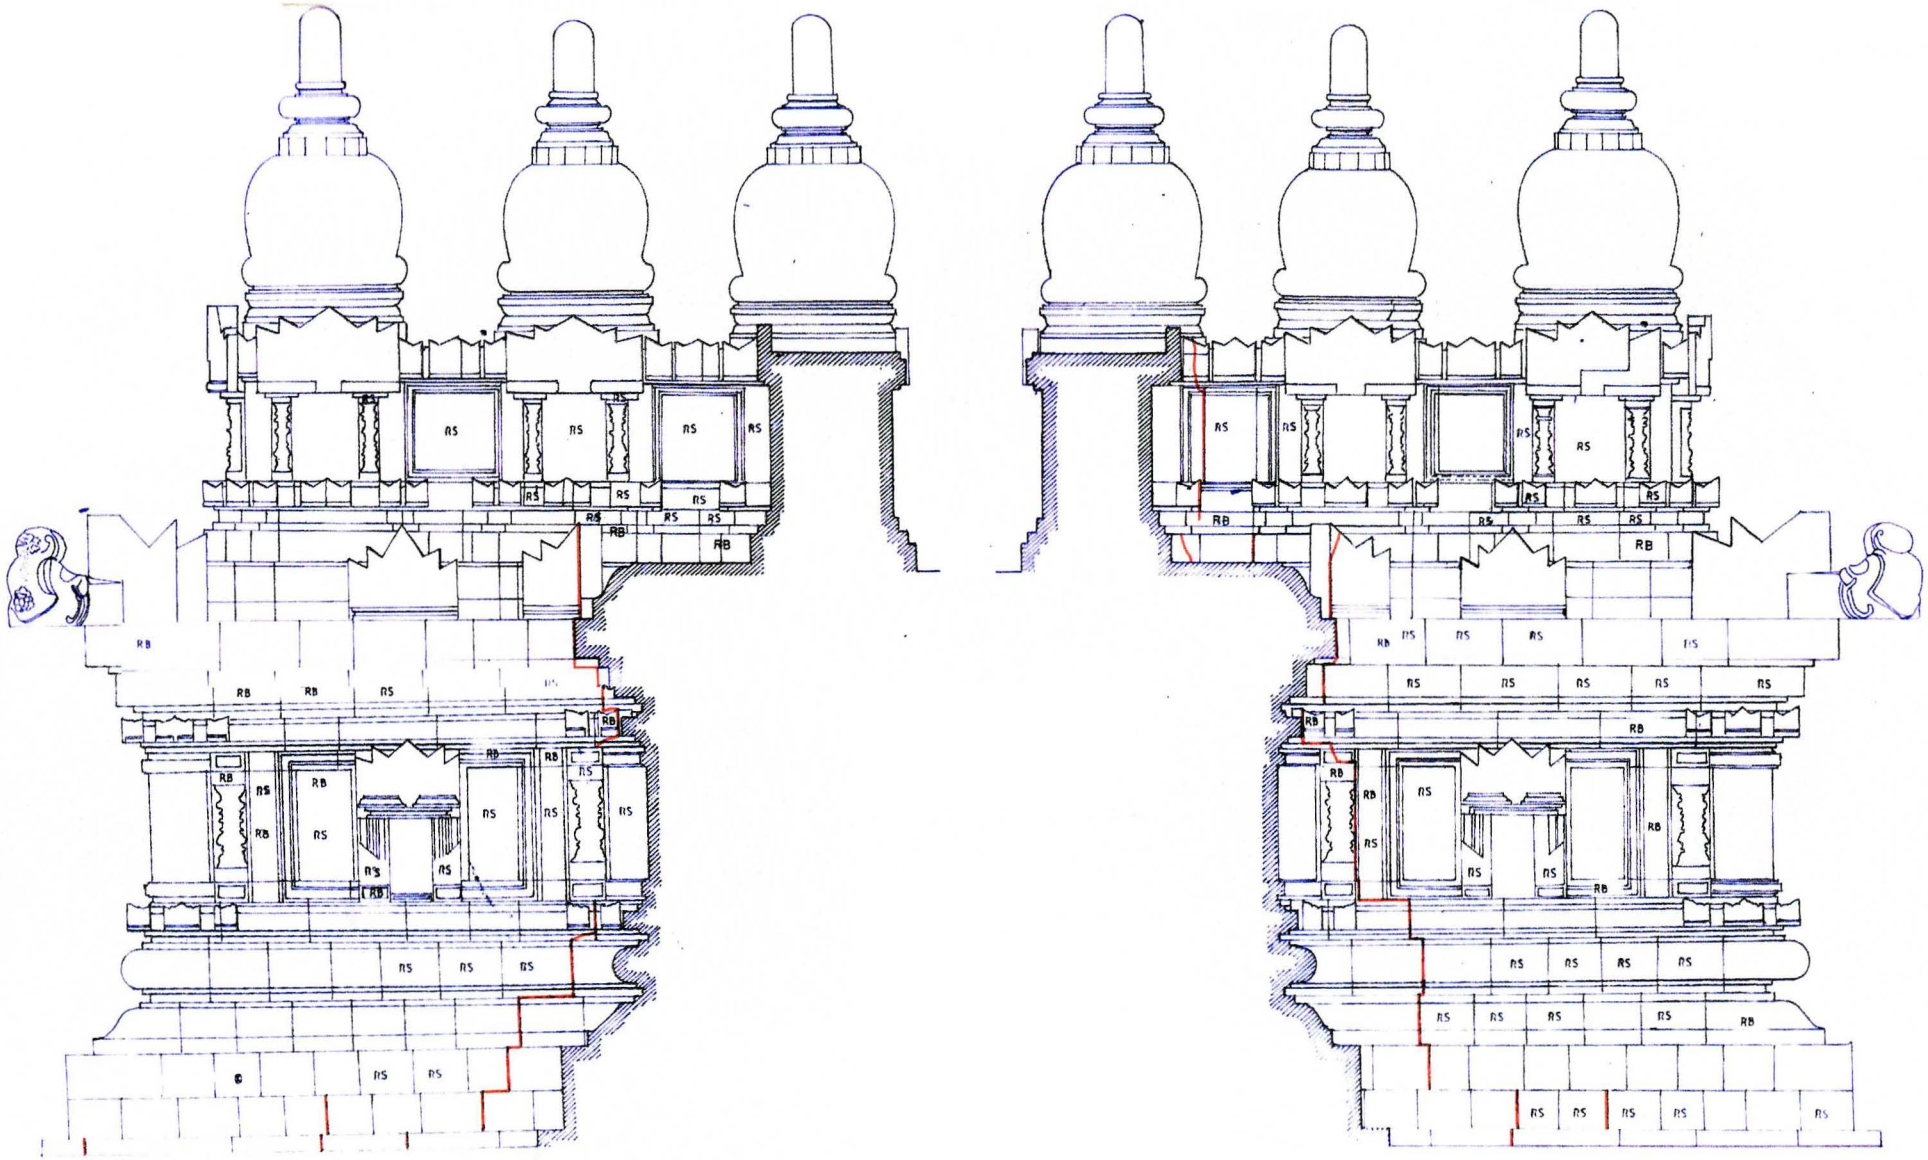
Bidang 20
(Section 20)

Candi Siwa
Kaki I dan Pagar Langkan
(Base Siwa 1 and balustrade)

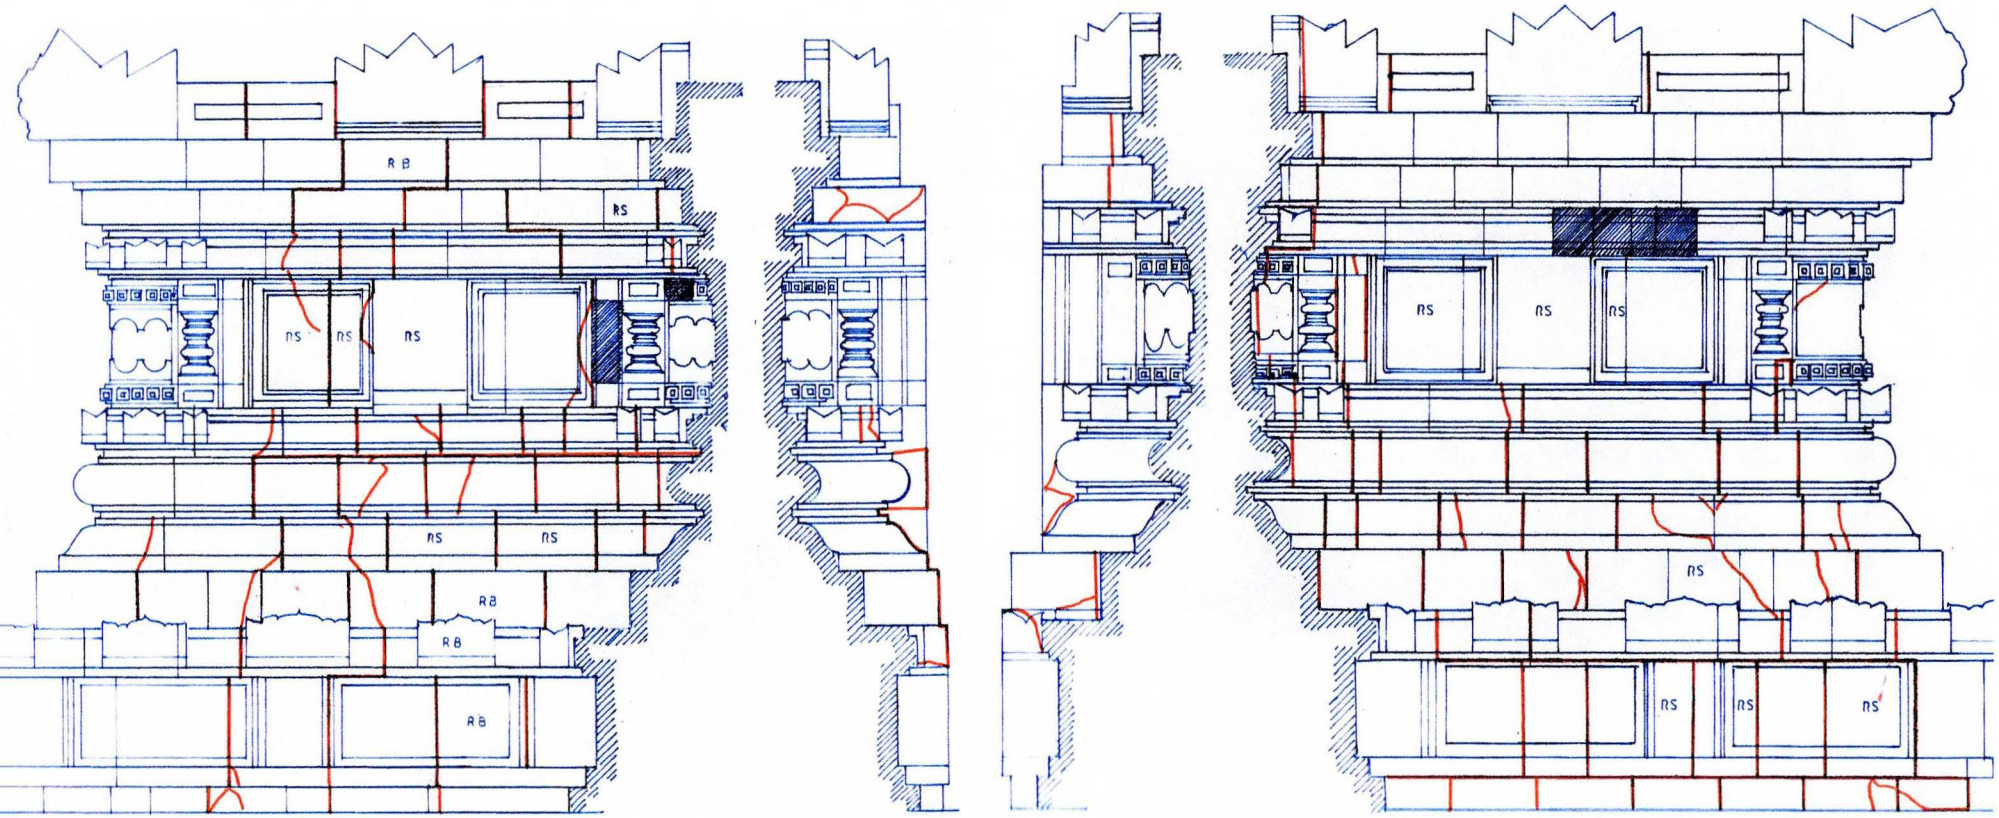
Area I

Siwa Temple
Base Part Level II

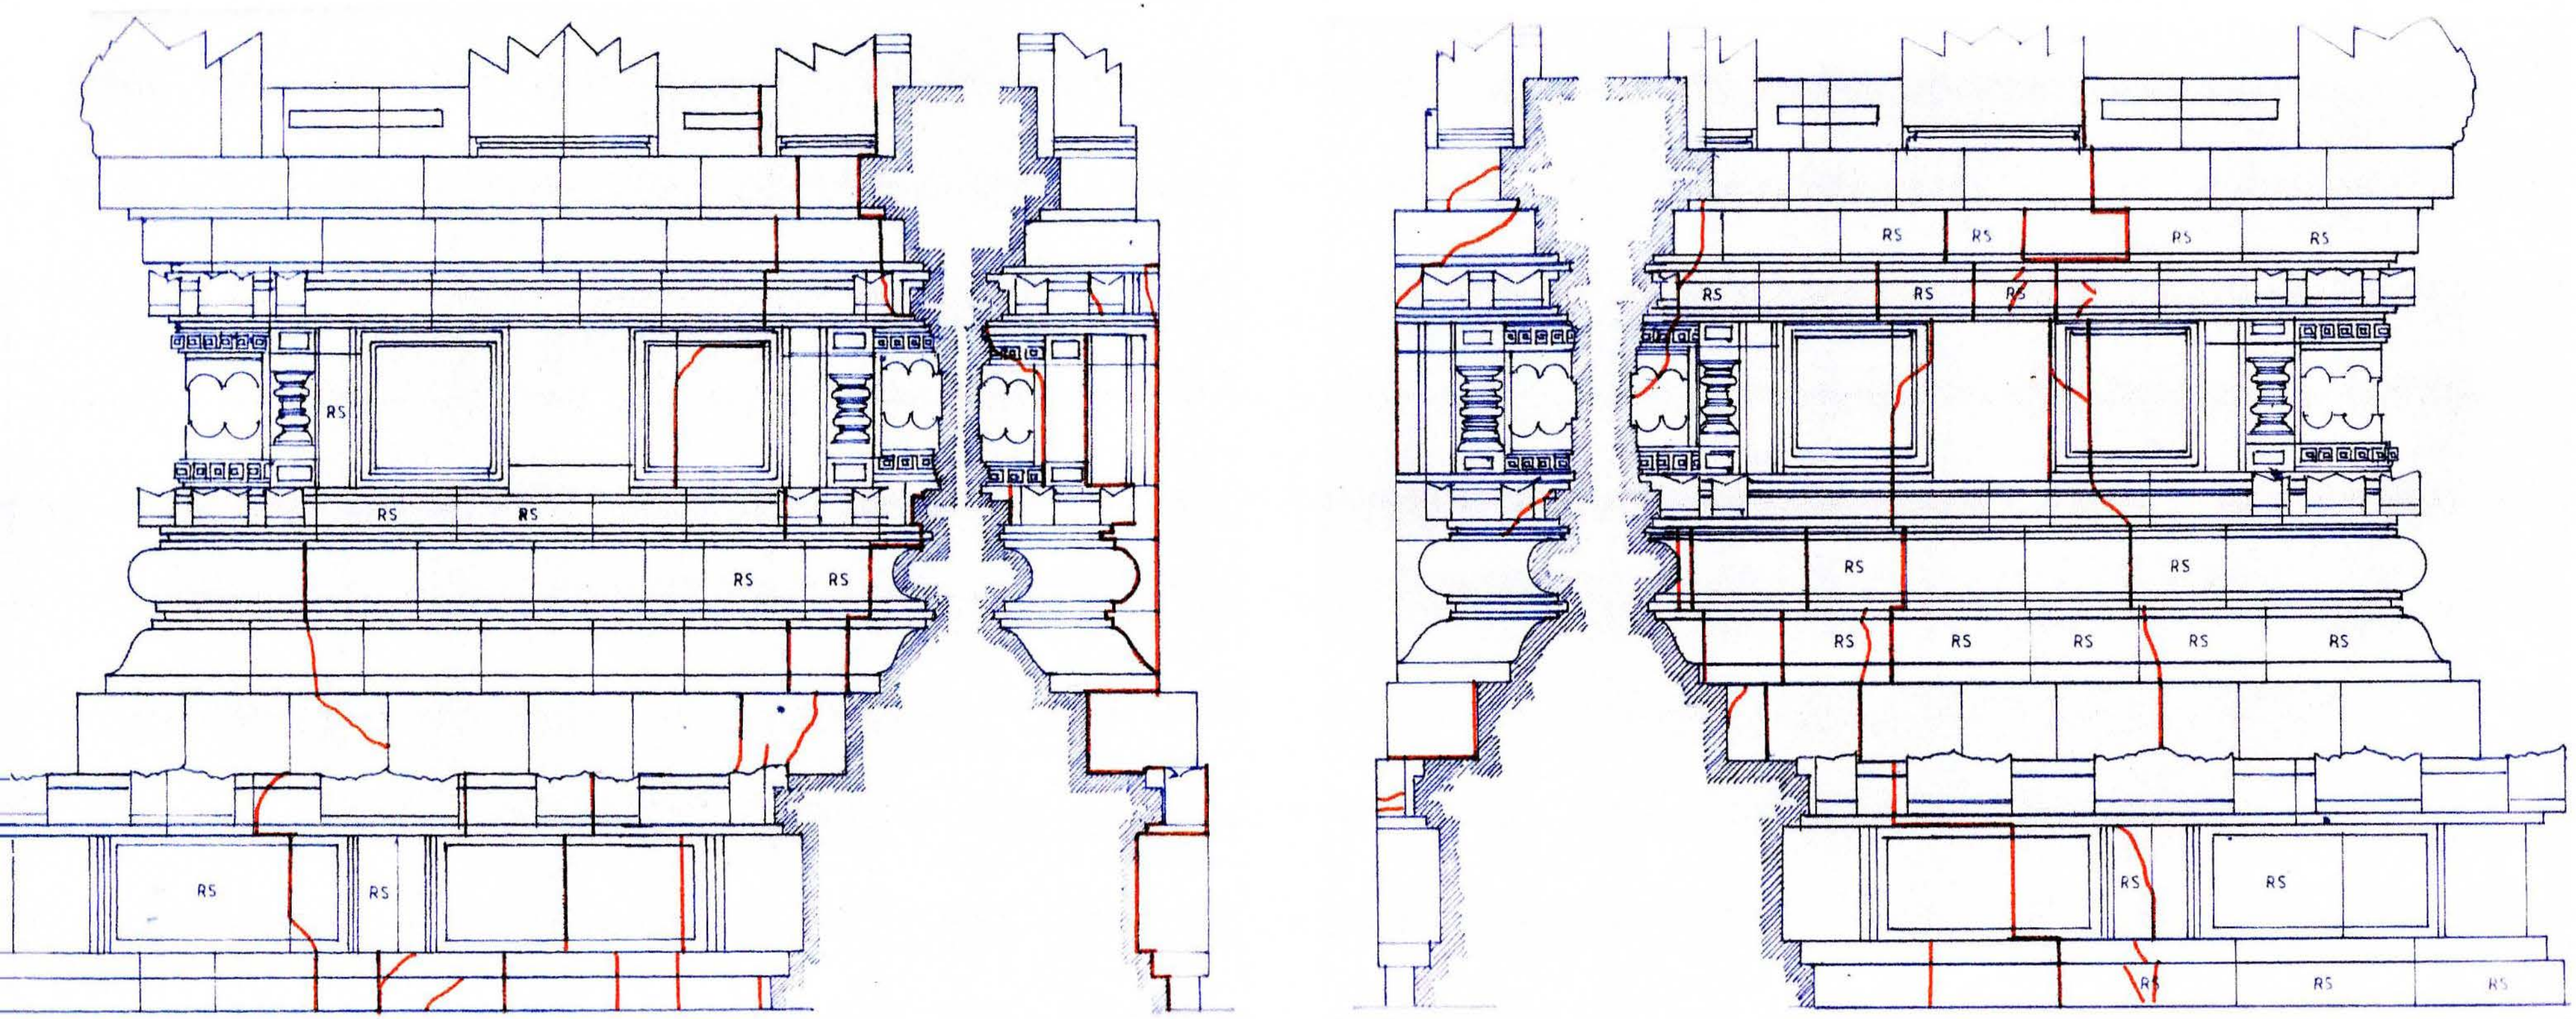
Craking and open joint stone

Siwa Temple
Base Part Level II

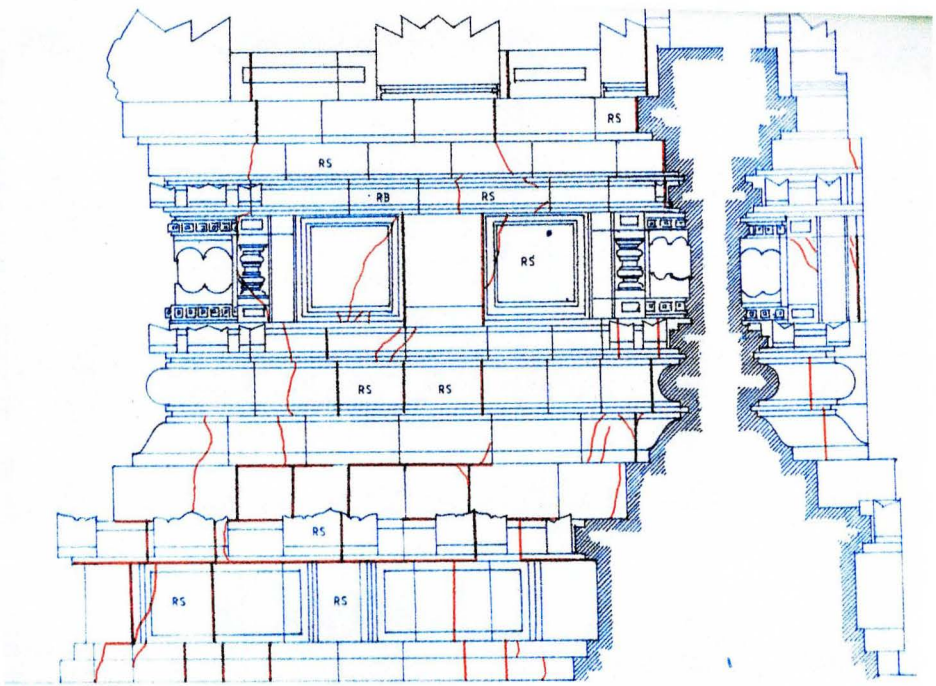
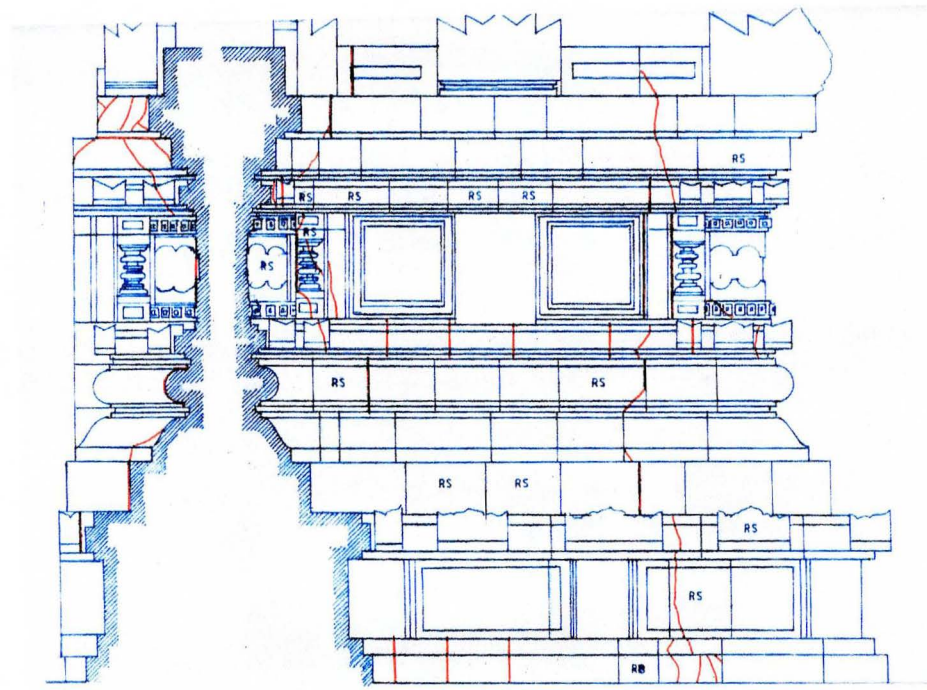
Area11

Craking and open joint stone

Siwa Temple
Base Part Level II

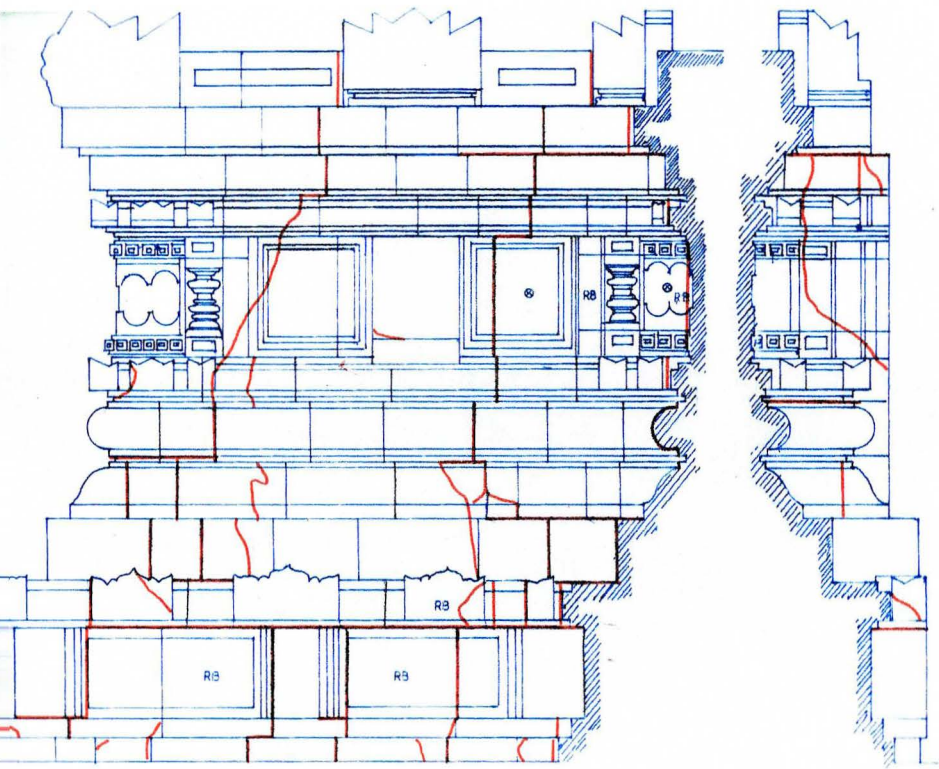
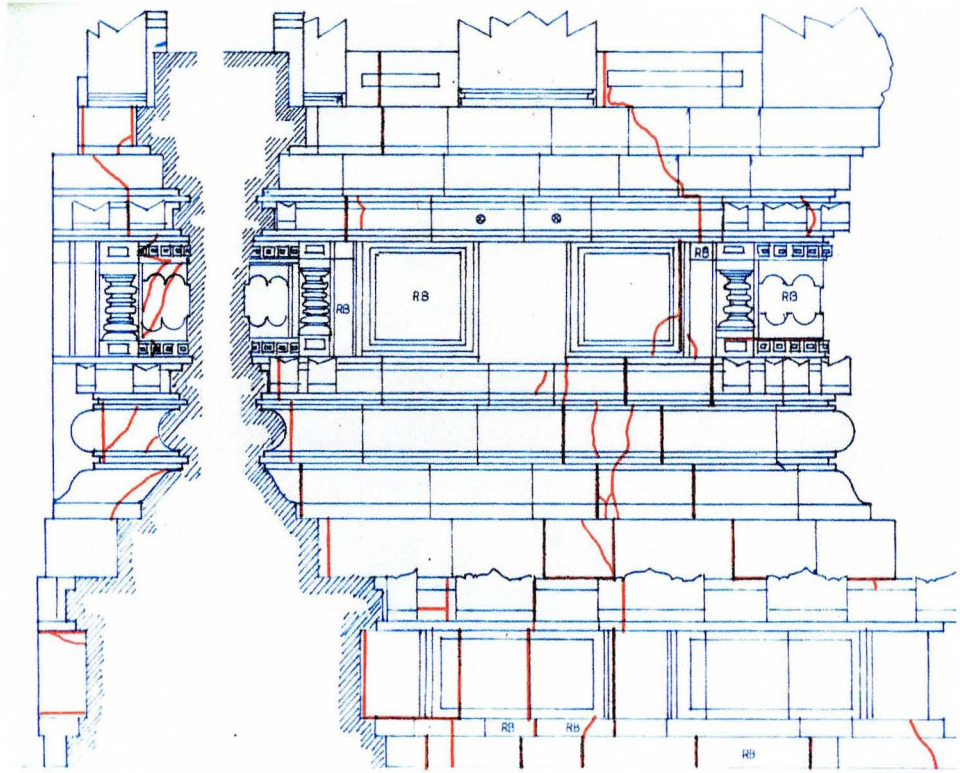
Craking and open joint

Siwa Temple
Base Part Level II

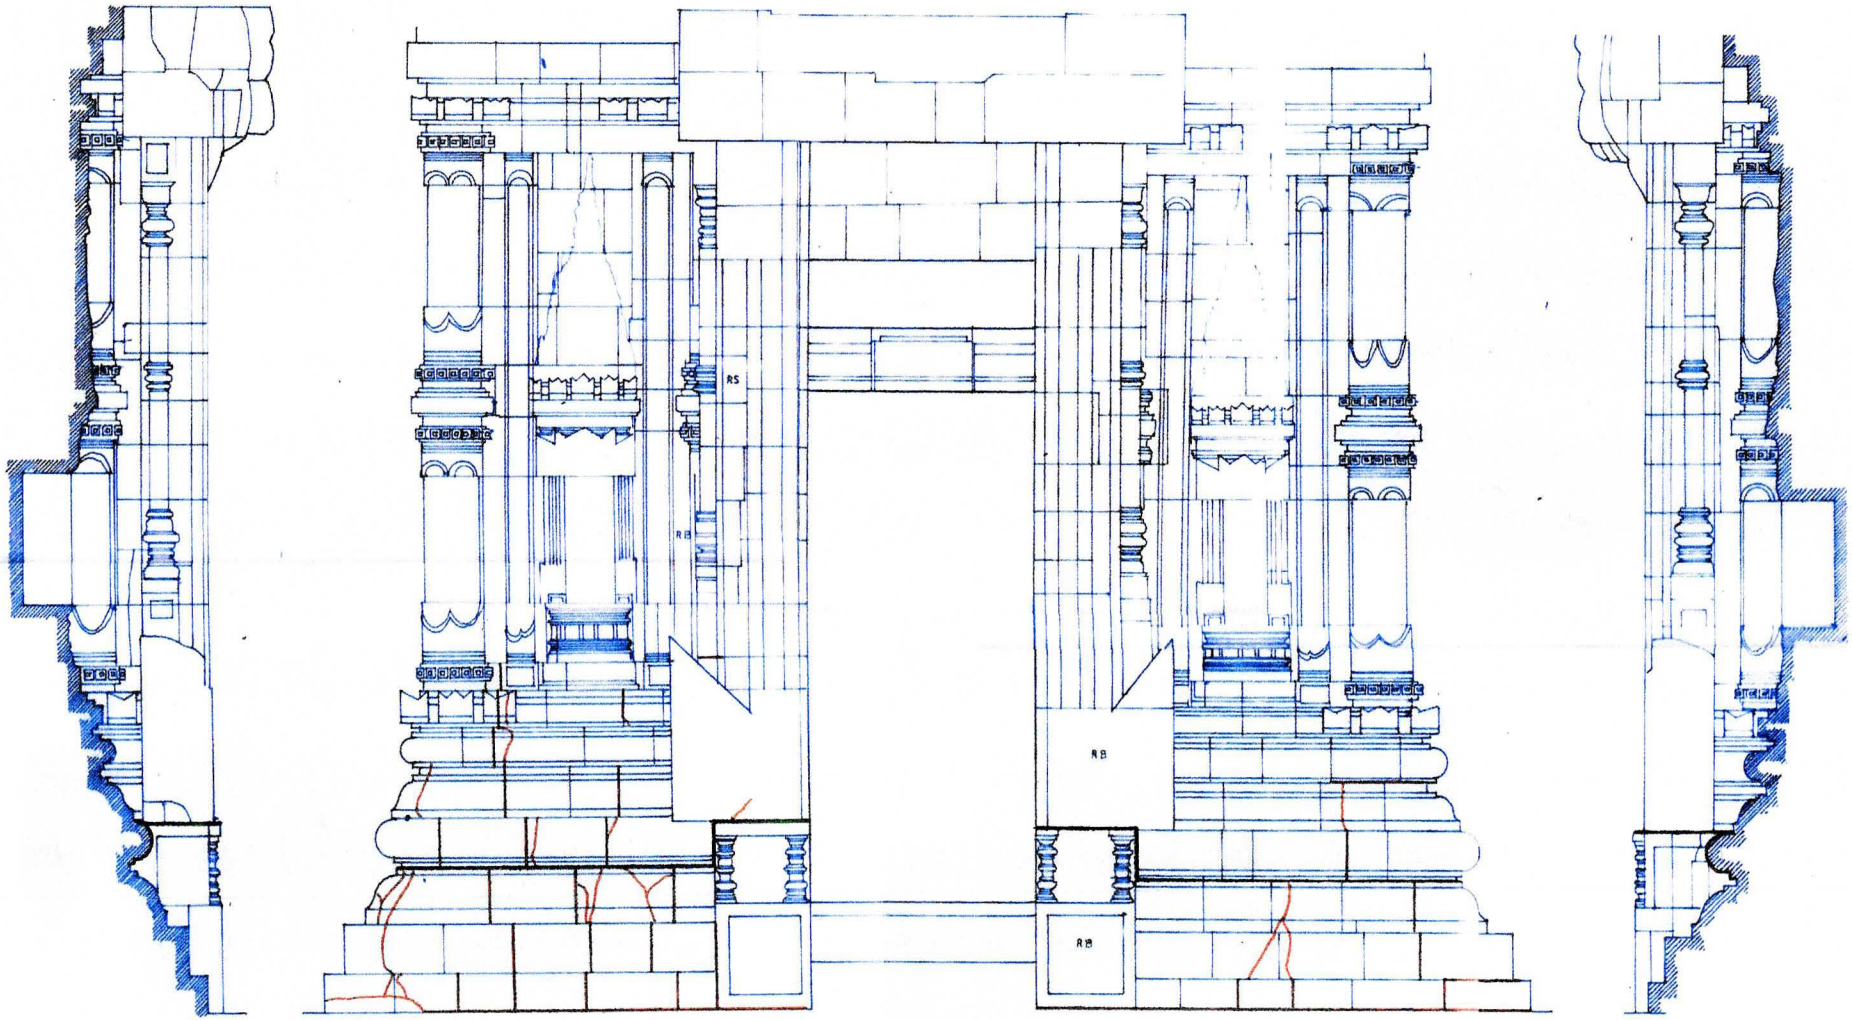
Craking and open joint stone

Siwa Temple
The Body Part I

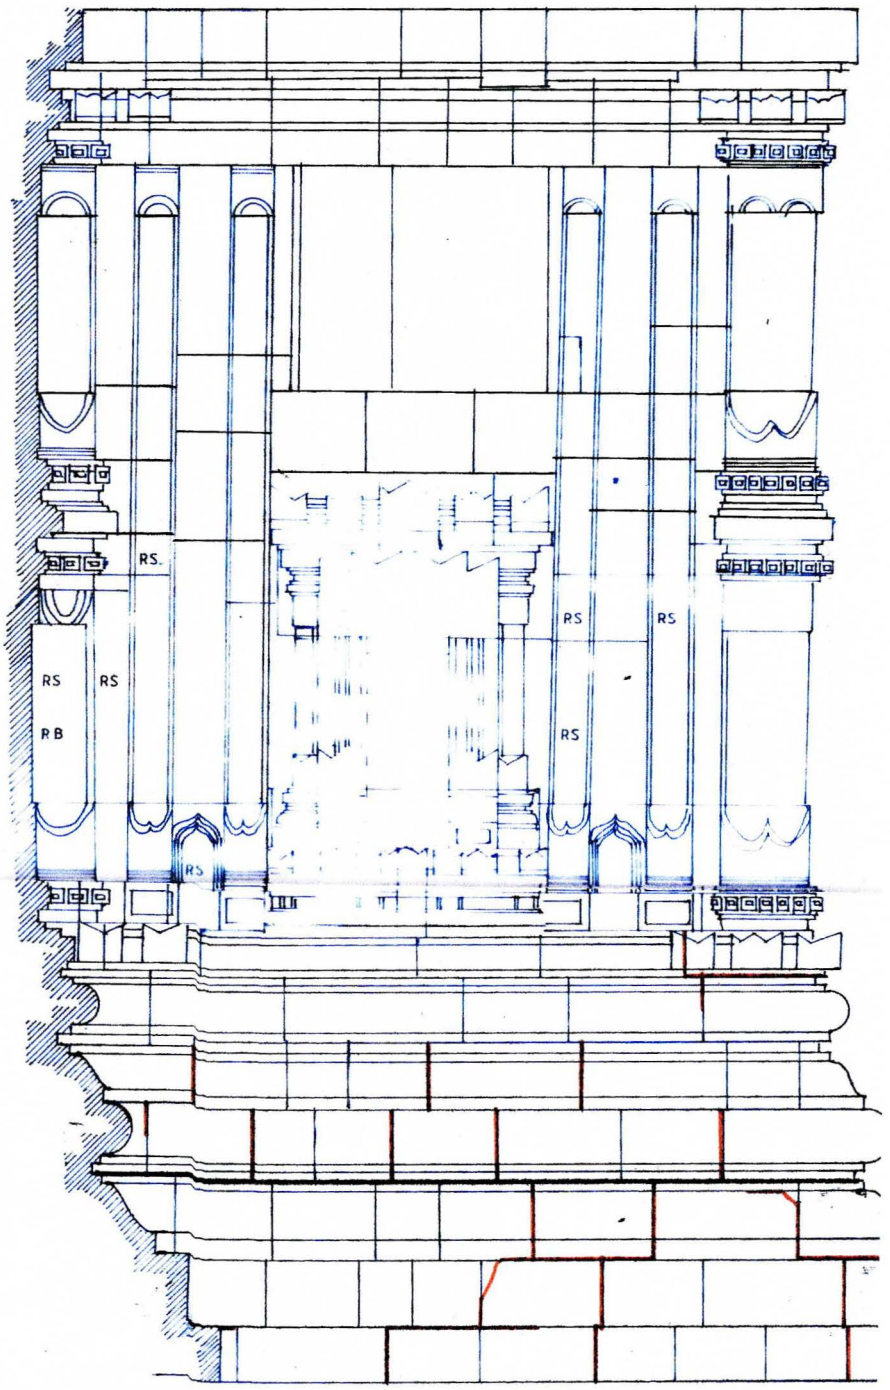
Area IV

Craking and open joint stone

Siwa Temple
The Body Part I

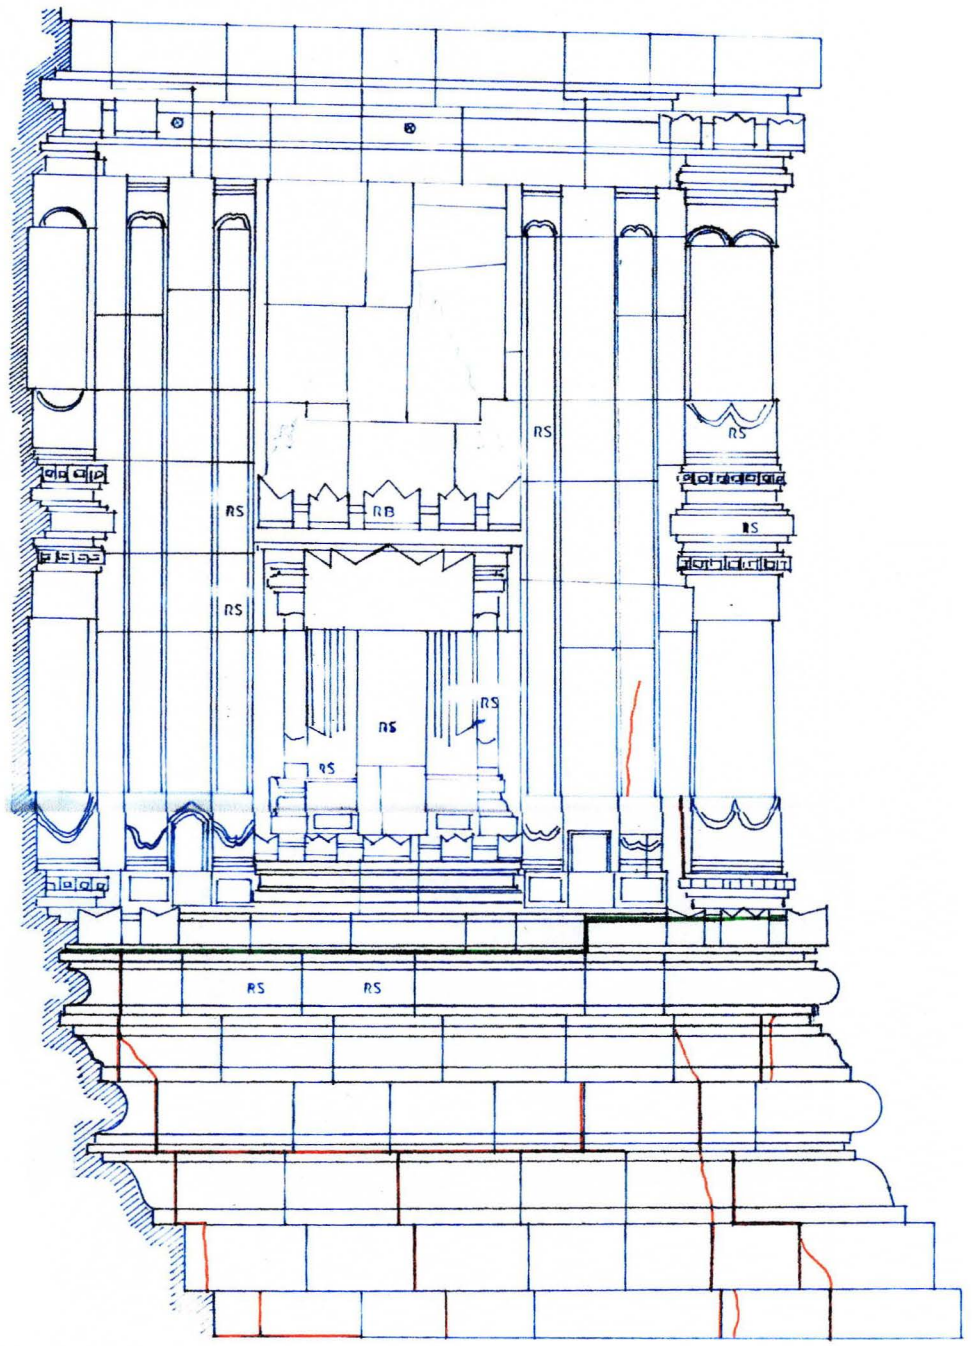
Area VII

Craking and open joint stone

Siwa Temple
The Body Part I

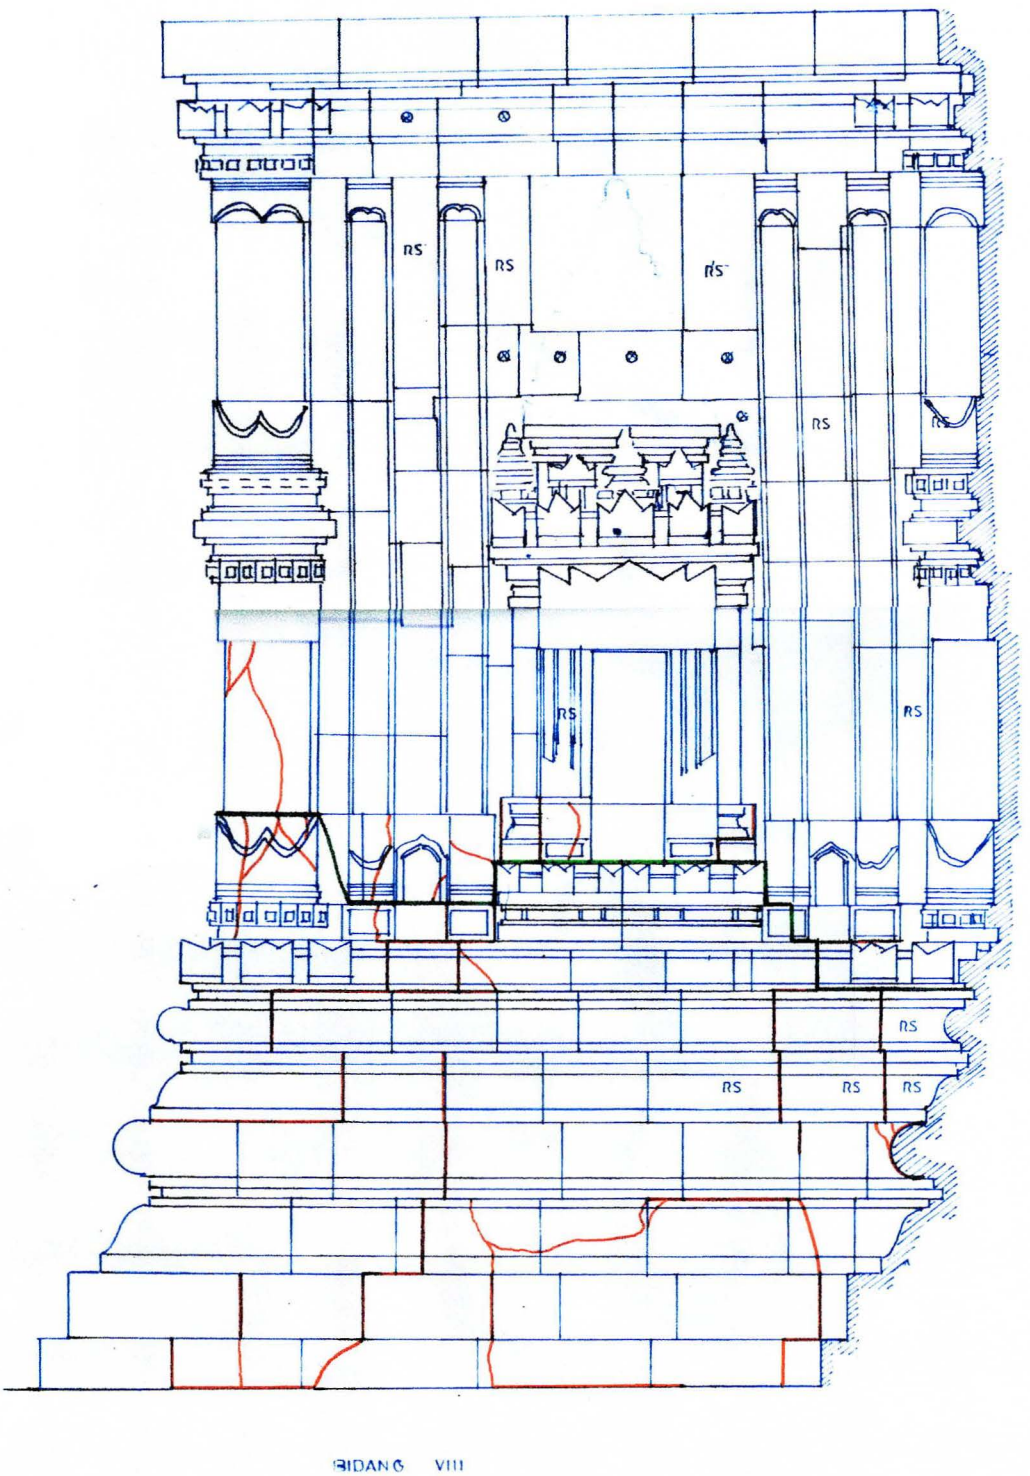
Area VIII

Craking and open joint stone

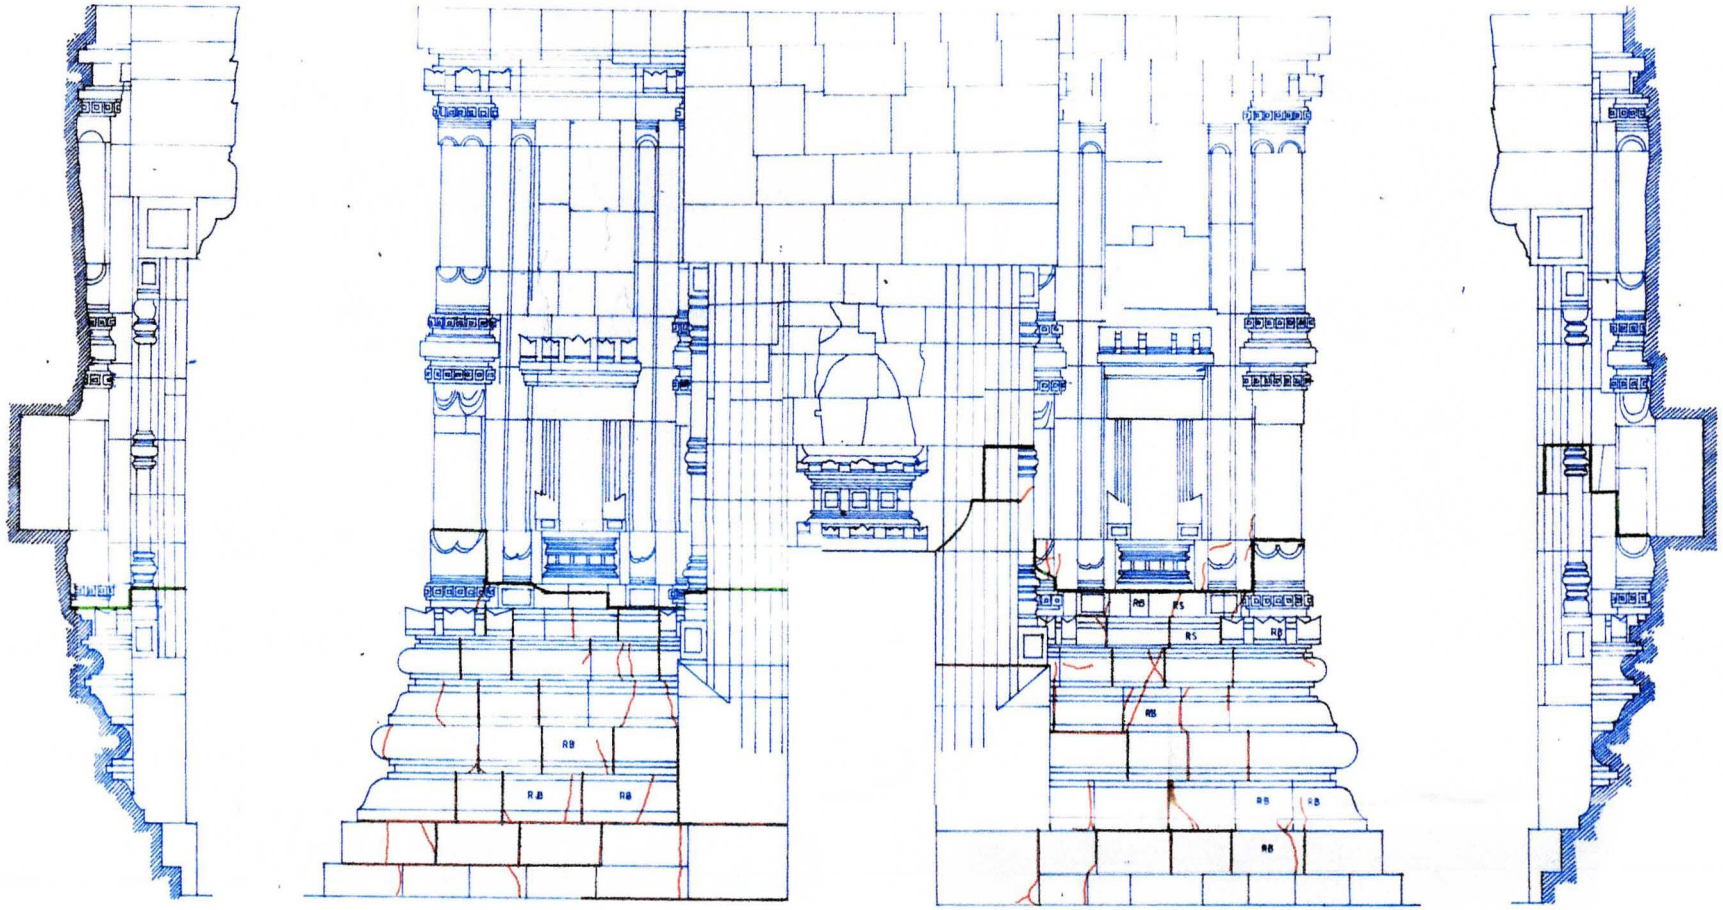
Craking and open joint ston e

Siwa Temple
The Body Part I
