TECHNICAL STUDY

FOR REHABILITATION ON PRAMBANAN TEMPLE COMPOUND AFTER EARTHQUAKE

BY
TECHNICAL STUDY TEAM
ARCHAEOLOGICAL OFFICE OF YOGYAKARTA

DEPARTMENT OF CULTURE AND TOURISM
2007

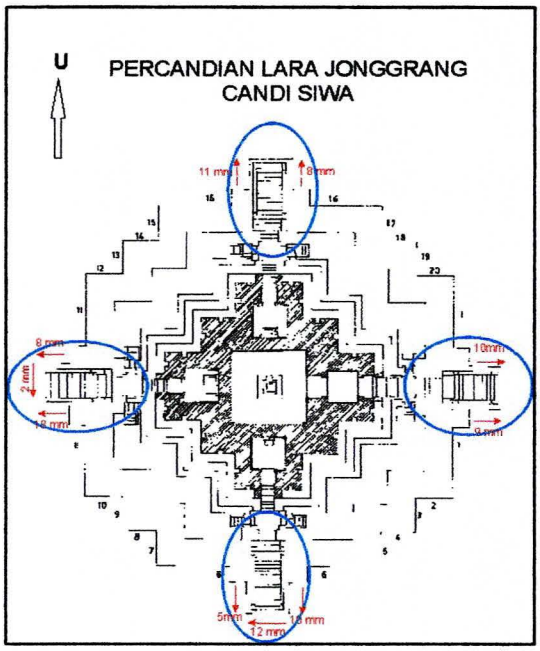
Siwa Temple

On Siwa temple the sink down occurs at the four stairways, about 2 cm deep. It makes horizontal crack on the balustrade doorway, exactly between the body and the roof of the doorway. Horizontal and vertical cracks occurs from the foot of the temple through the floor, up to the body of the temple. The cracks can be observed on the whole 30 sections. There is a significant crack that encircles the lower body of the temple, from the 1^{st} to the 20^{th} plane. This crack is accompanied by horizontal outward move about 2 cm – 5 cm.

Cracks on the outer wall and alley of west gate way of Siwa Temple.

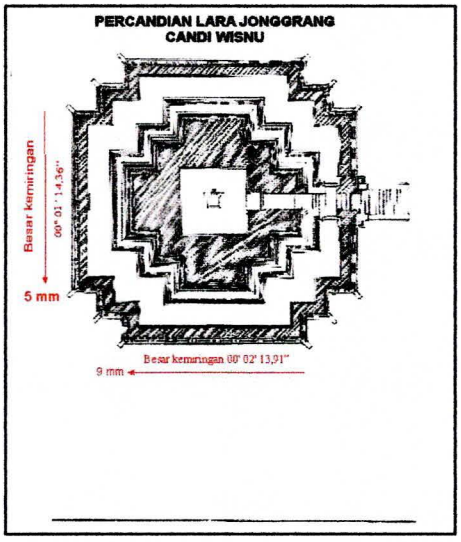
Wisnu Temple

On Wisnu temple the sink down presents on the foot of the temple, exactly on the 6 and 7 planes on the south side, about 2 cm deep. Horizontal move occurs on the balustrade, on the floor, and the top of the foot. It is accompanied by twisted crack and slanting toward the outside. The horizontal move on the floor is about 0,5 cm to 5 cm.

DEFORMATION

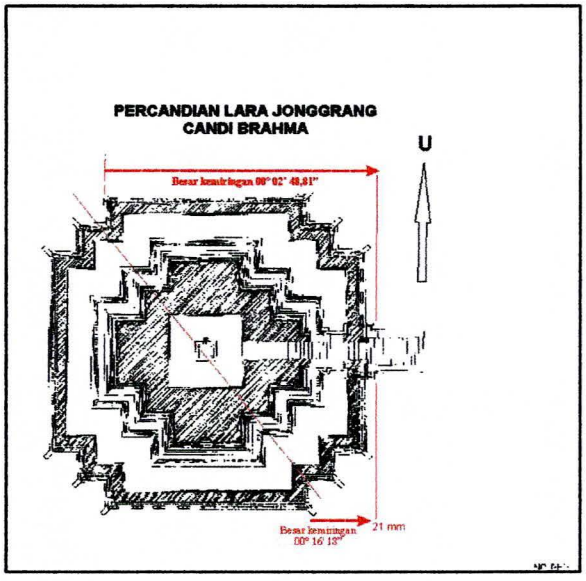
Brahma Temple

The types of structural damage are : sink downwards, horizontal move, and vertical and horizontal cracks. On Brahma temple there are sink downwards about 2 cm at the east staircase towards the south-east as far as the $1^{st} - 5^{th}$ and the 20^{th} sections. The sink down is accompanied by vertical and horizontal cracks. Horizontal move occurs at the balustrade and the doorway, third and fourth stories of the roof. There is also twist caused by cracks, and horizontal and vertical cracks.

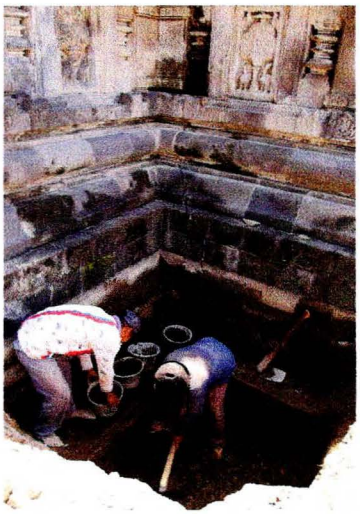
4. Hole IV/a 1/i 6 and Hole IV/a 1/h 6

This hole is dig to expose the condition of the structure basement similar with the hole III/b I/u IX. The different is only the location. The damage which can be observed on the temple basement is crack on the space between stone blocks. The crack occurs along the basement. The hole measures 2 x 1 m^2 while its depth is 187 cm. The south and west wall of the holes are a andhesite stone structure (two level) and a lime stone structure of the temple basement. The lime stone structure consists of 2 (two) level. The base of the hole, there are some stone arrangement which is used to strengthen the temple's basement. This data shows that Siwa temple's basement has a different type from Brahma temple's basement. Its lime stone blocks arrangement in the basement structure of Siwa temple are wider than on the Brahma temple. On Brahma temple's basement, the lime stone structure is arranged vertically with the andhesite one.

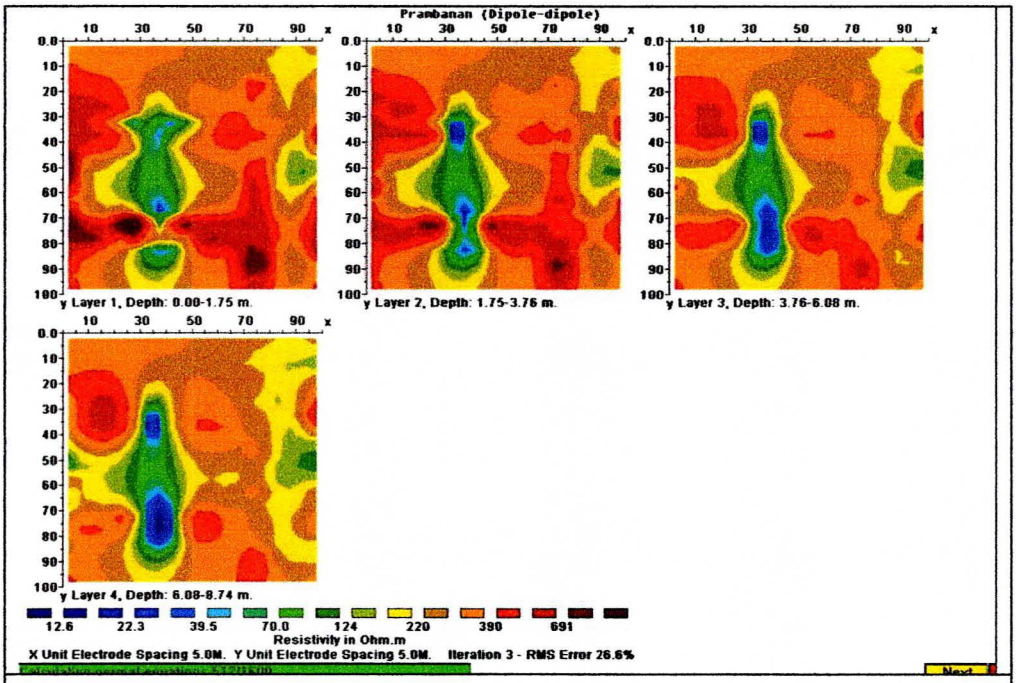
Resistivity distributions of dipole-dipole configuration for difference depth are shown at Fig.2. This area indicates that there are a low resistivity zones (in blue color). The depth of the anomaly is 2m to 8m; physically it may caused by wet soil. According to Izjerman, in the Prambanan temple vicinity there is much drainage system to absorb the surface water until 5.75 m deep of wet soil under the floor (Jordaan, 1996). The anomalies (low resistivity zone) are interpreted as drainage system infiltration in the subsurface. Meanwhile, the high resistivity zone depth is about 7 to 8 m (the red one). The high resistivity zone indicates the hard rock layer that is a base of the soil. The existence of wet sand or soil in the subsurface rock is good for supporting the body of temple.

Horizontal distribution modeling of resistivity data layer by layer (RES3DMOD)

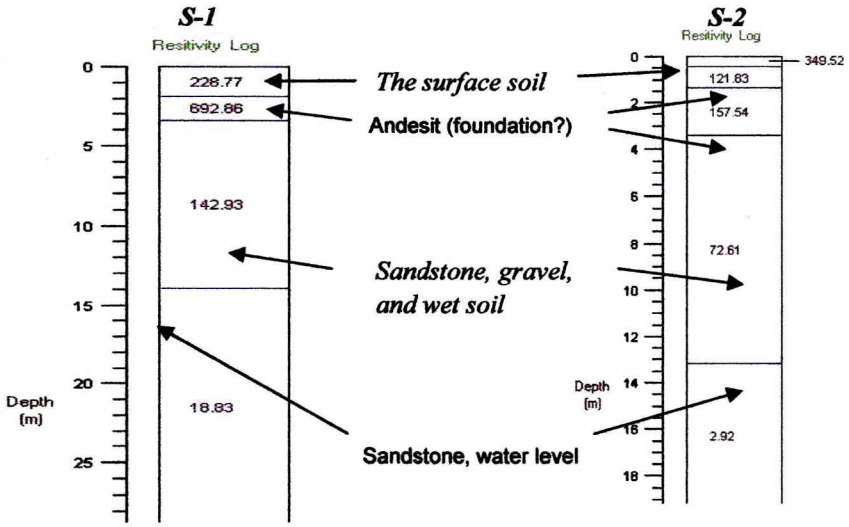
The vertical electrical sounding interpretation of point S1 and S2 are illustrated in Fig 3. S1 is located in east side of Siwa and S2 is located in west side of Nandi. Based on the model, thick of the surface soil is less than 2 m, and there is about 2 m thick of high resistivity layer (ohm-m) at Siwa floor. We interpret it as an andesitis rock or a foundation rock. However, in S2 the resistivity is not so high, and lower than this layer is low resistivity area, it may be a wet sandstone, wet soil, and gravel as a water level. According to Ijzerman in Jordaan, 1996 in a depth of 5.75 m under the floor, there was a container 41 cm long and wide and 53 cm deep. The top of lid, which is made of soft marlstone, is diamond-shape and coping of soft, light-yellow sandstone fits into the container. The foundation consists of three layers of stone, which together achieve a thickness of 1.15 m, on digging further, round river stones in sand were discovered and at 15.90 m, water.

Vertical electrical sounding interpretation of points S1 and S2 by Progress 3.0.

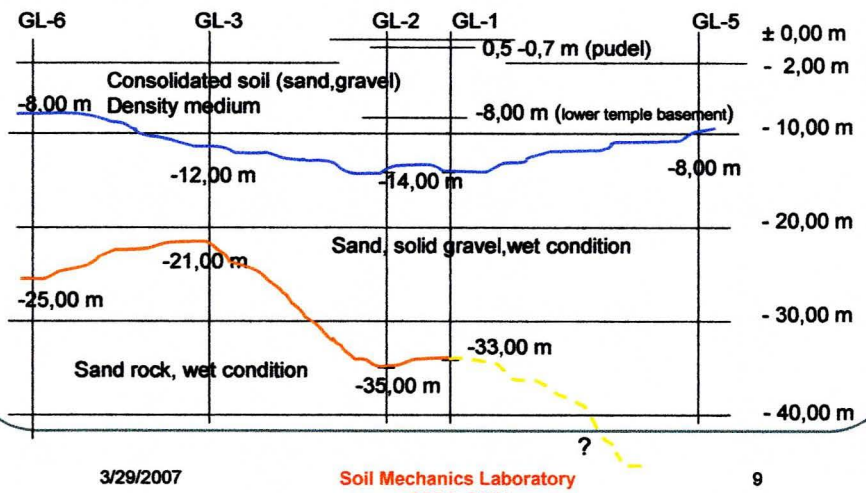
Potongan barat – timur (GL-6; GL-3; GL2; GL-1; GL-5)

- Original ground surface of temple area is basin.
- At Çiwa temple, original ground surface is located at 14,00 m of depth.
- Foundation of Çiwa temple is composed limestone (batu putih) and located at depth 8,00 m.
- Under limestone (batu putih) is followed compacted sand layer.
- Ground water level is observed at depth of 12,00 – 15,00 m.

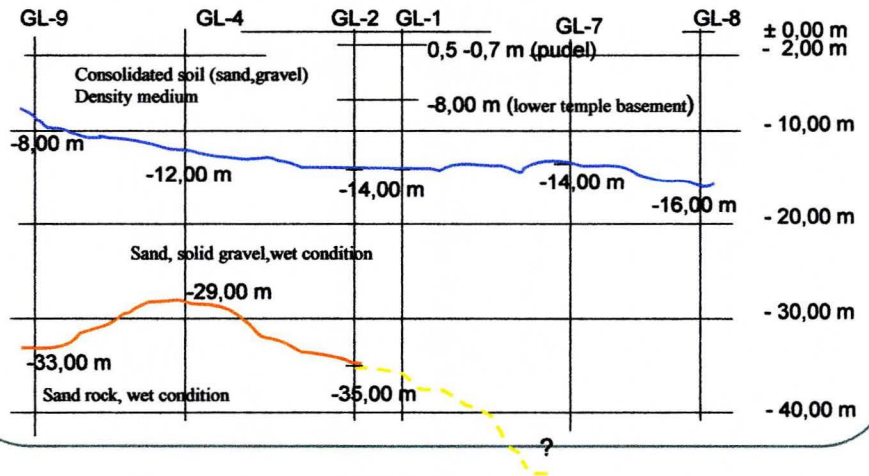
Potongan utara – selatan (GL-9; GL-4; GL2; GL-1; GL-7; GL8)

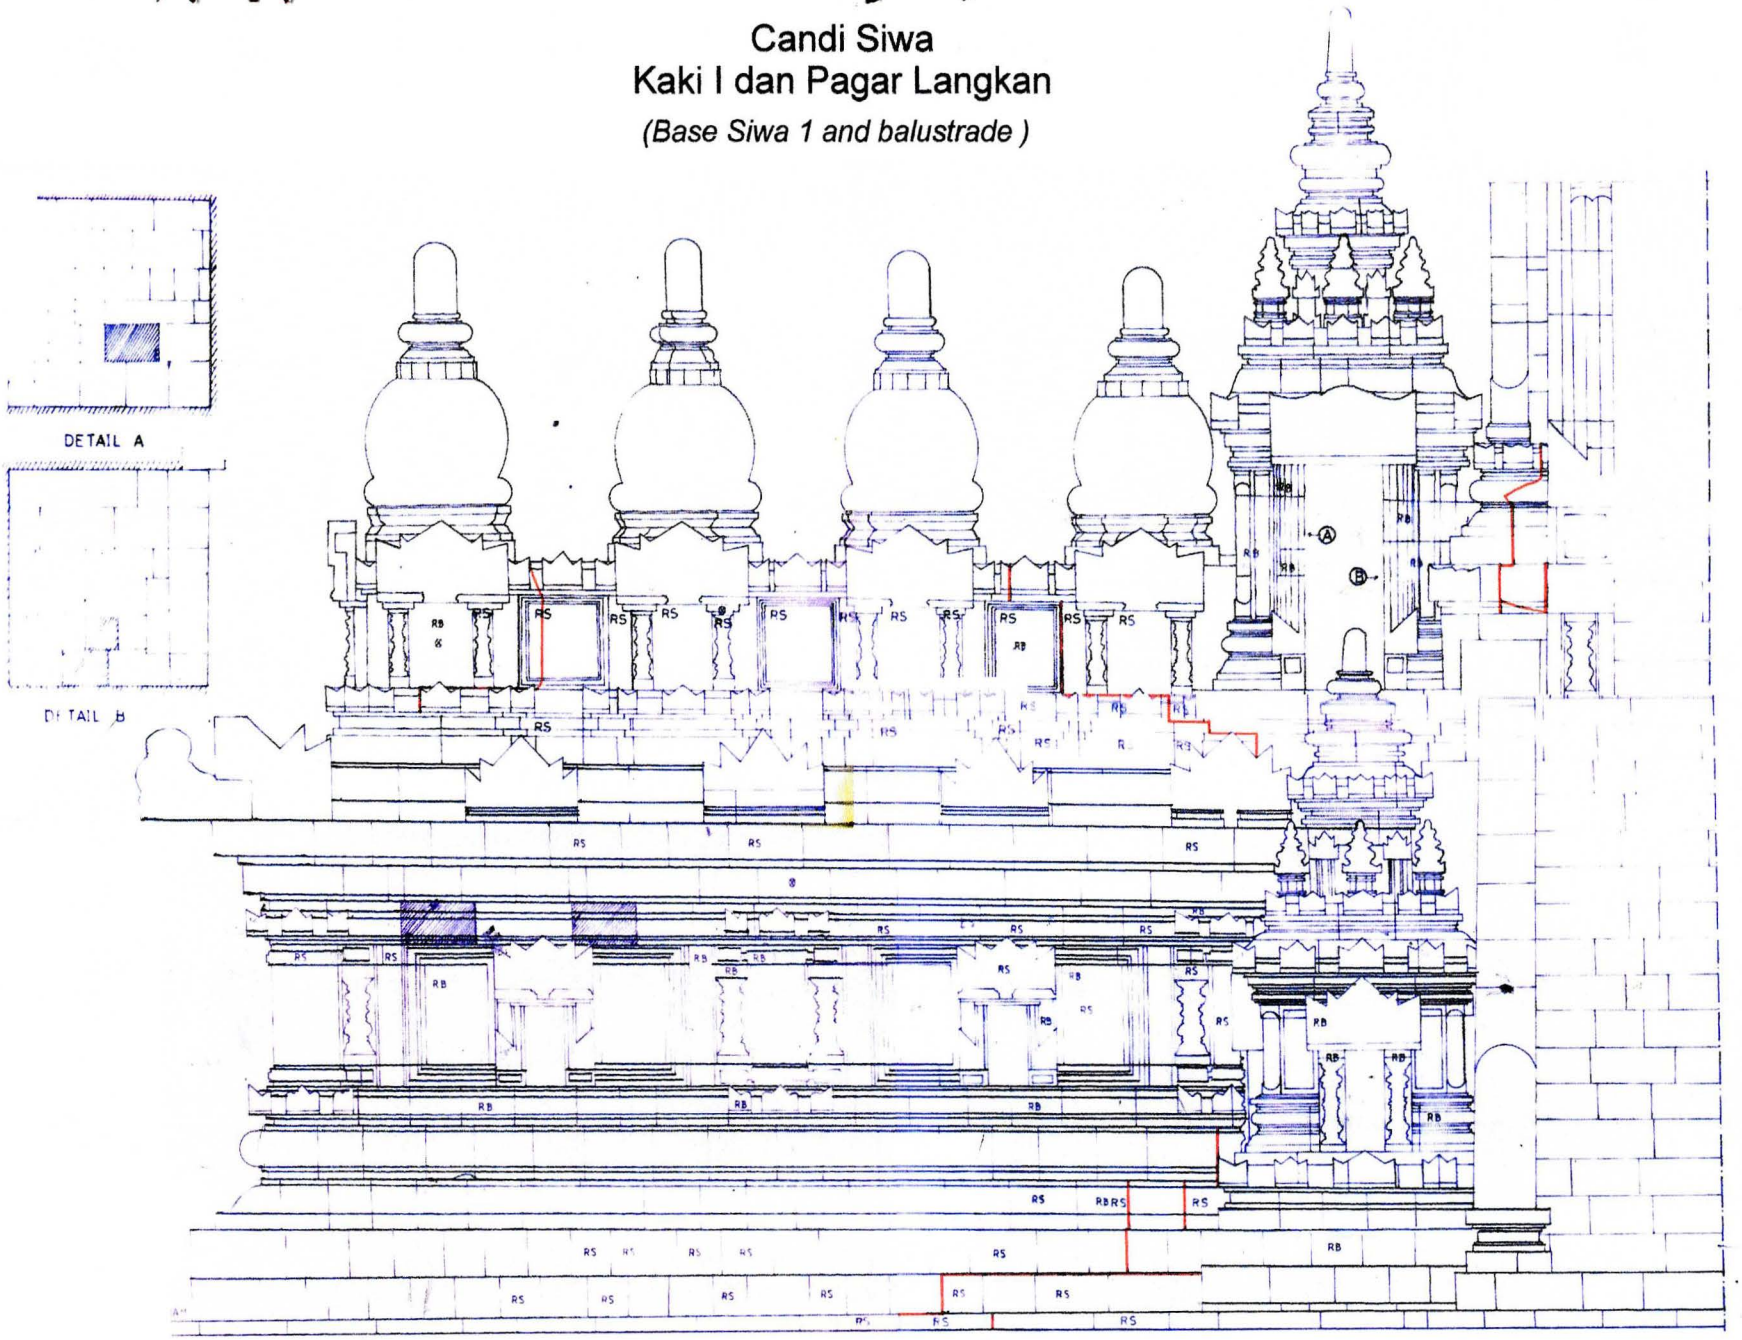
Candi Siwa
Kaki I dan Pagar Langkan
(Base Siwa 1 and balustrade)

CRACKING AND OPEN JOINT STONES ON SIWA TEMPLE

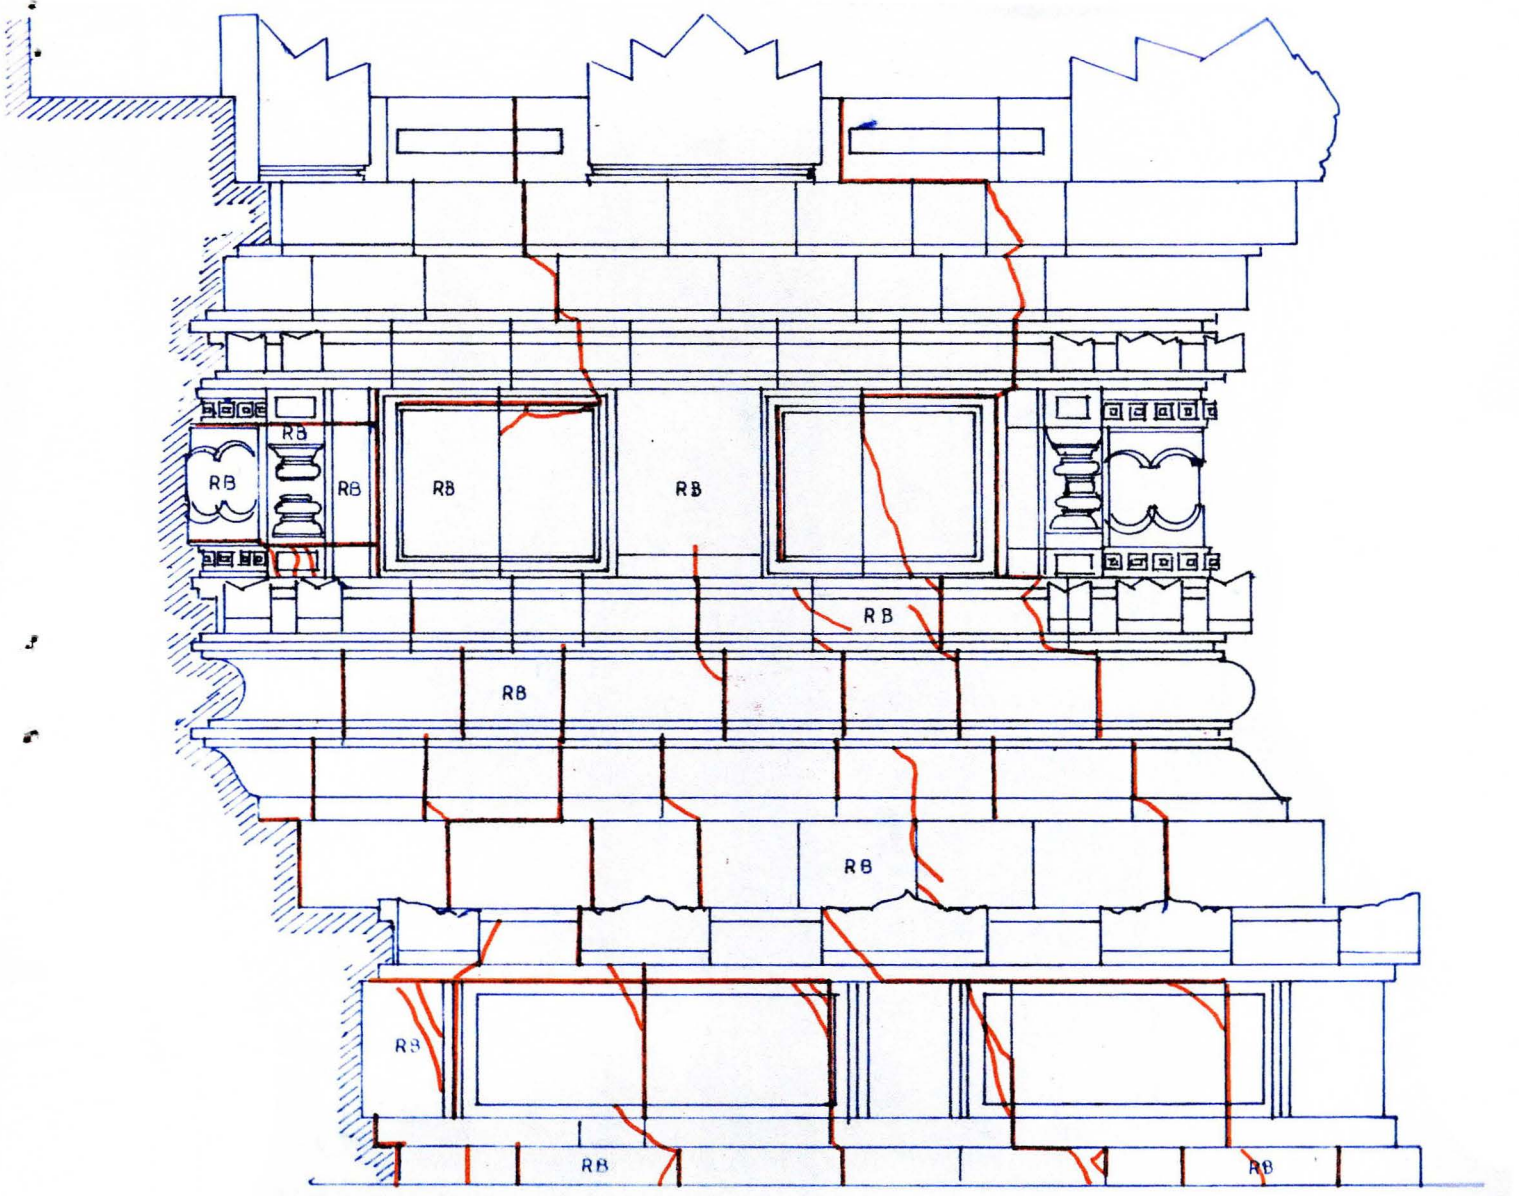
Area II

——— Craking and open joint stone

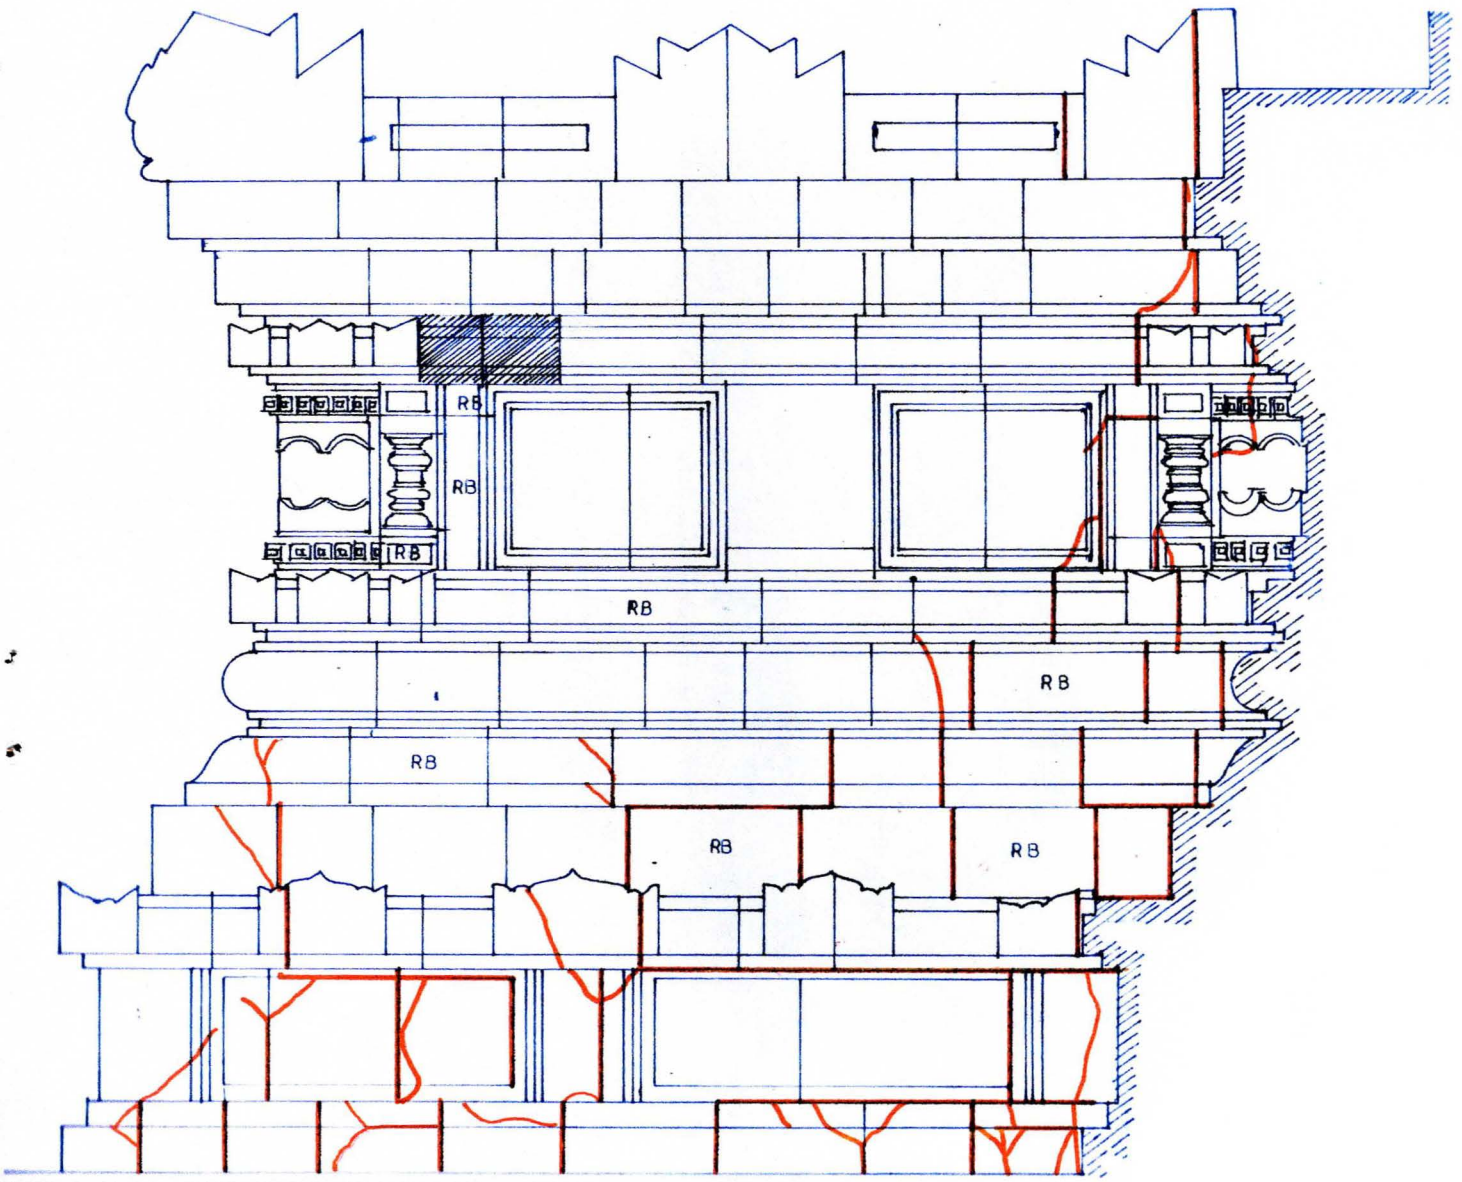
Area 3

Craking and open joint stone

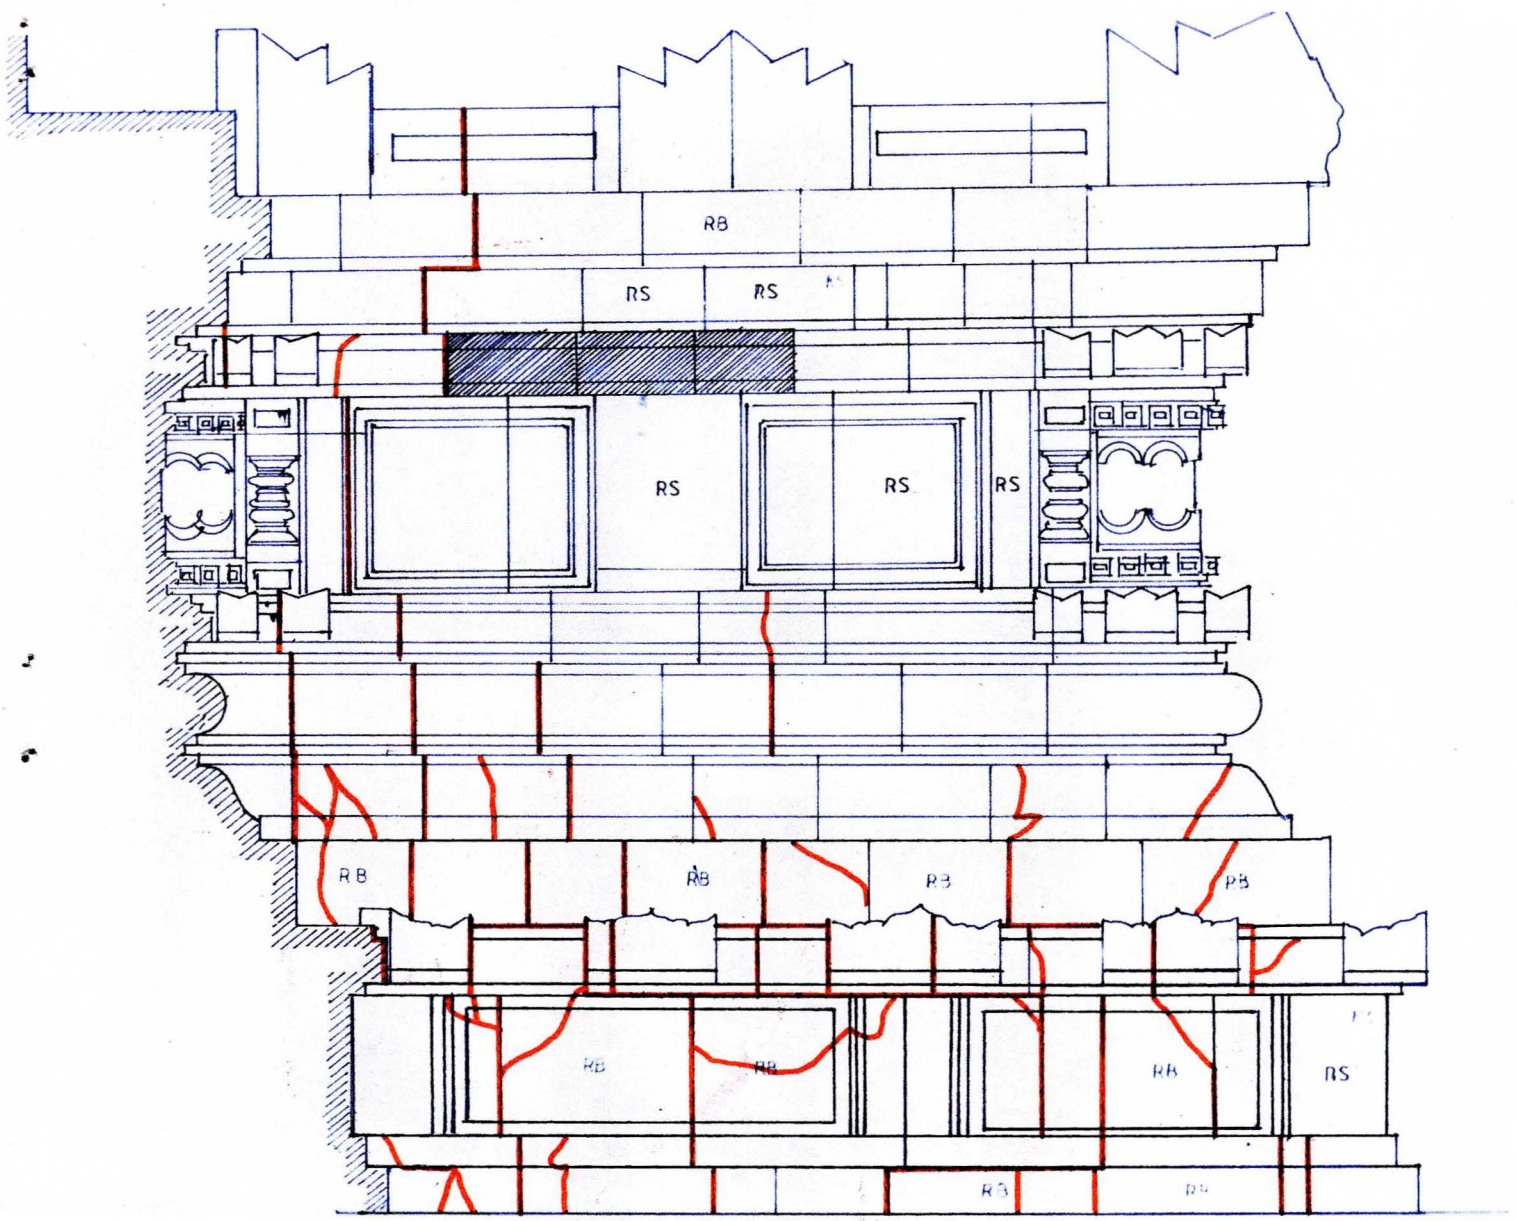
Area 4

Craking and open joint stone

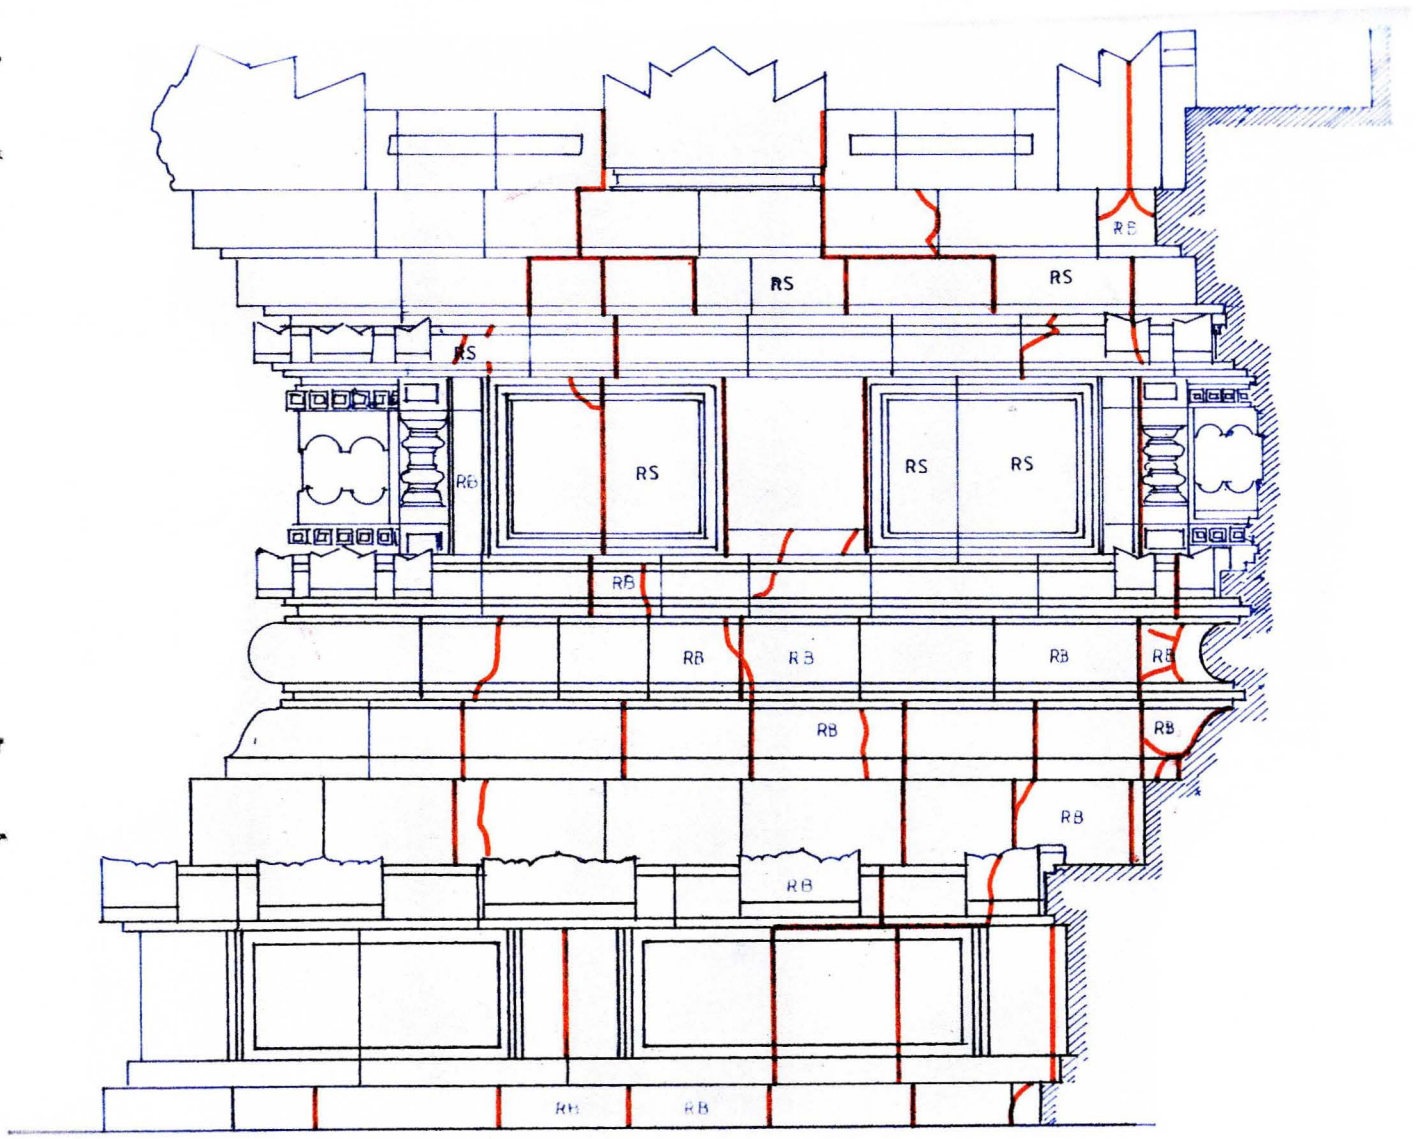
Area 5

Craking and open joint stone

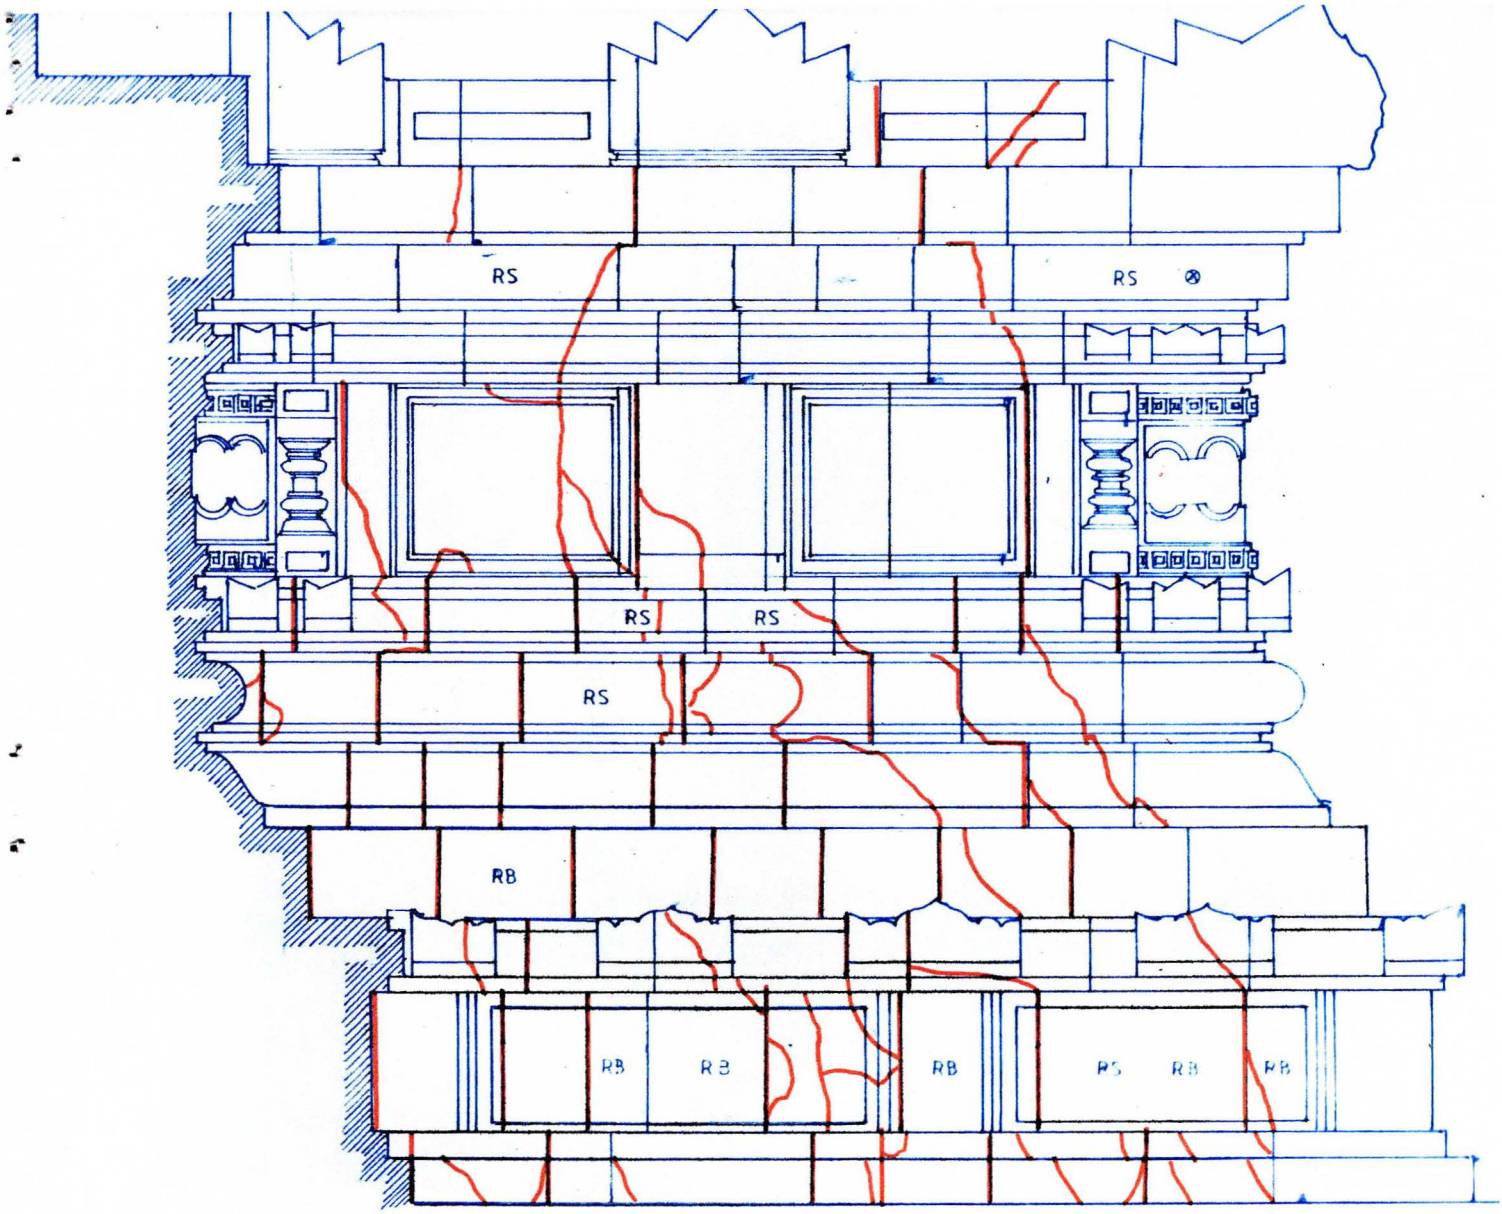
Area 7

Craking and open joint stone

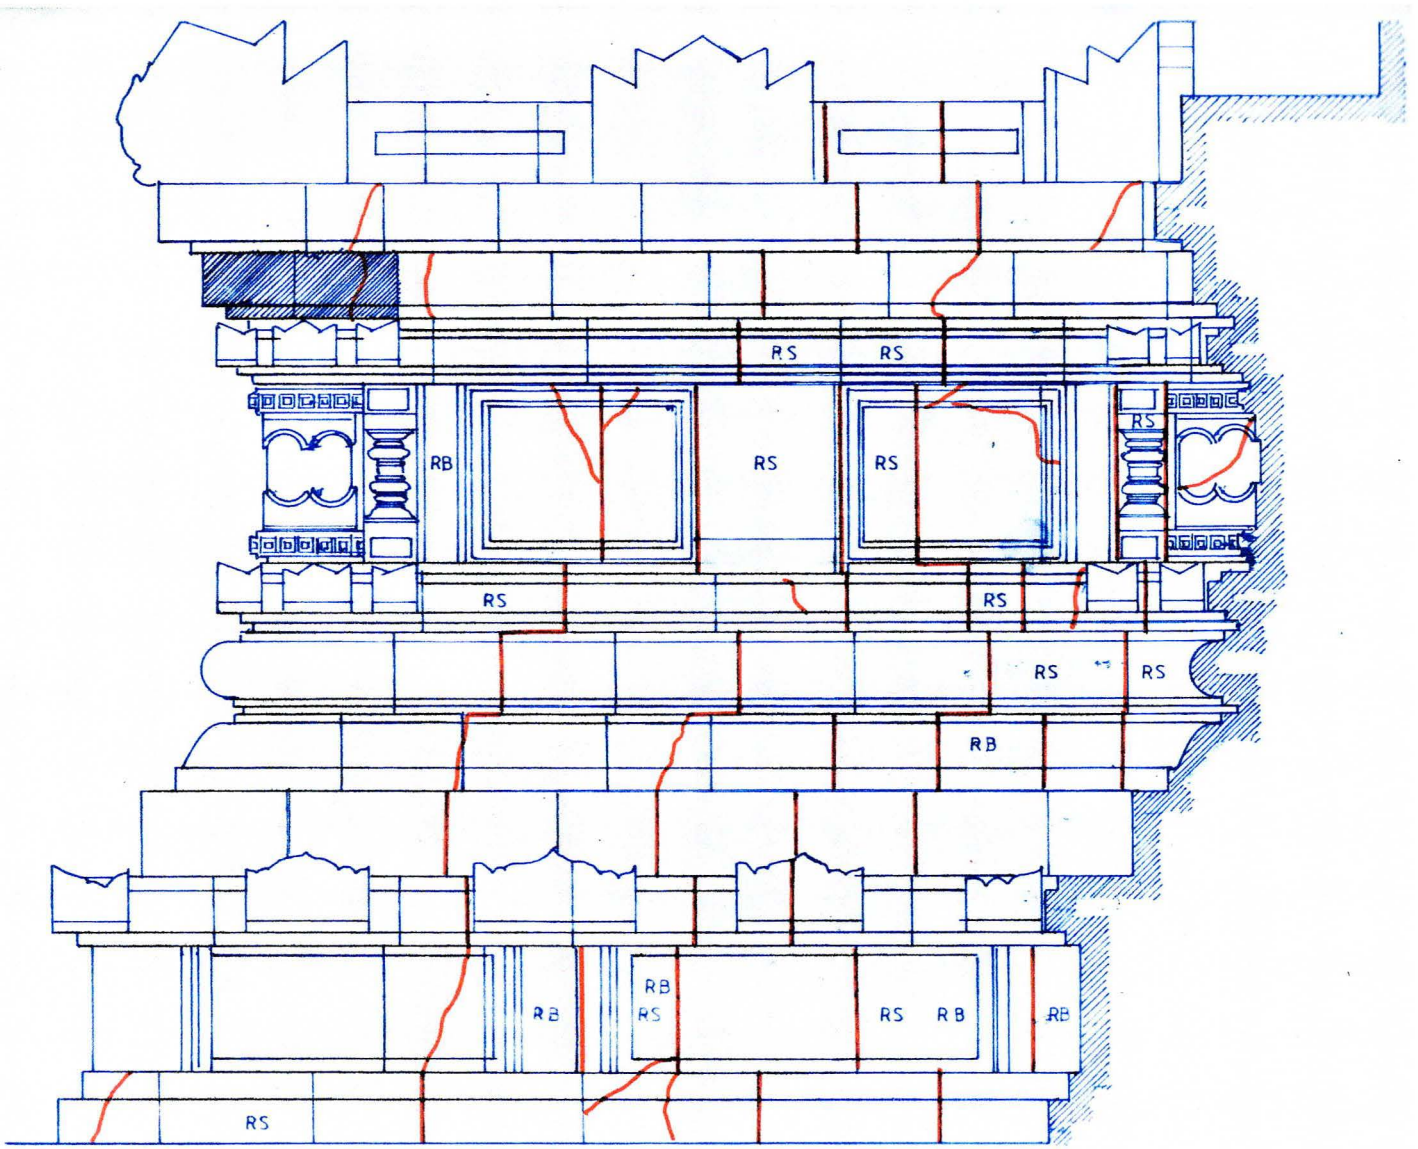
Area 8

Craking and open joint stone

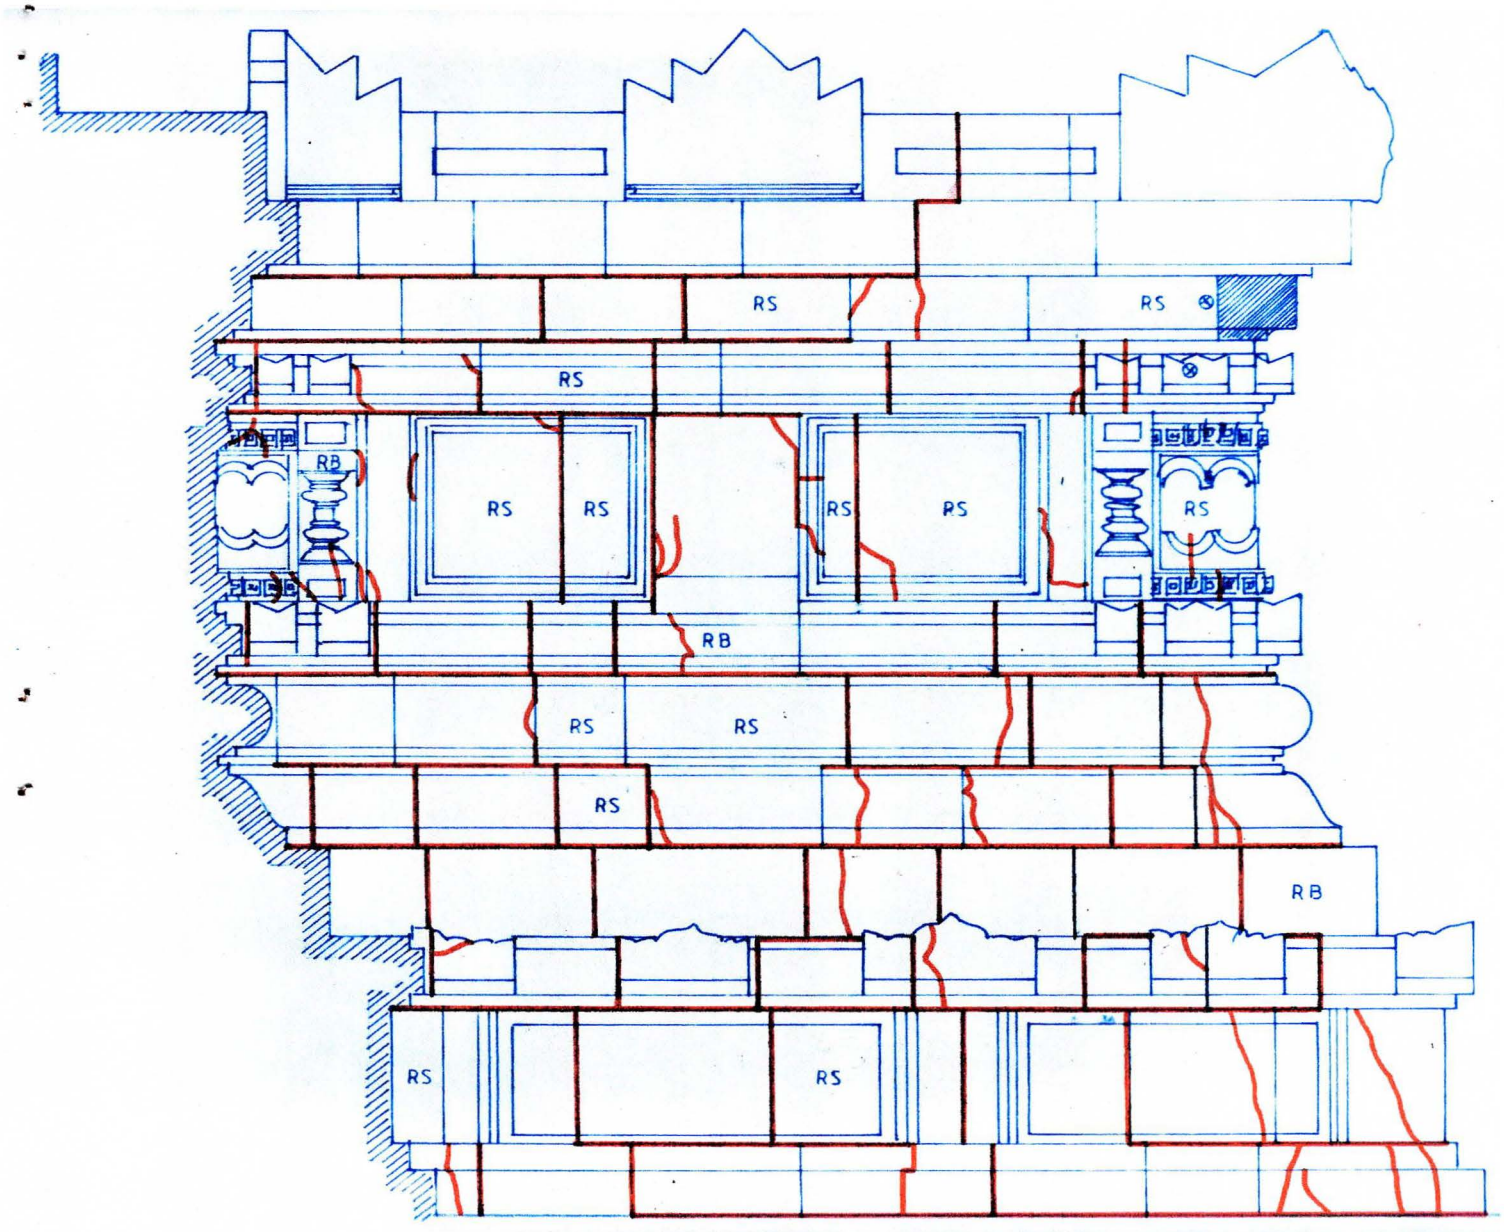
Area 9

Craking and open joint stone

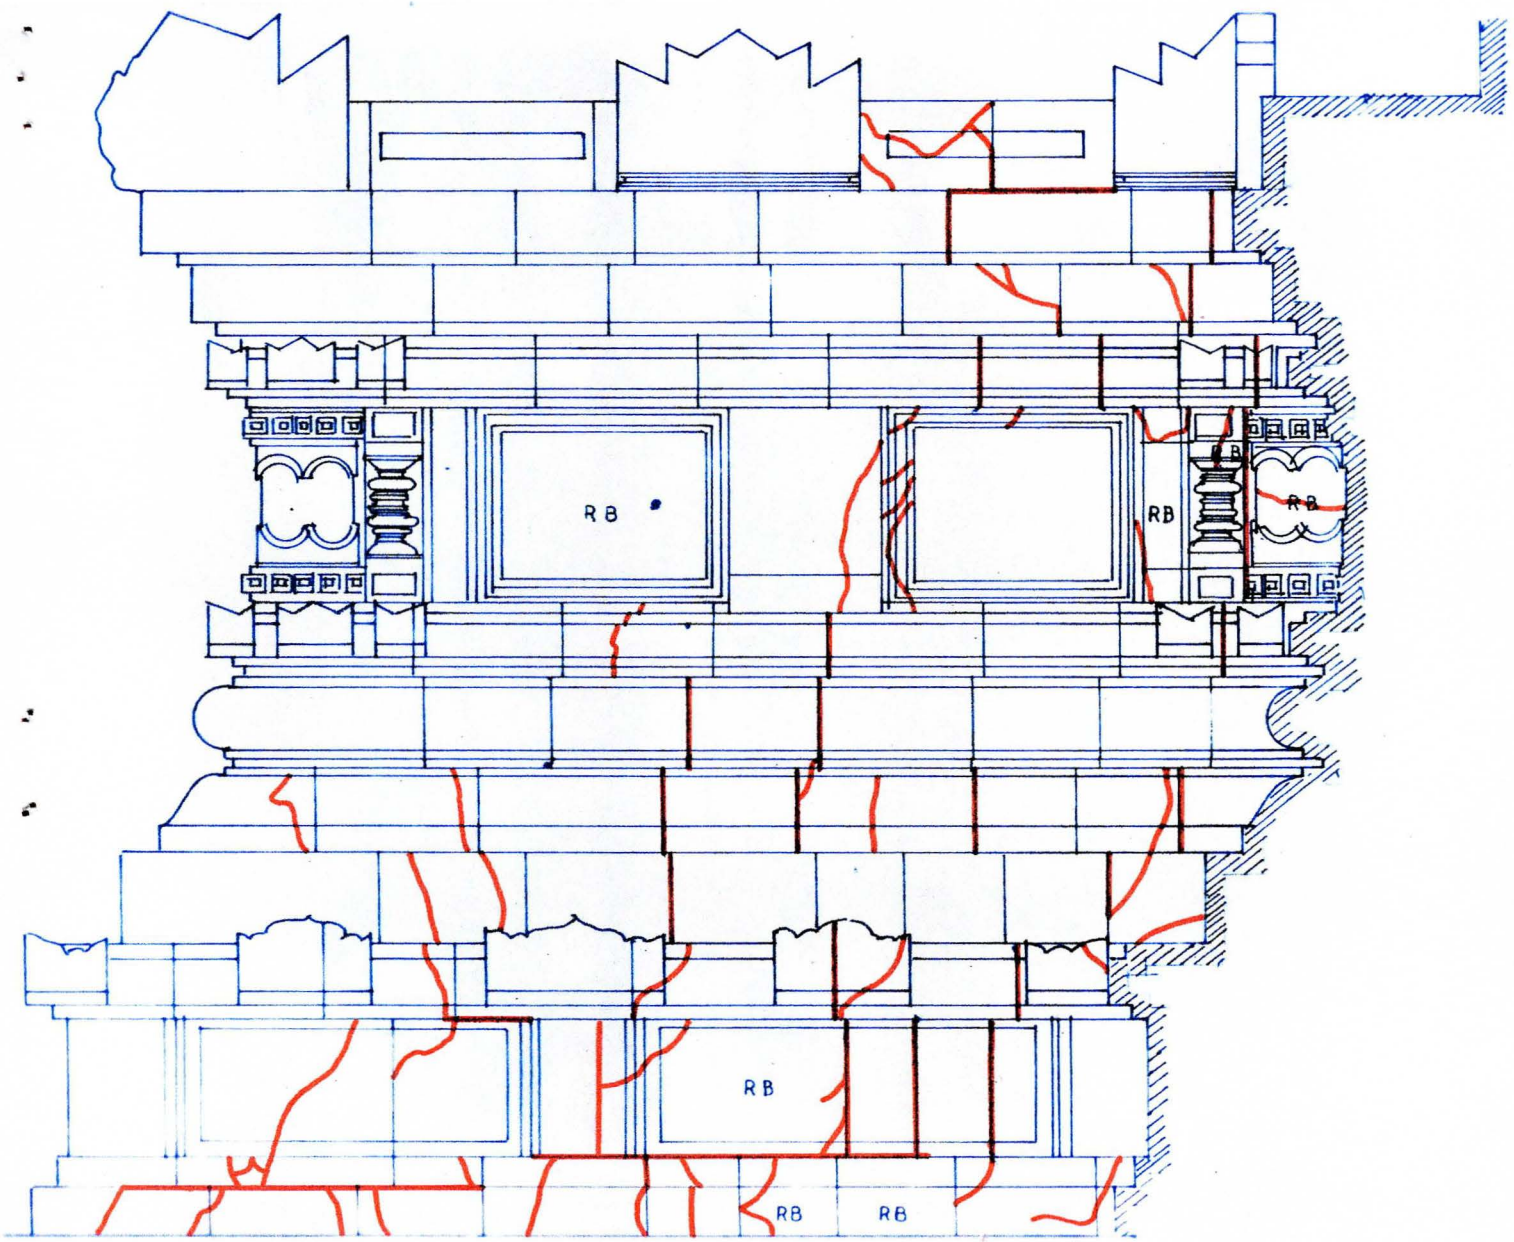
Area 10

Craking and open joint stone

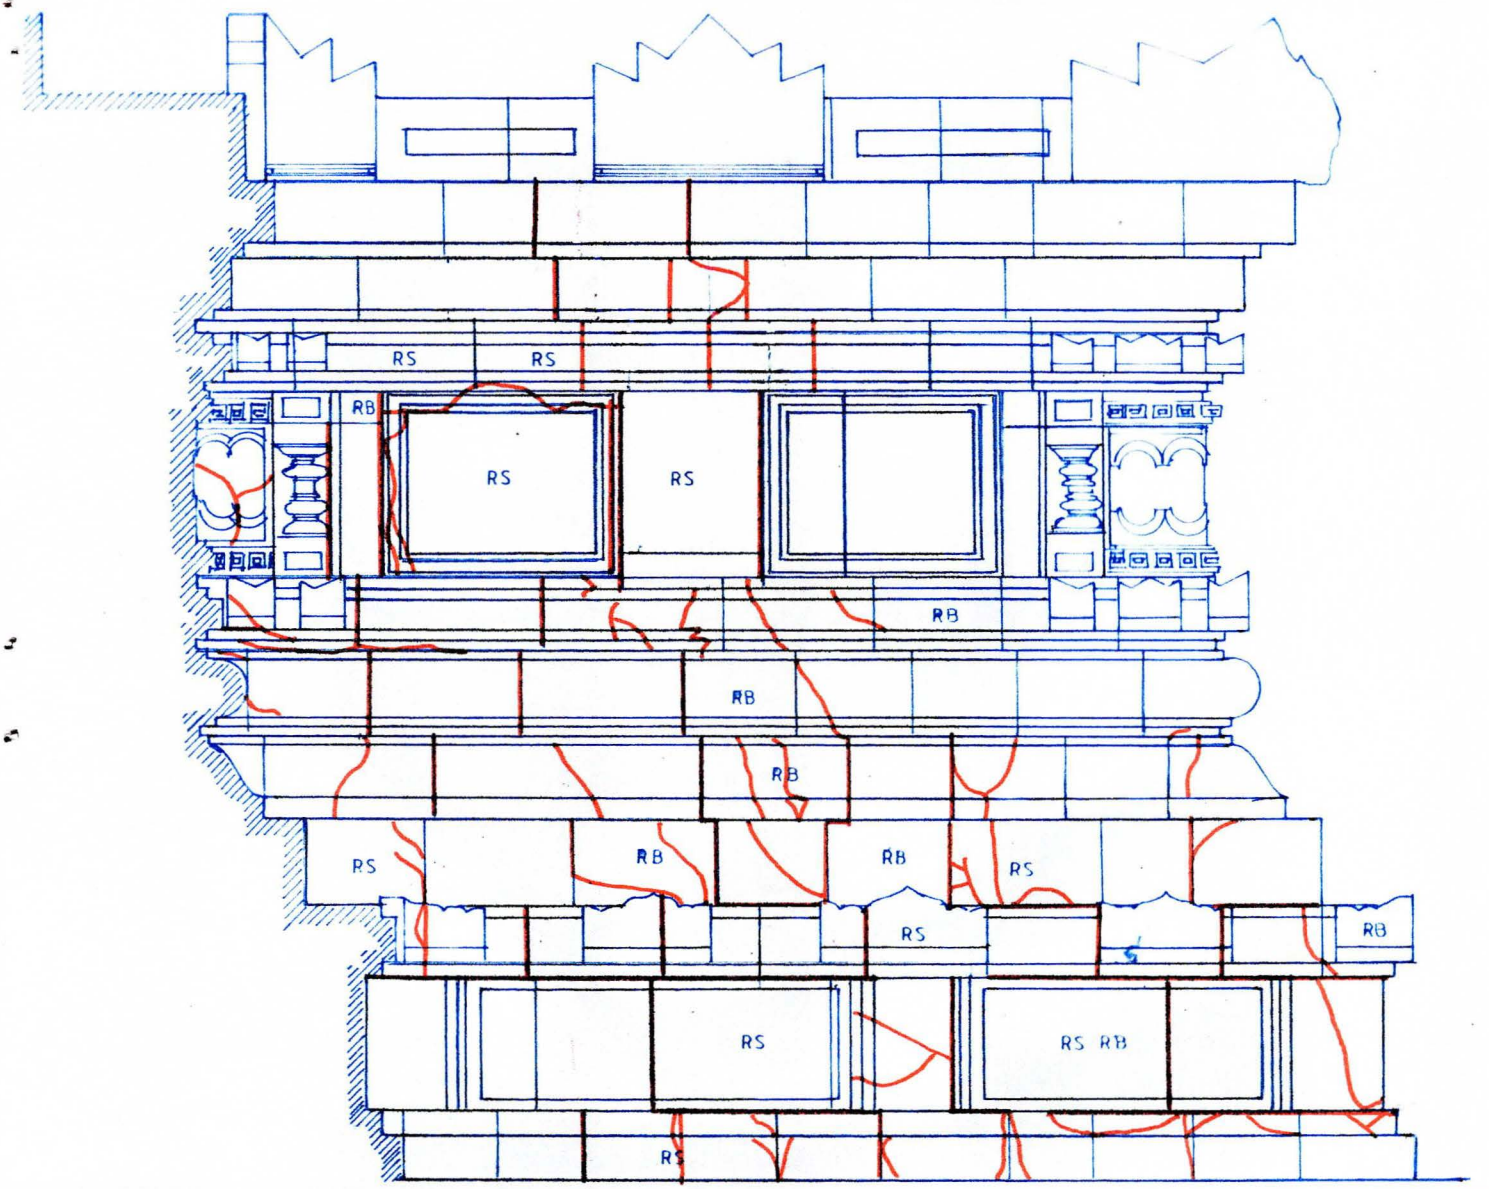
Area 12

Craking and open joint stone
