TECHNICAL STUDY

FOR REHABILITATION ON PRAMBANAN TEMPLE COMPOUND AFTER EARTHQUAKE

BY
TECHNICAL STUDY TEAM
ARCHAEOLOGICAL OFFICE OF YOGYAKARTA

DEPARTMENT OF CULTURE AND TOURISM
2007

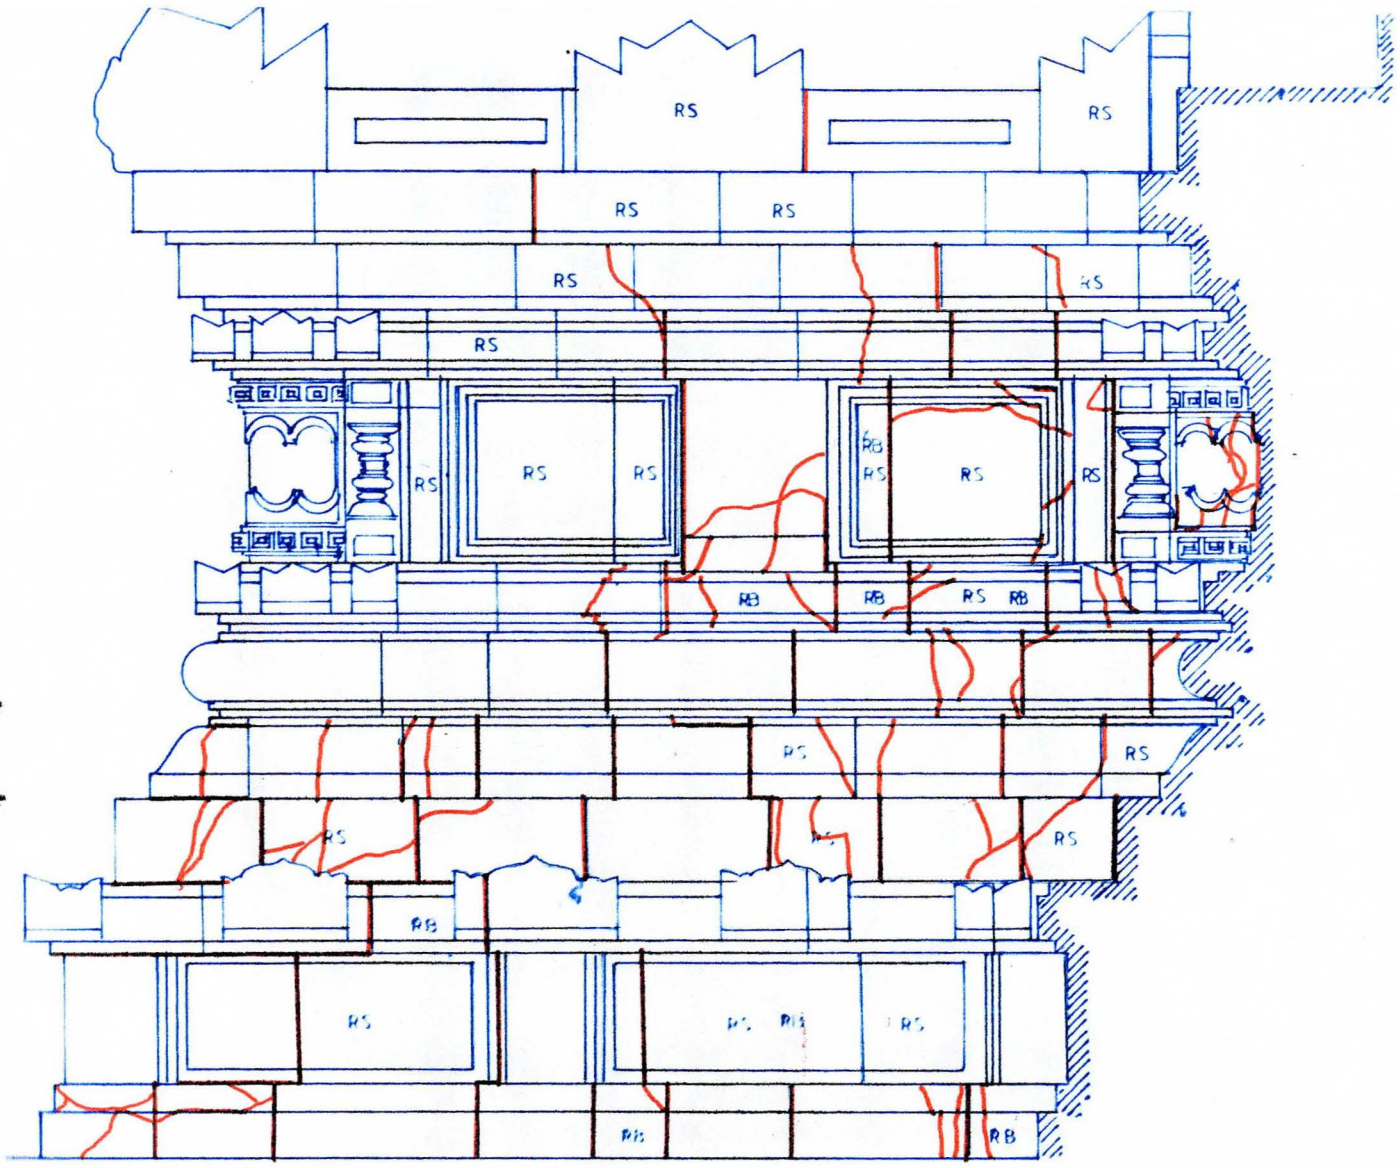
Area 13

Craking and open joint stone

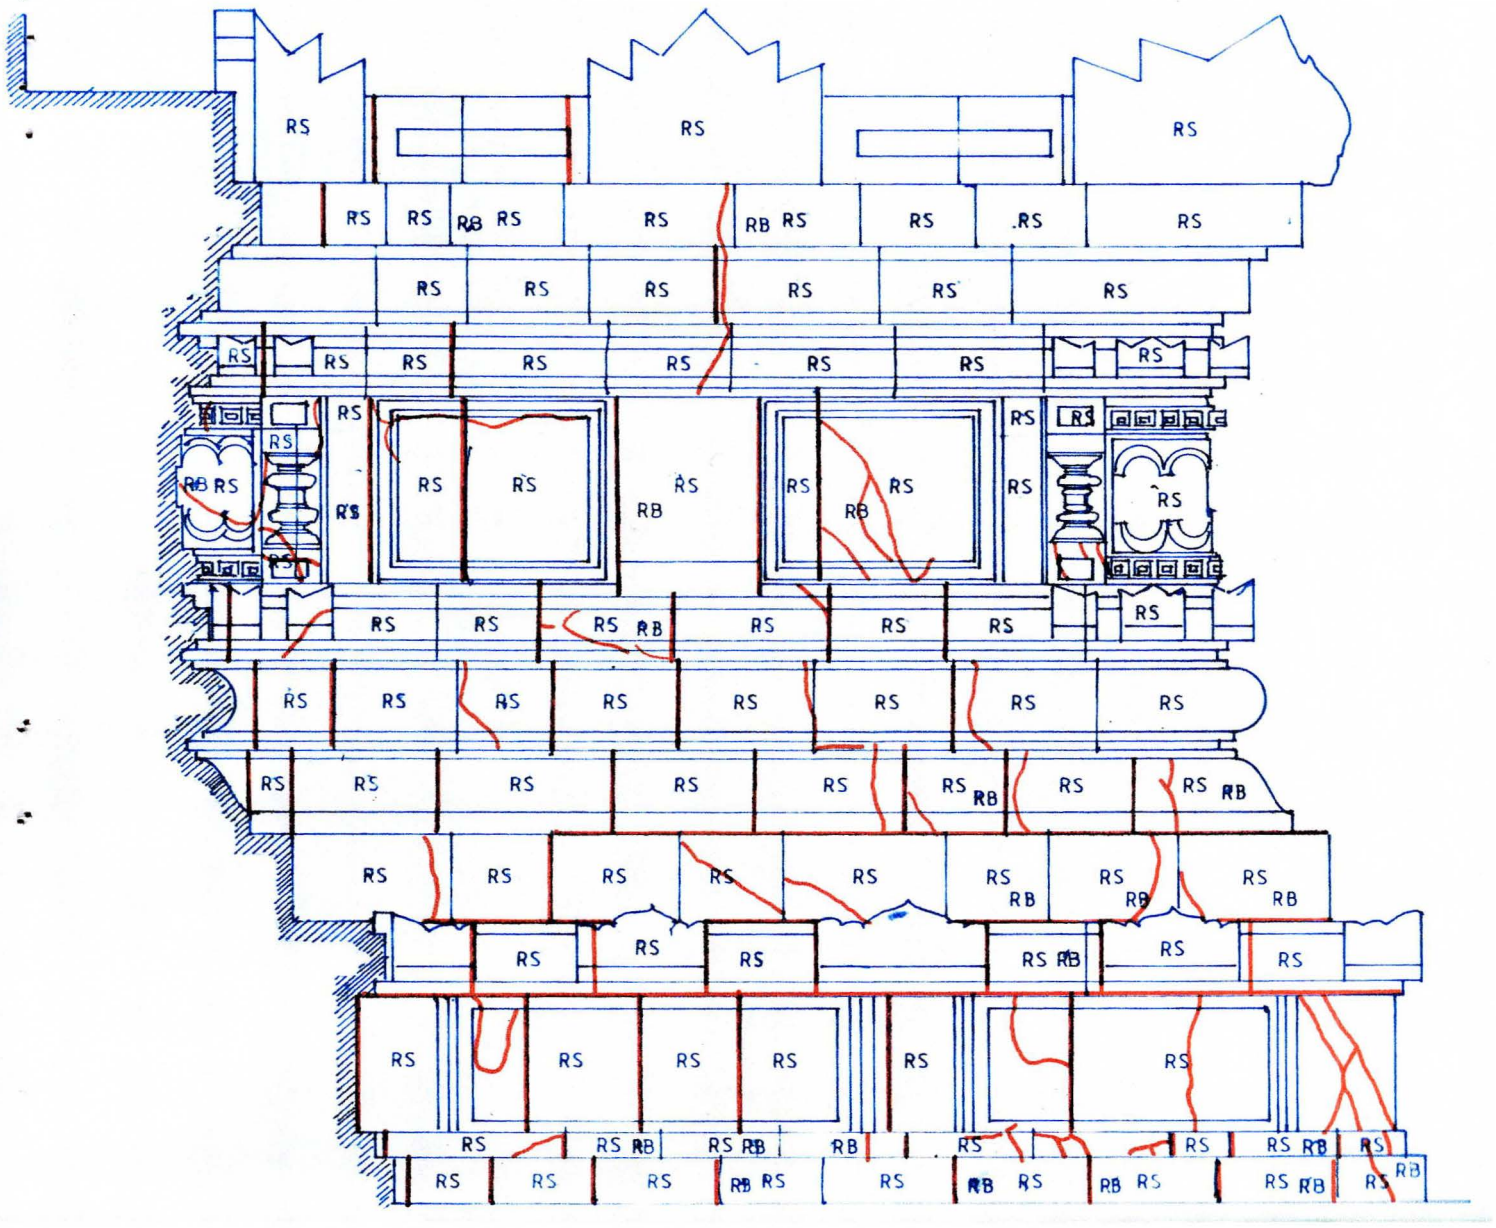
Area 14

Craking and open joint stone

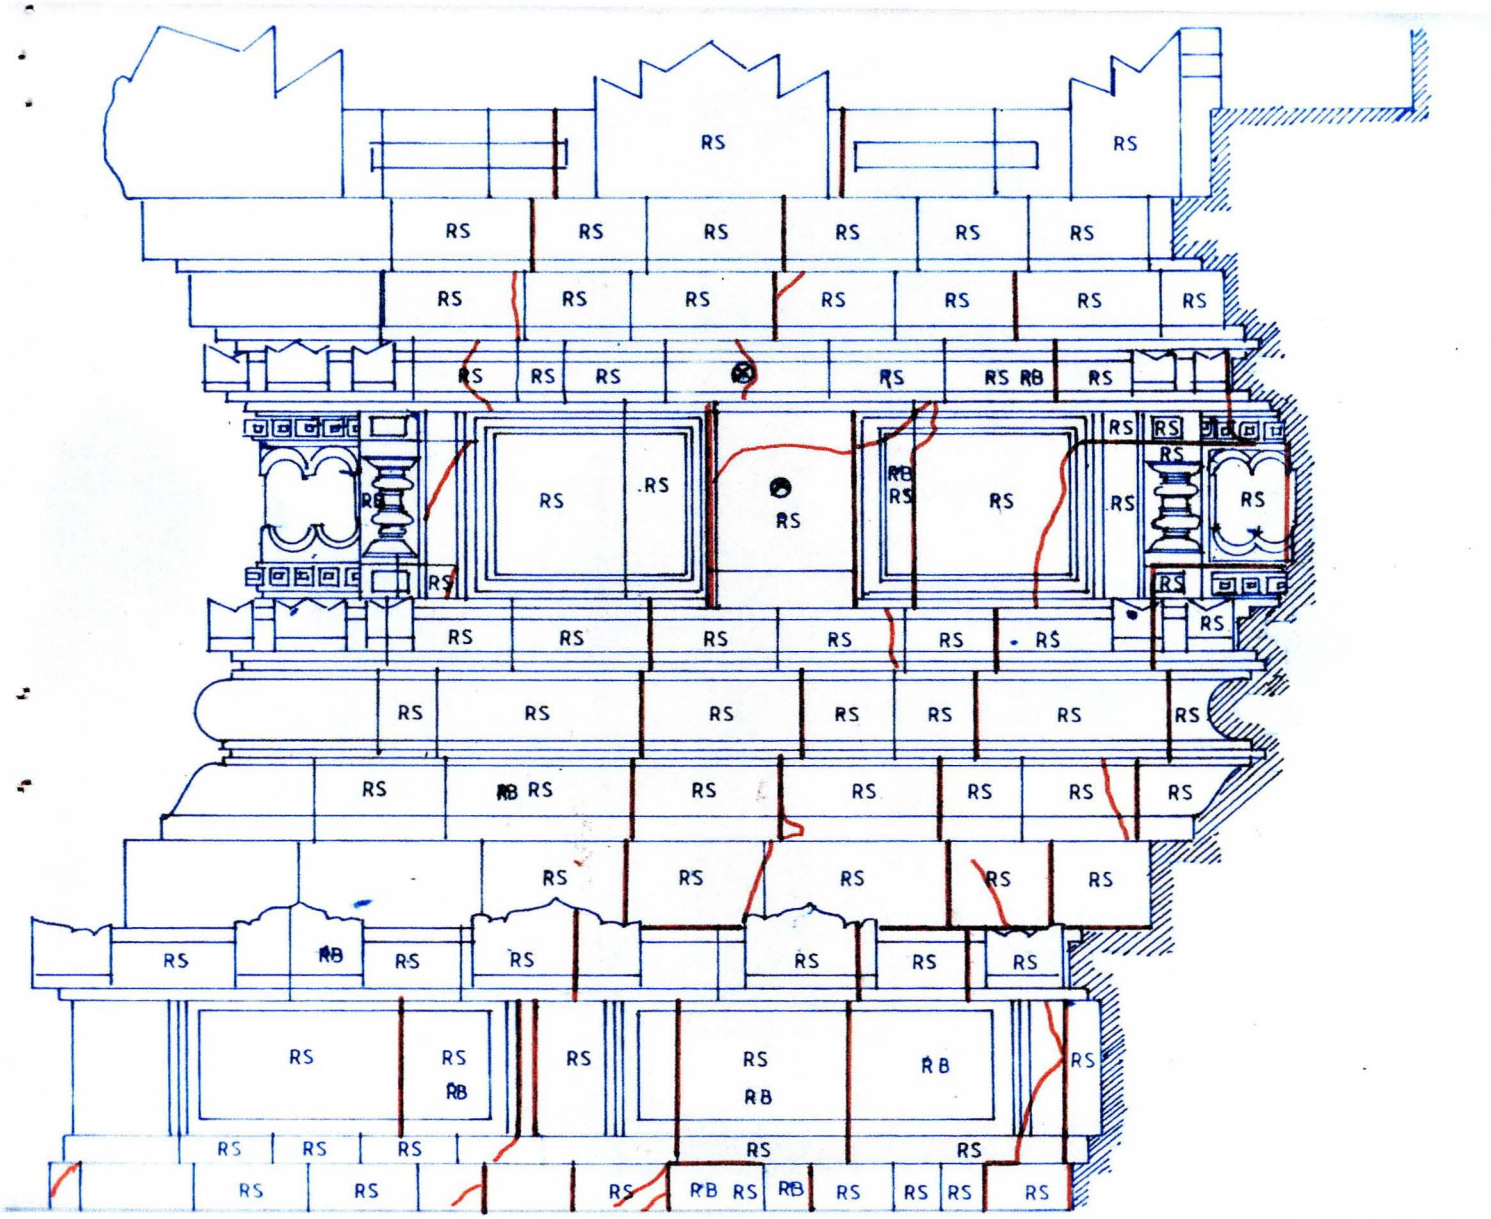
Area 15

Craking and open joint

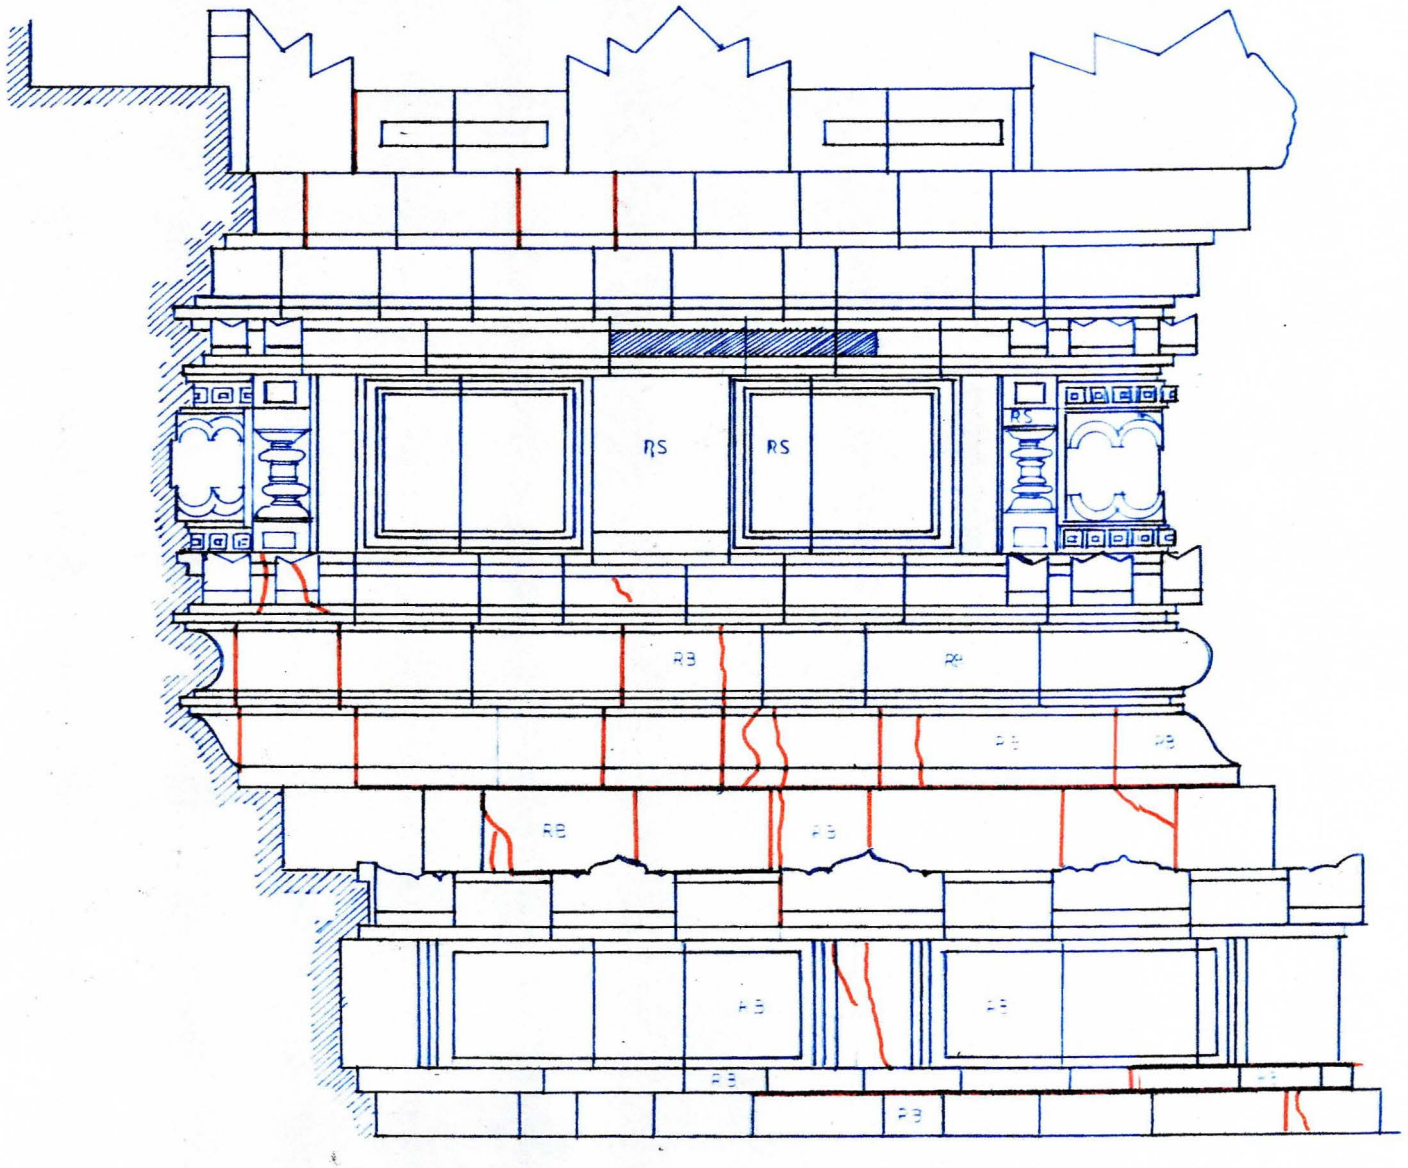
Area 17

Craking and open joint stone

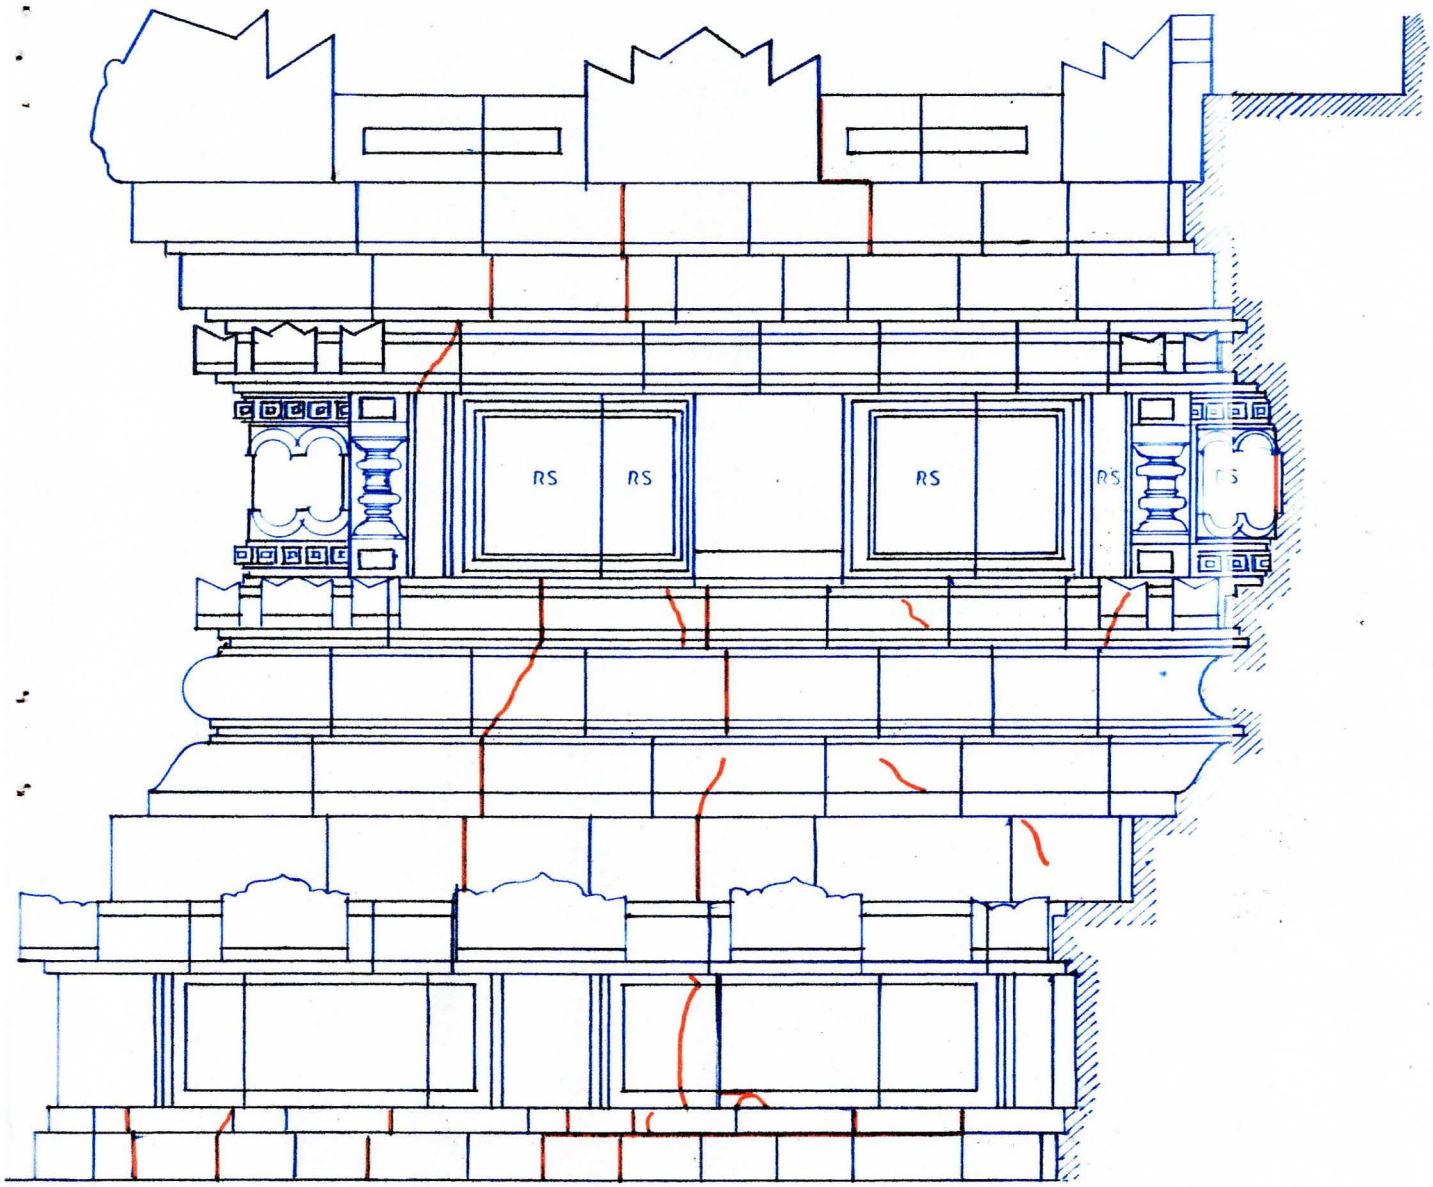
Area18

Craking and open joint stone

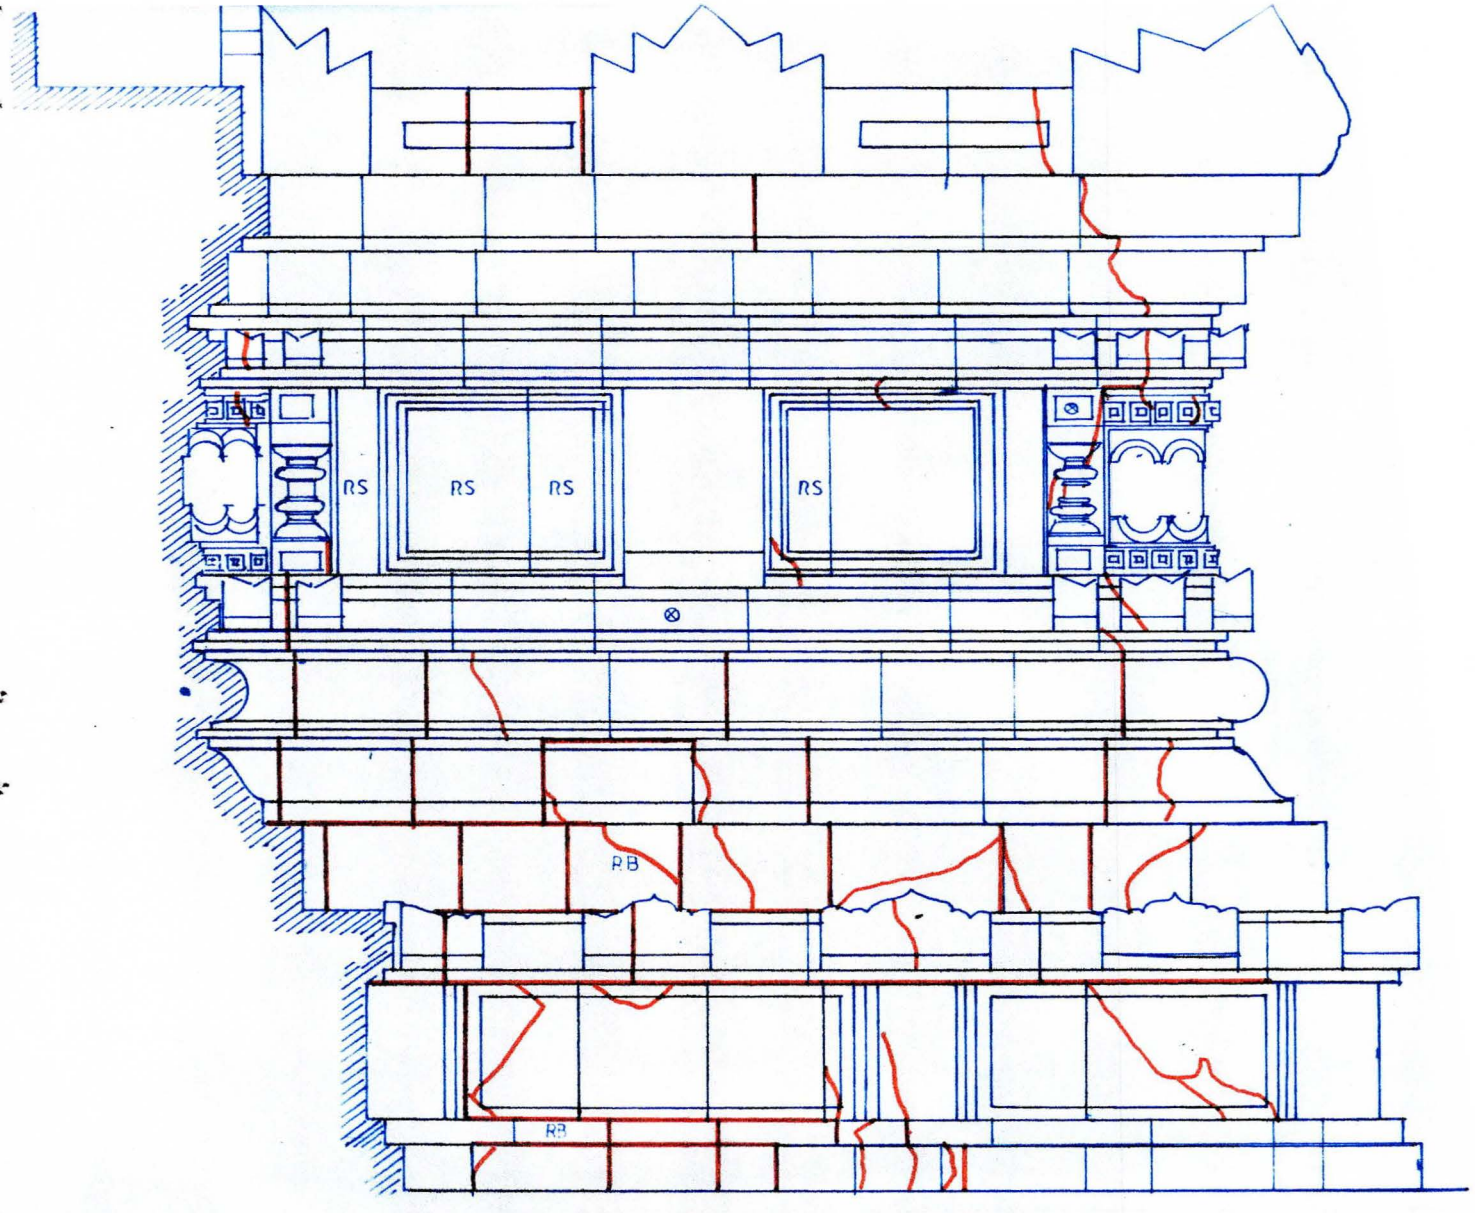
Area 19

Craking and open joint stone

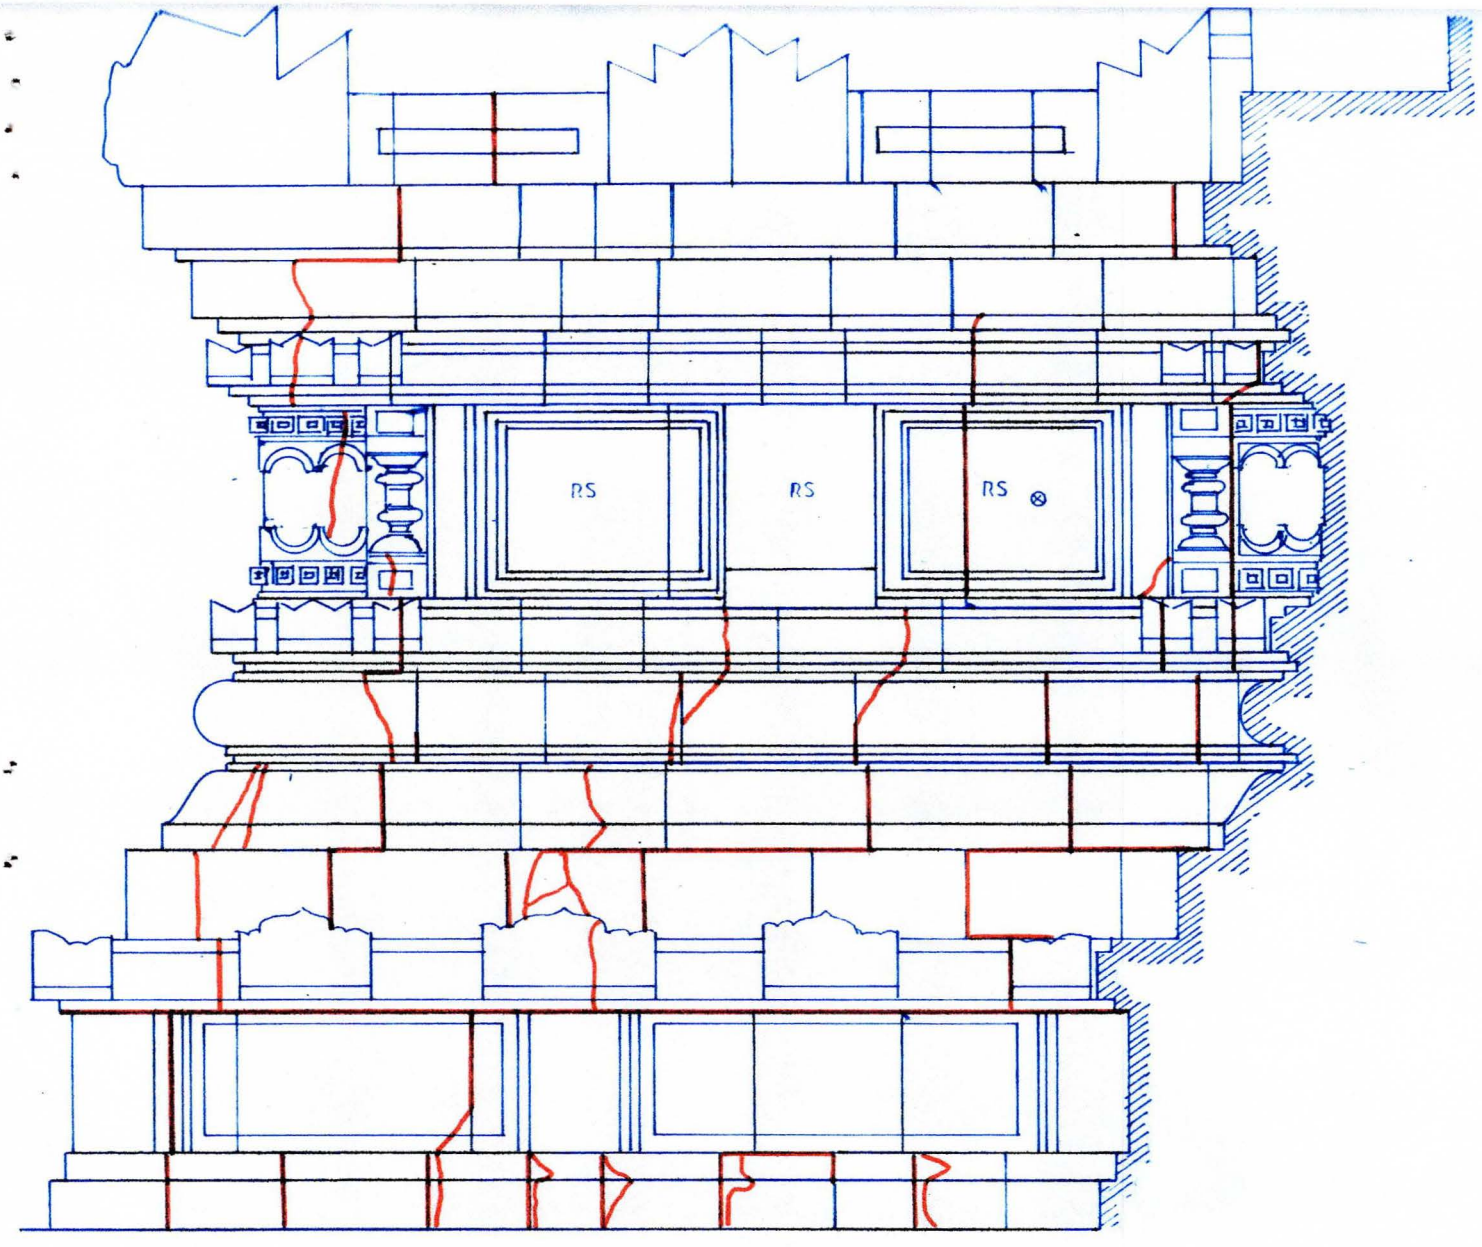
Area 20

Craking and open joint stone

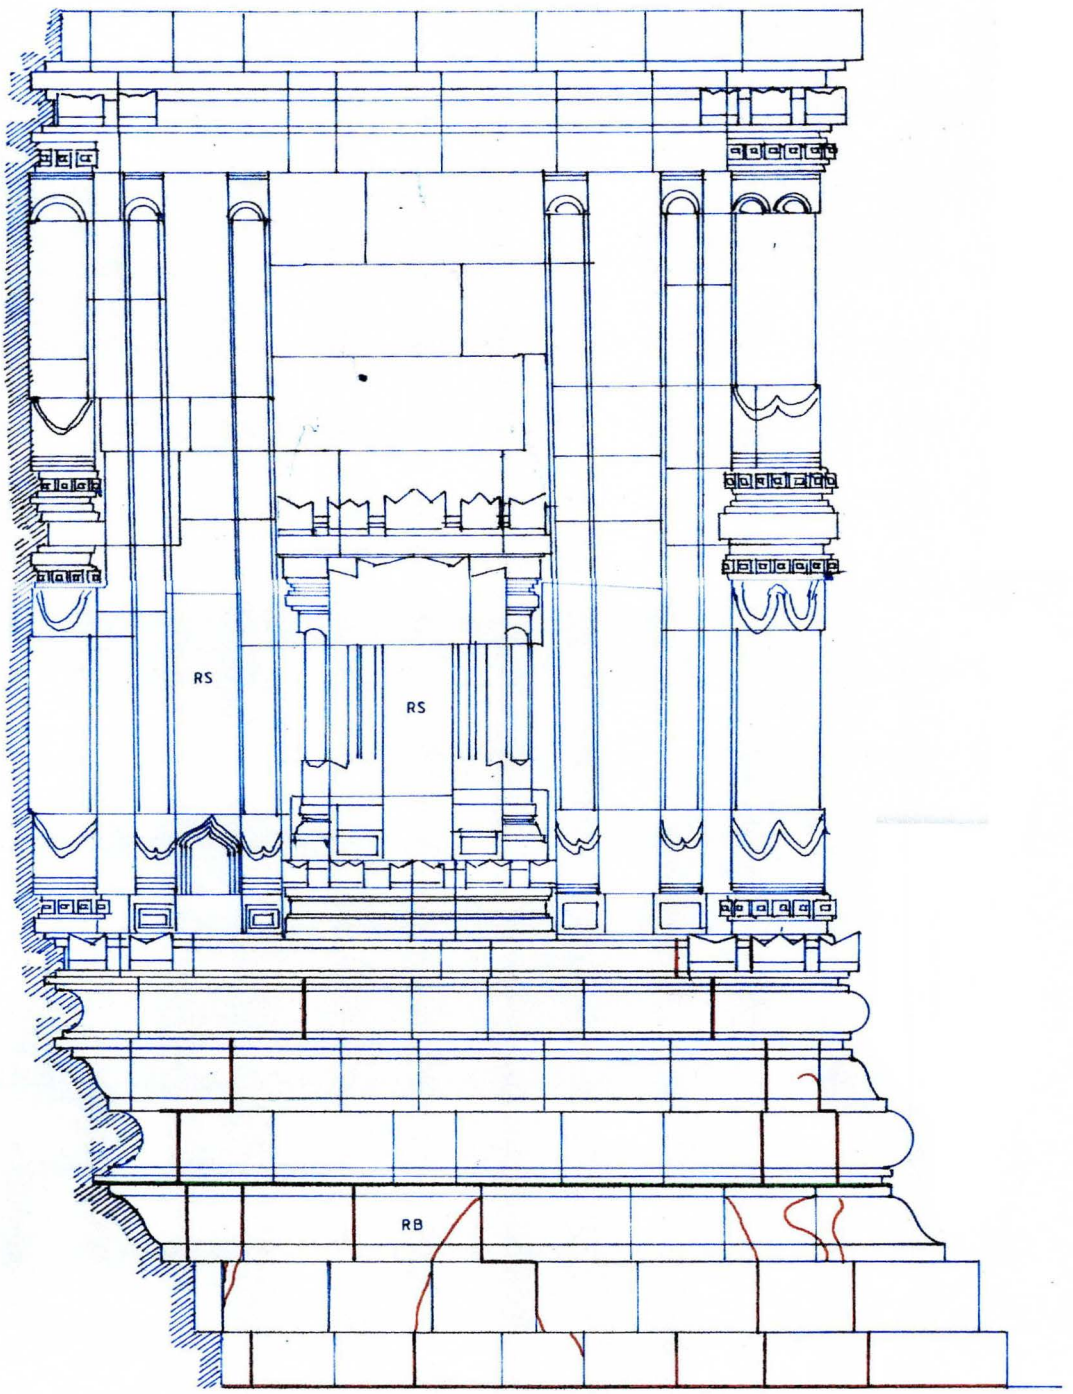
BIDANG II

Craking and open joint stone

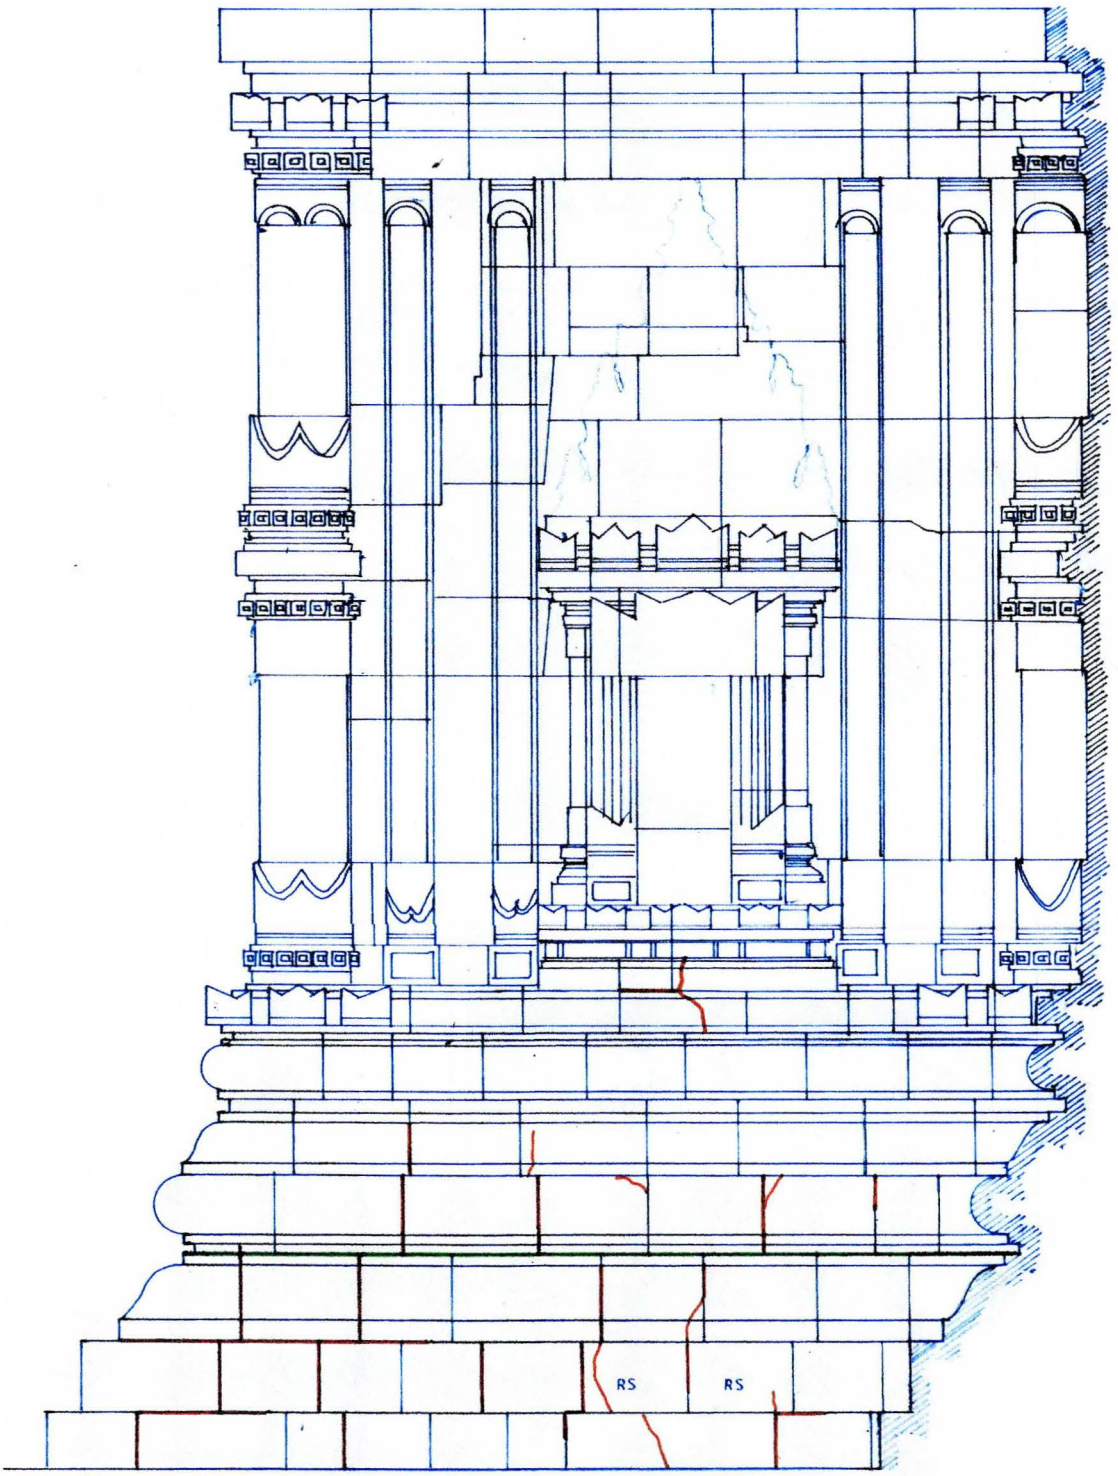
Area III

——— Craking and open joint stone

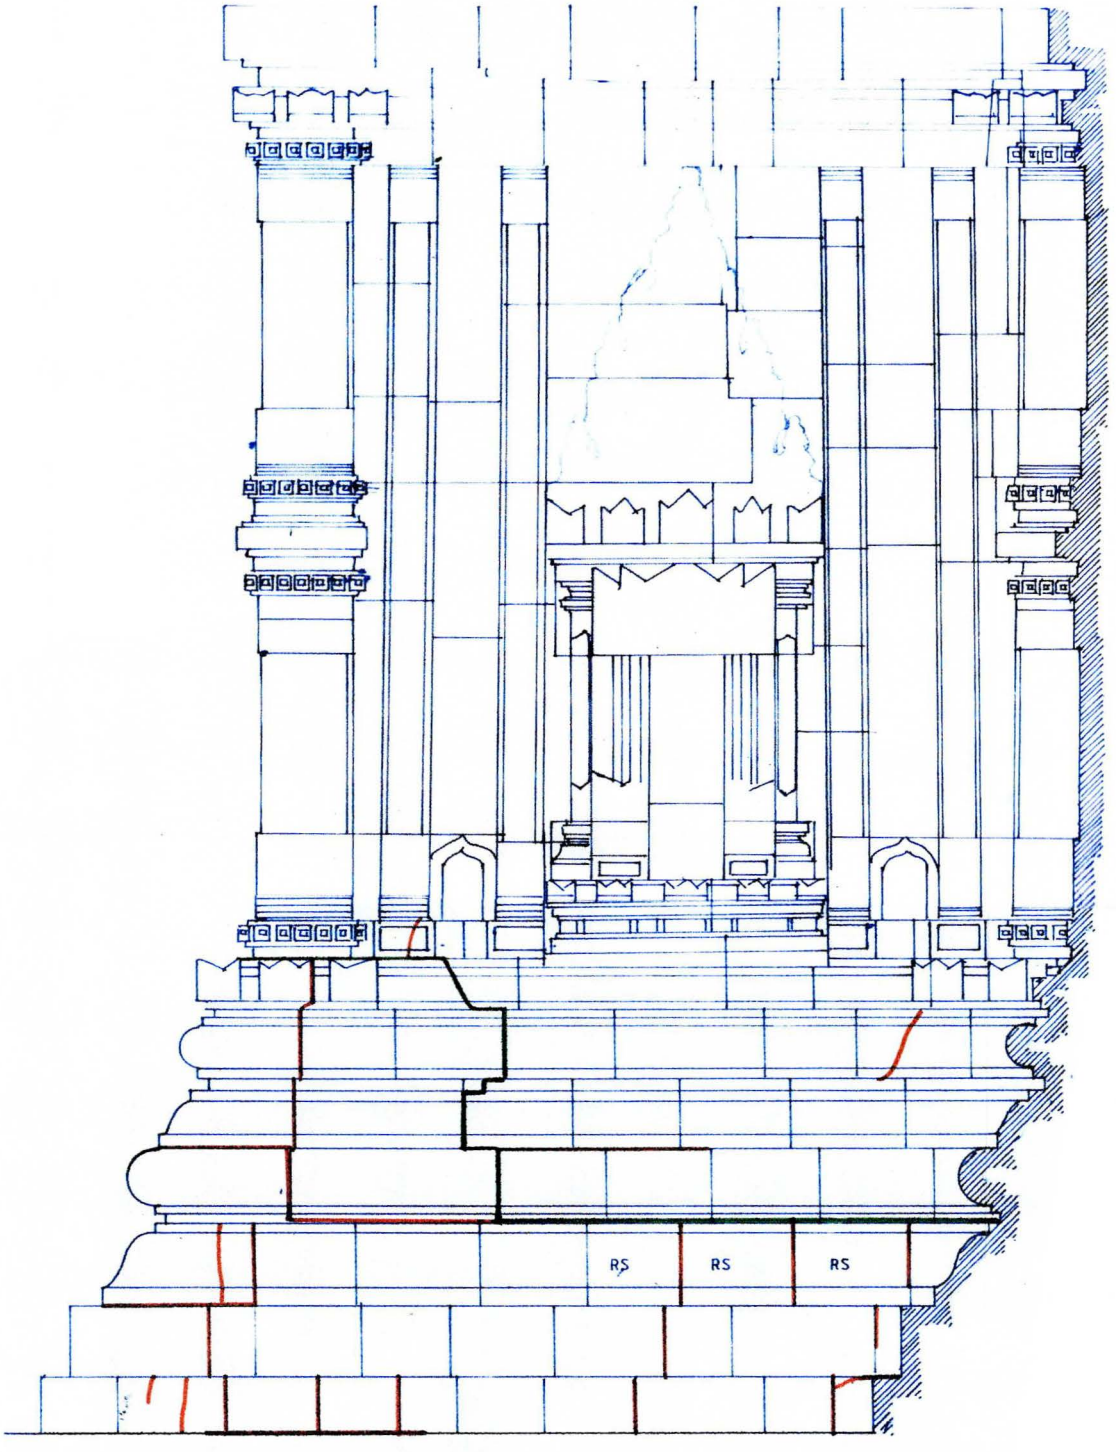
Area V

Craking and open joint stone

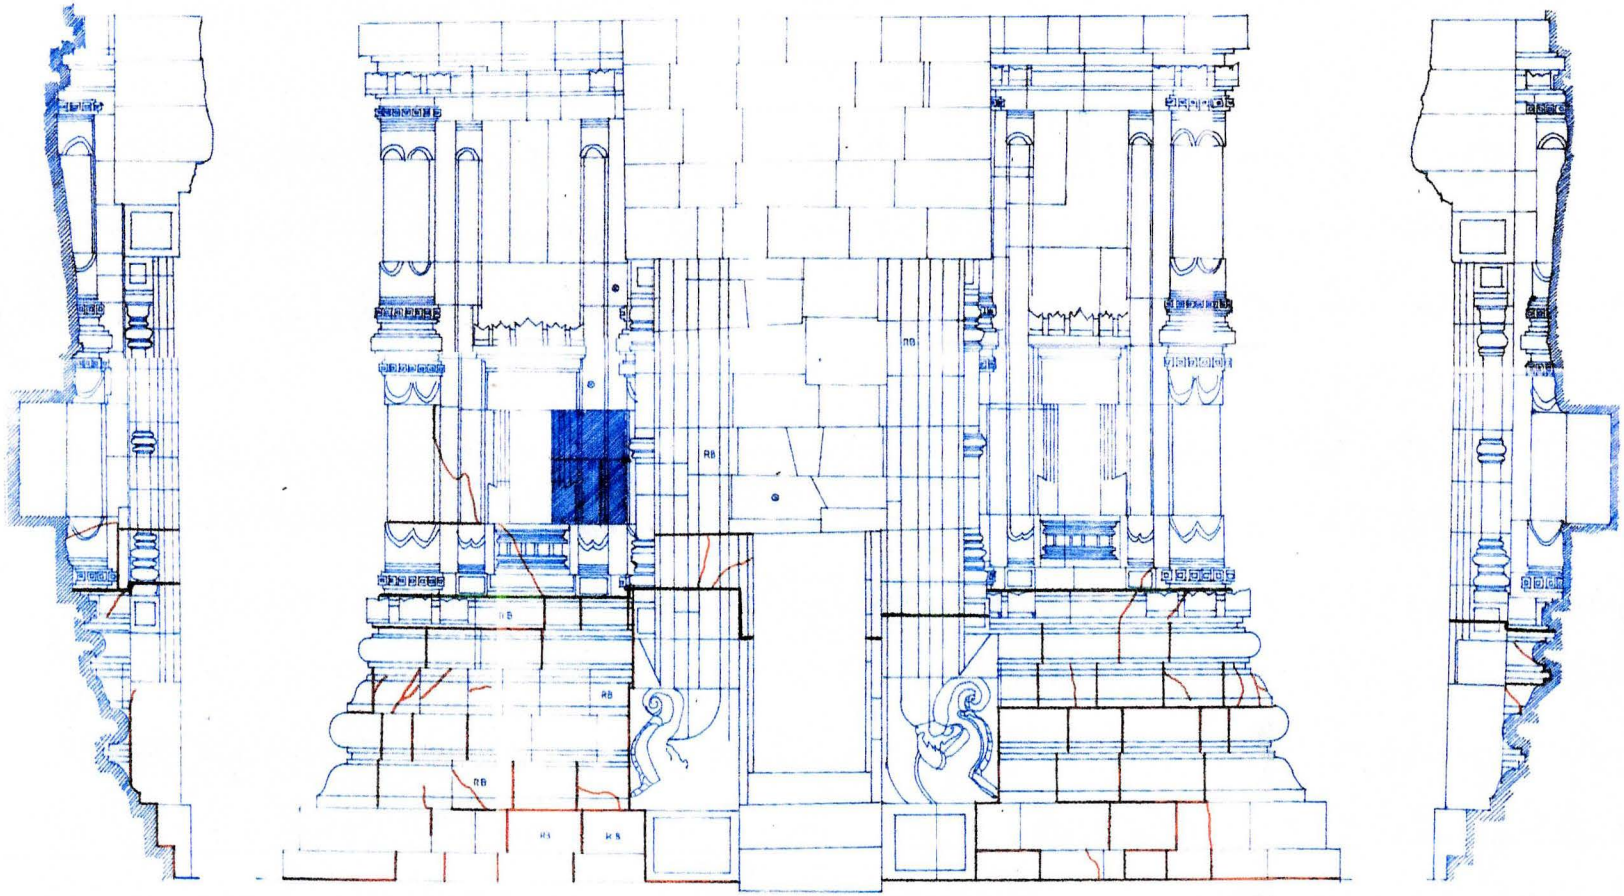
Area VI

Craking and open joint stone

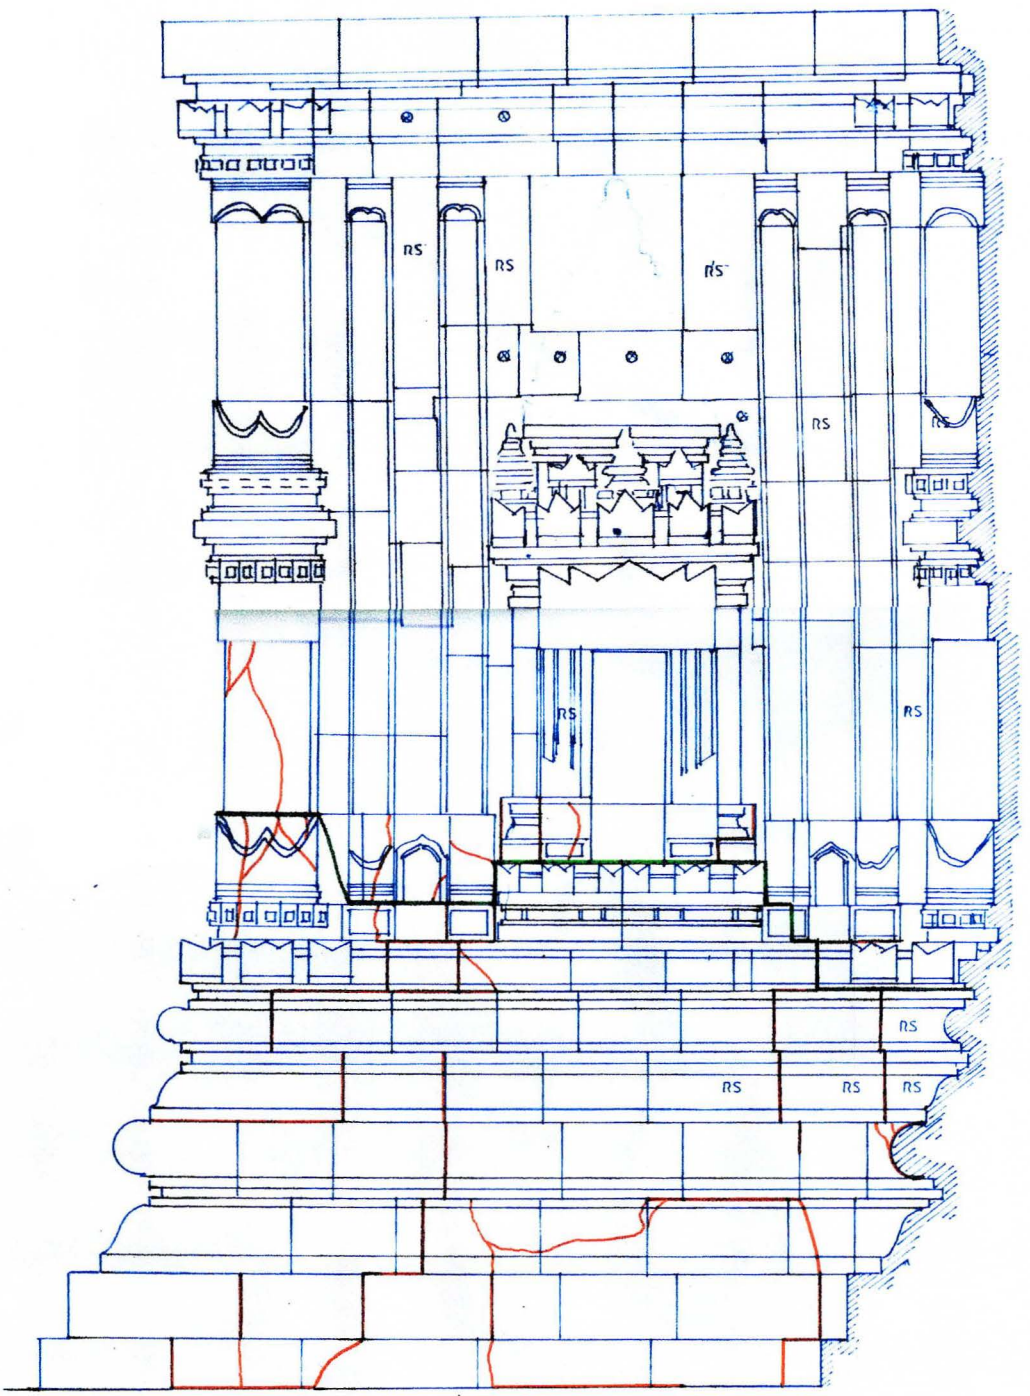
Area VIII

Craking and open joint stone

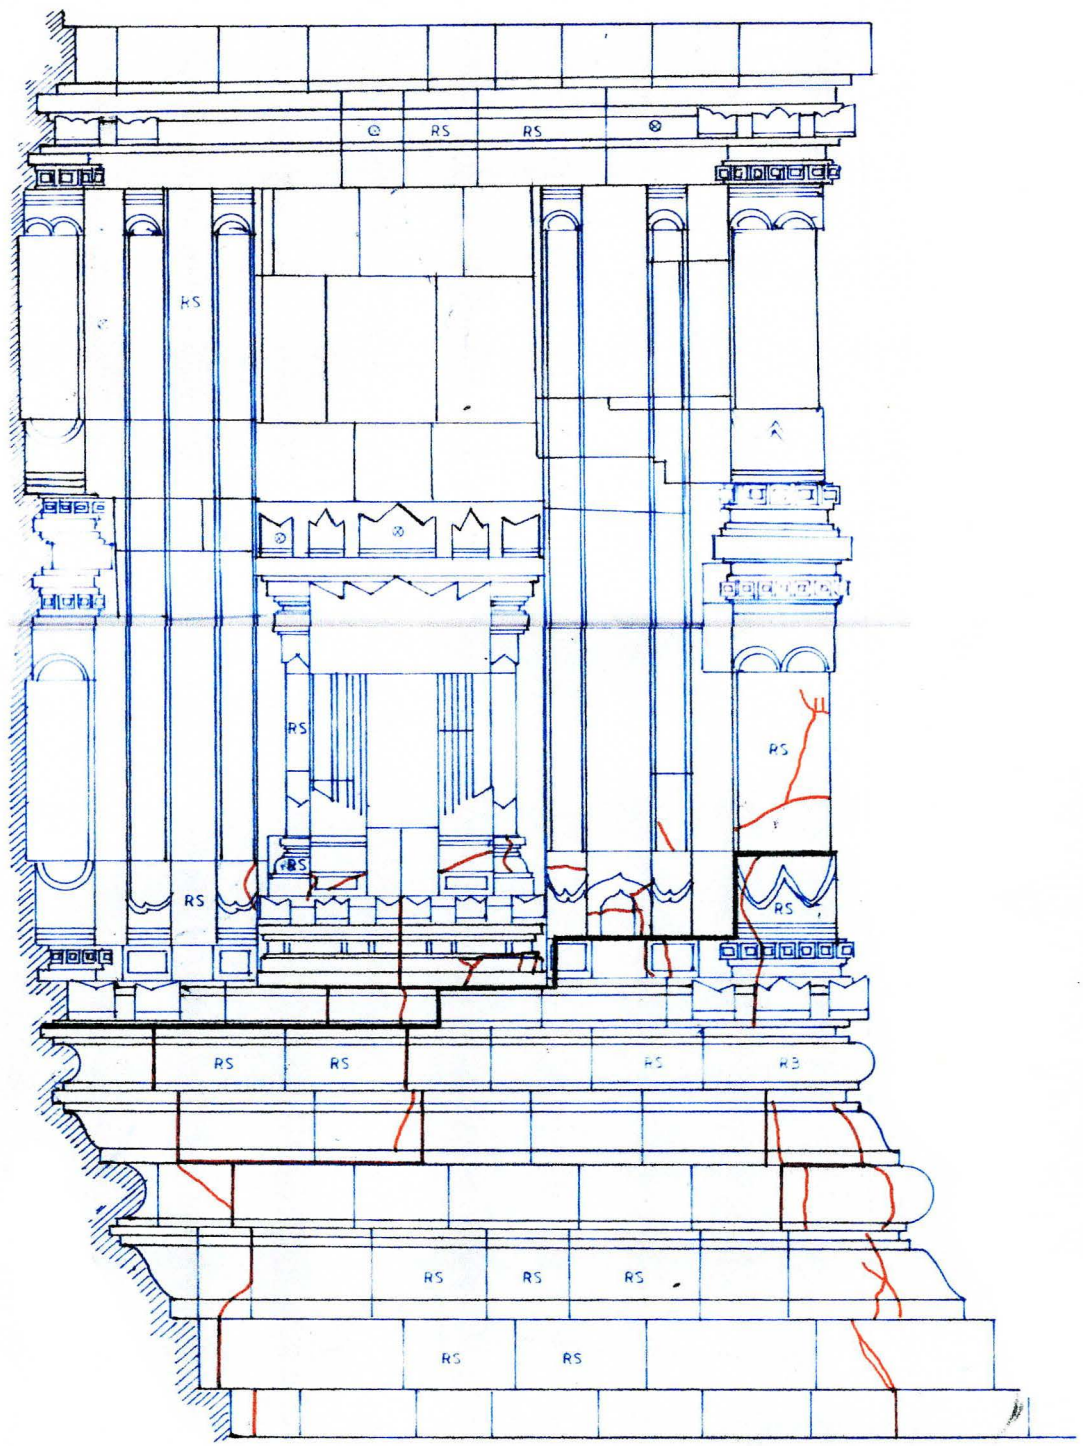
Area 9

Craking and open joint stone

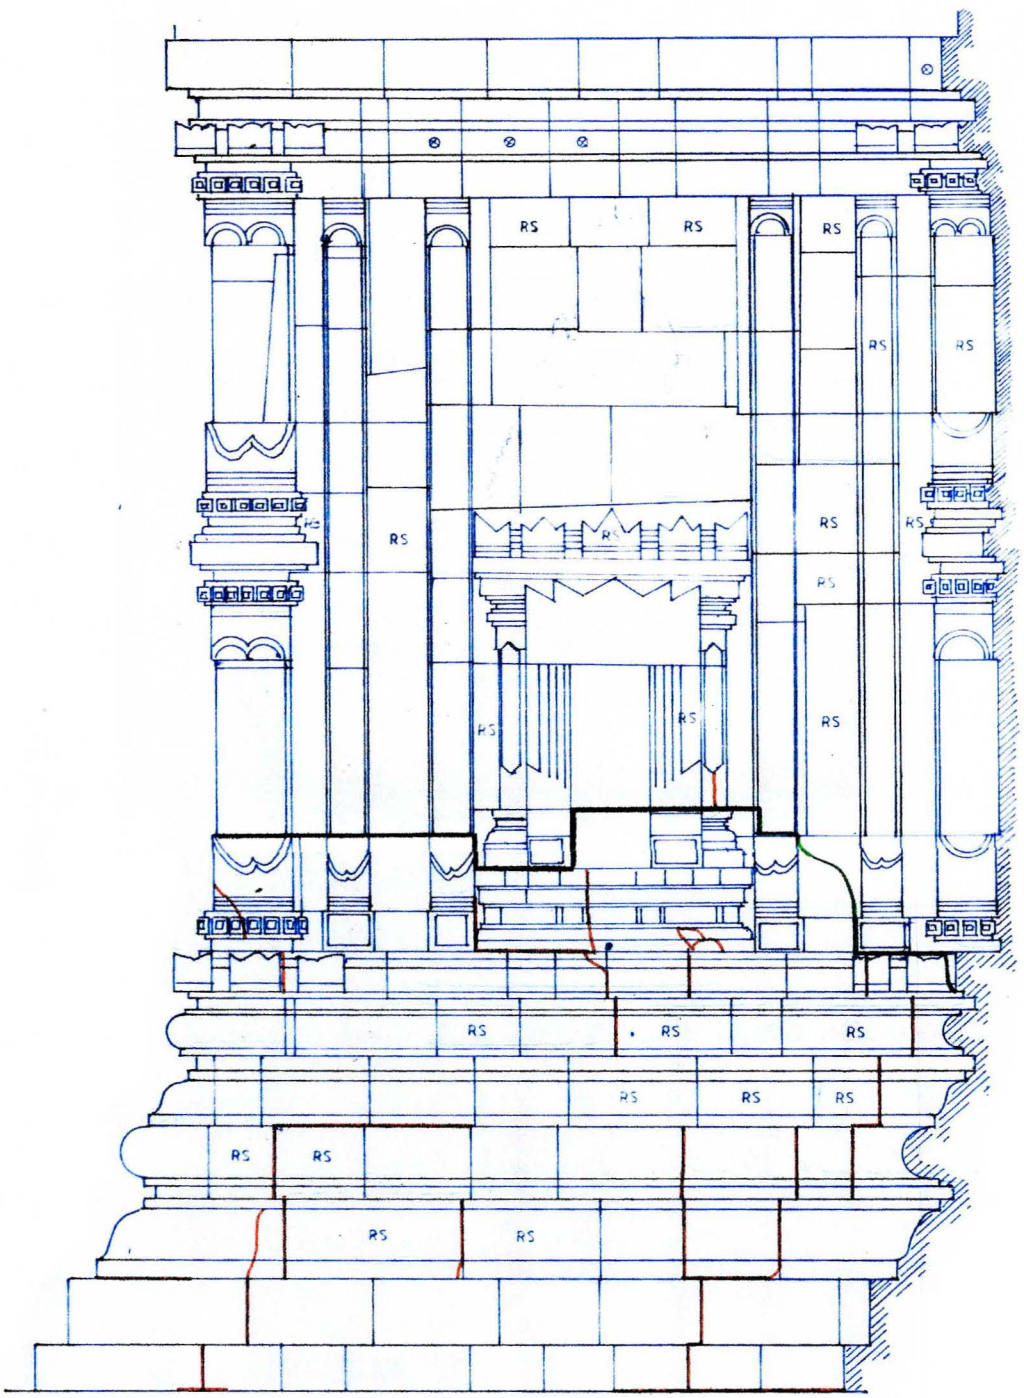
Area X

Craking and open joint ston e
