TECHNICAL STUDY

FOR REHABILITATION ON PRAMBANAN TEMPLE COMPOUND AFTER EARTHQUAKE

BY
TECHNICAL STUDY TEAM
ARCHAEOLOGICAL OFFICE OF YOGYAKARTA

DEPARTMENT OF CULTURE AND TOURISM
2007

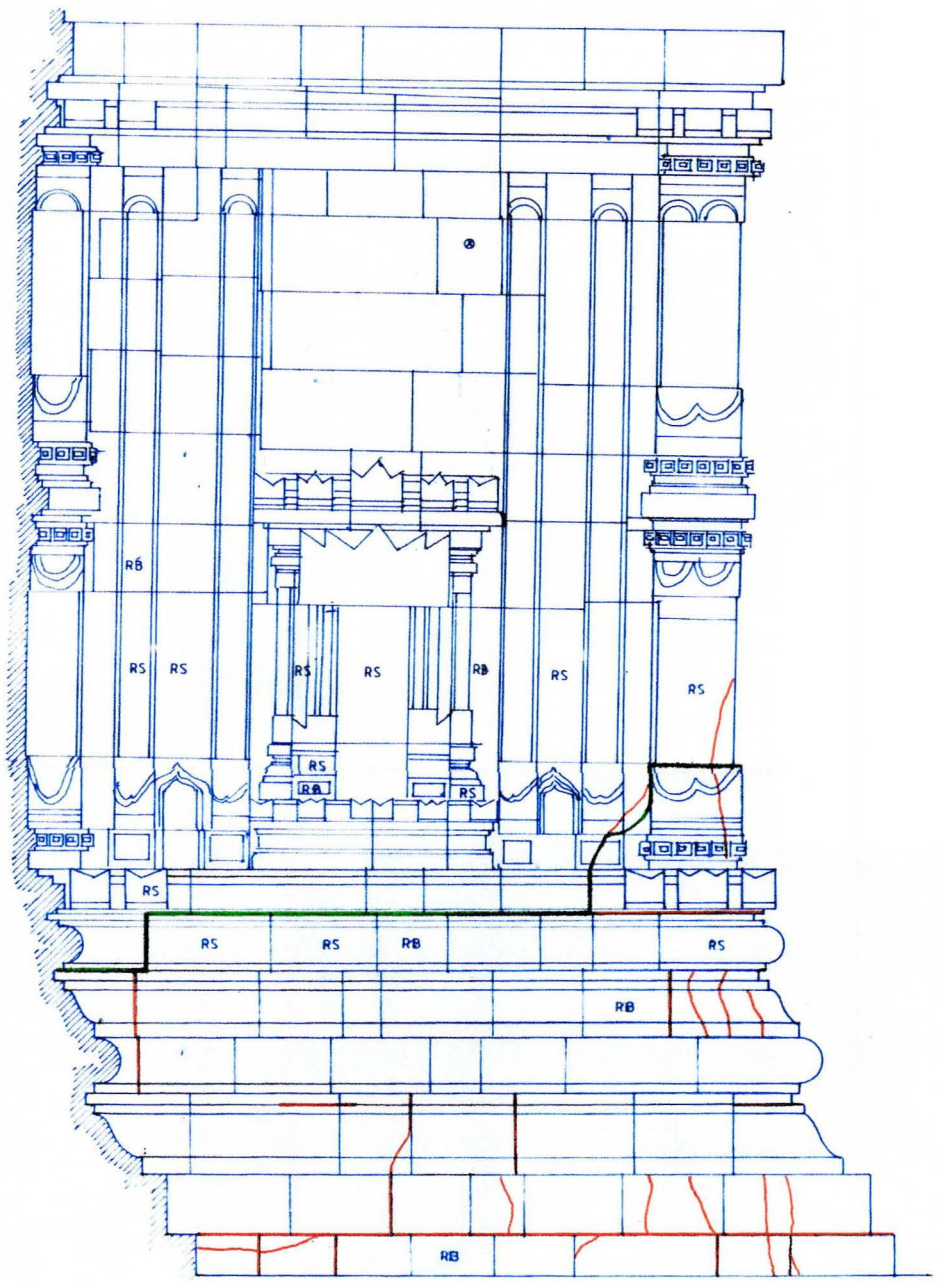
Area XII

Craking and open joint stone

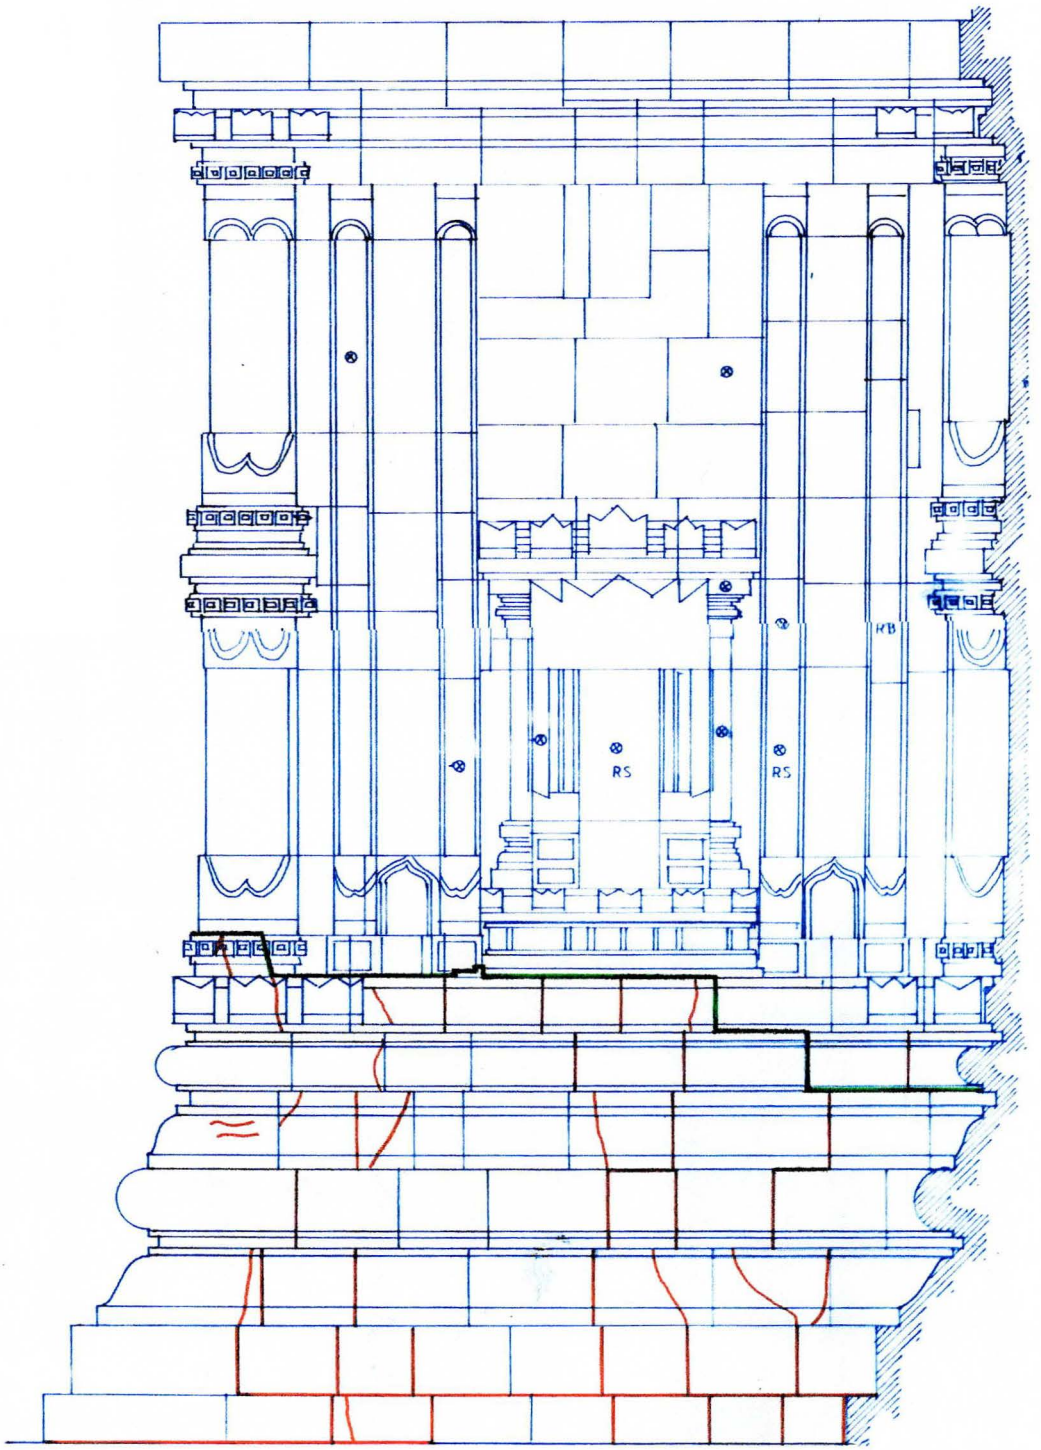
Area XIII

Craking and open joint stone

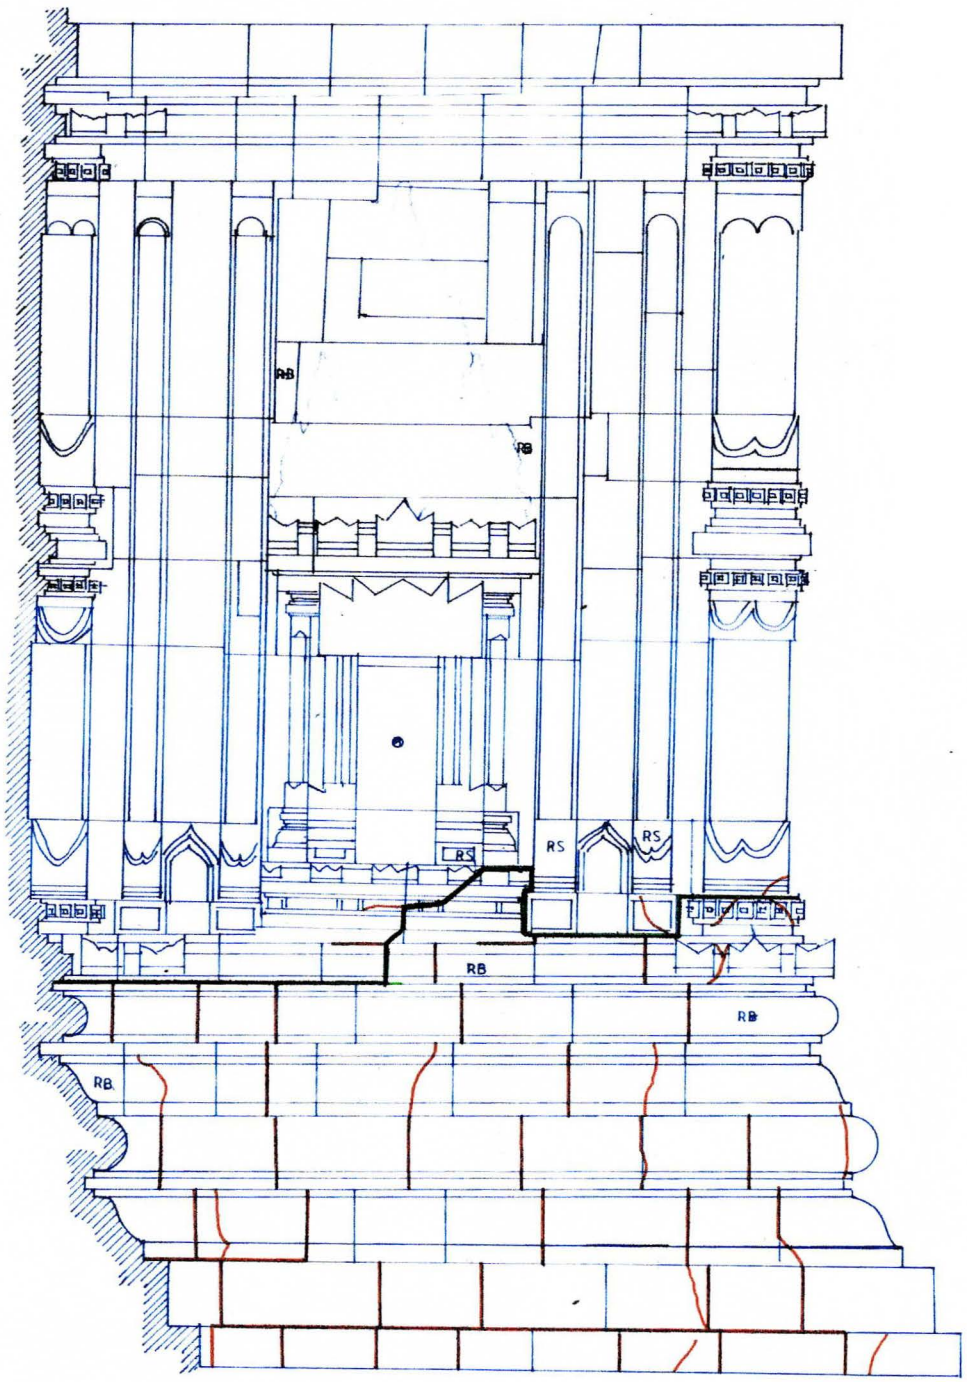
BIDANG XIV

Craking and open joint stone

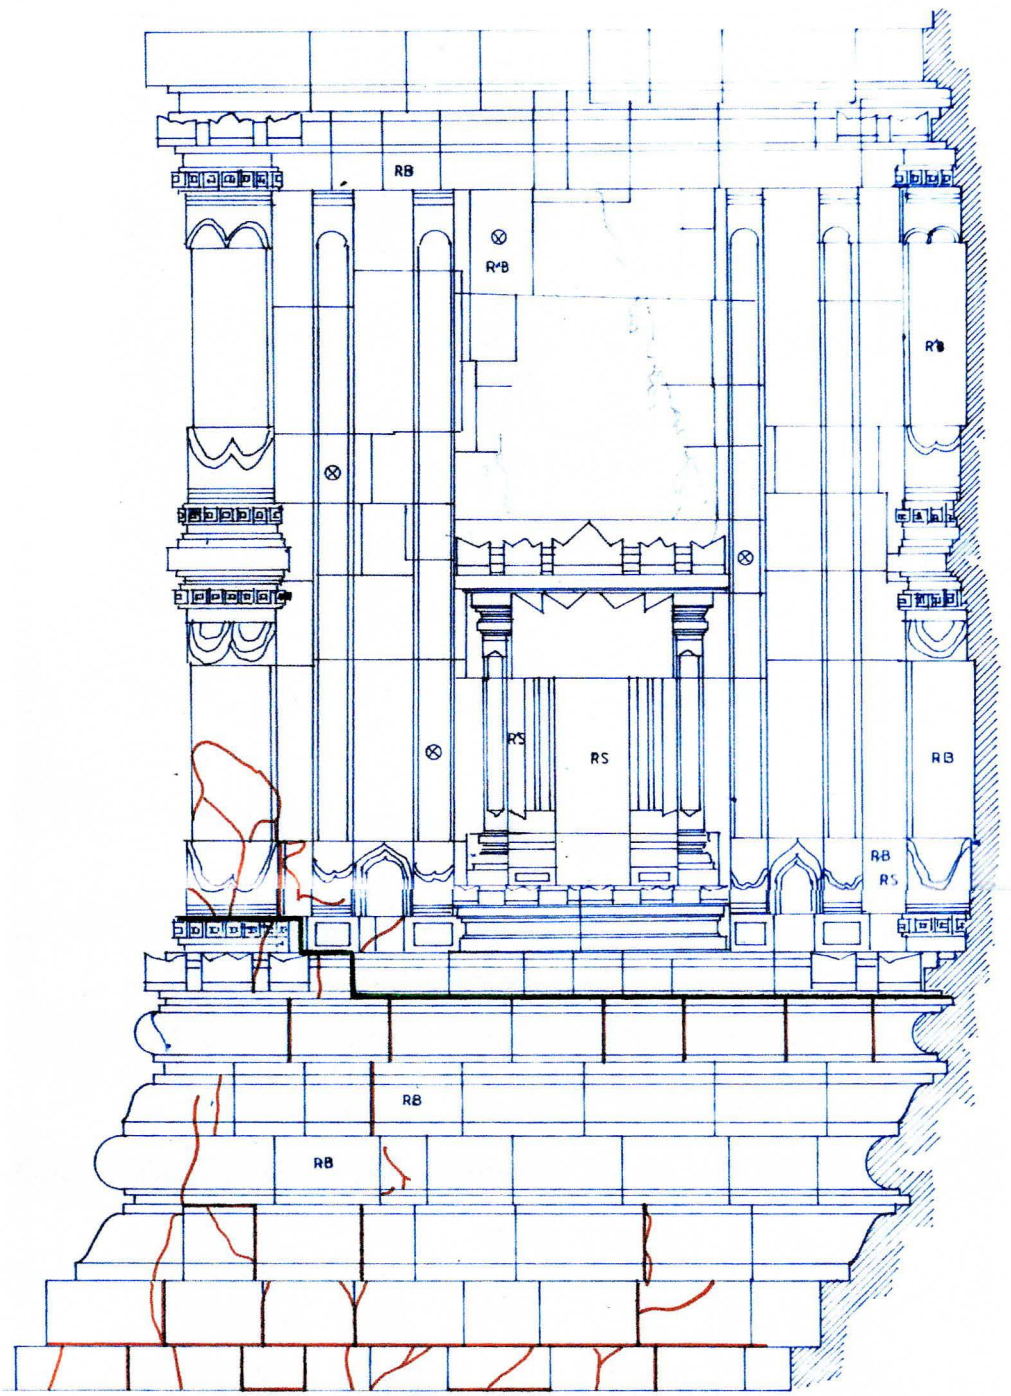
Area XV

Craking and open joint stone

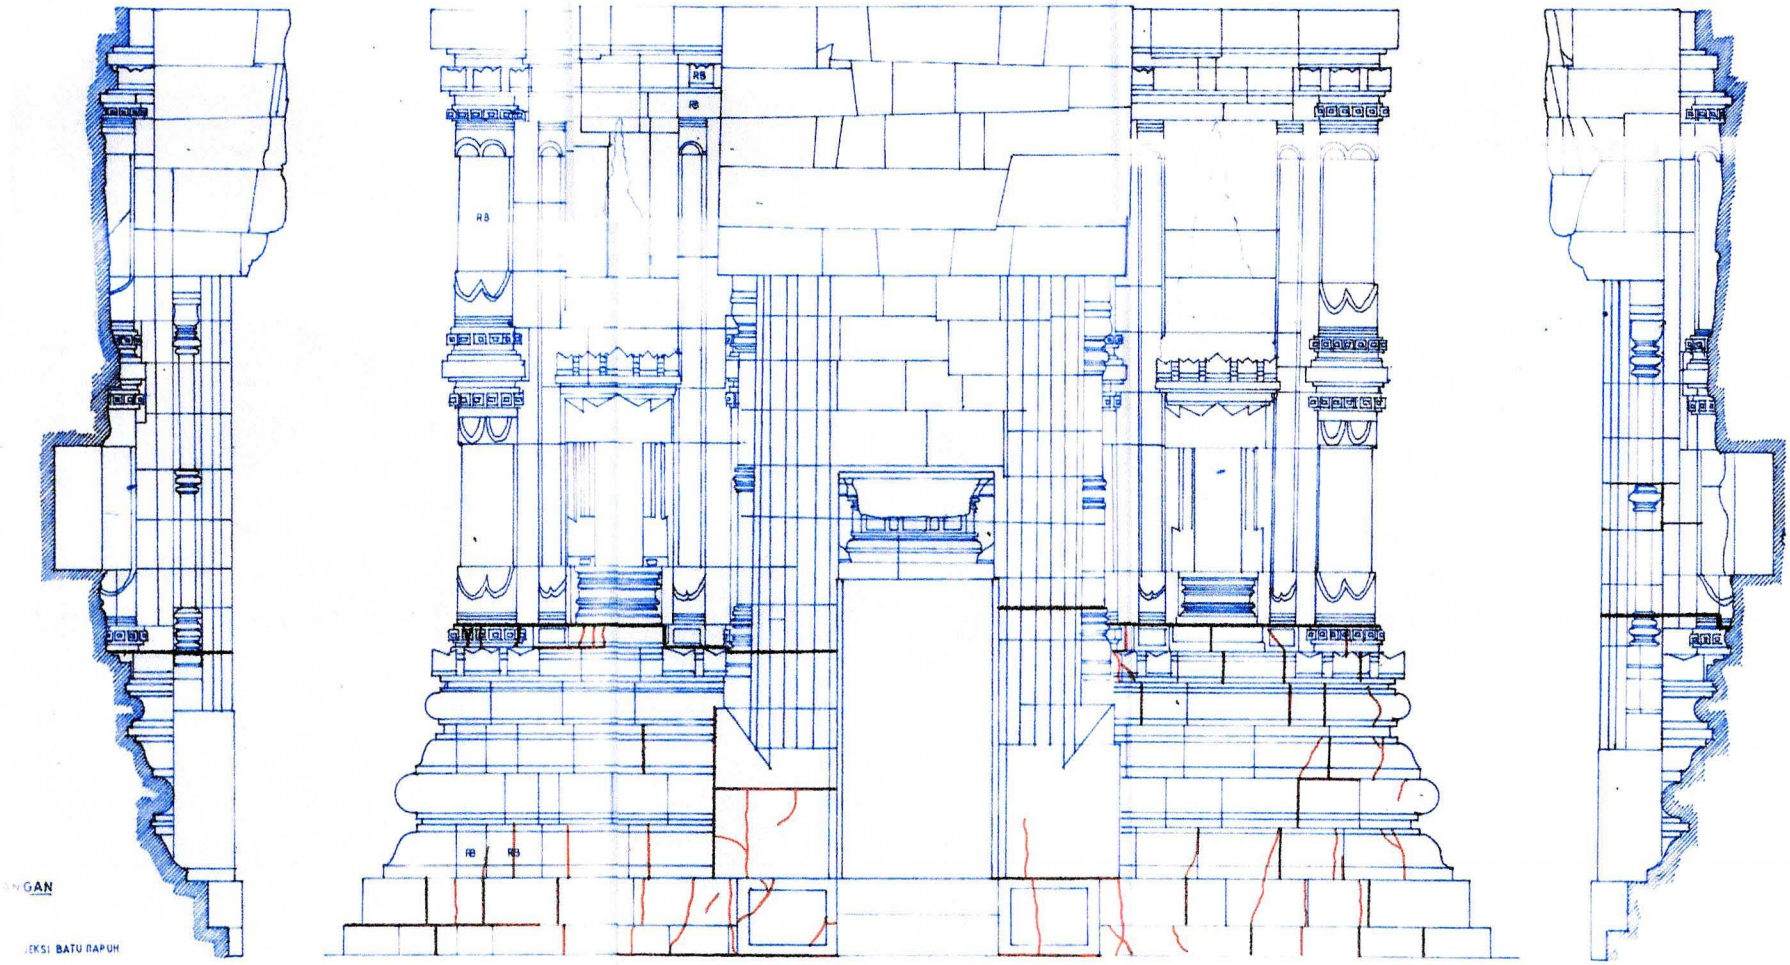
Area XVI

Craking and open joint stone

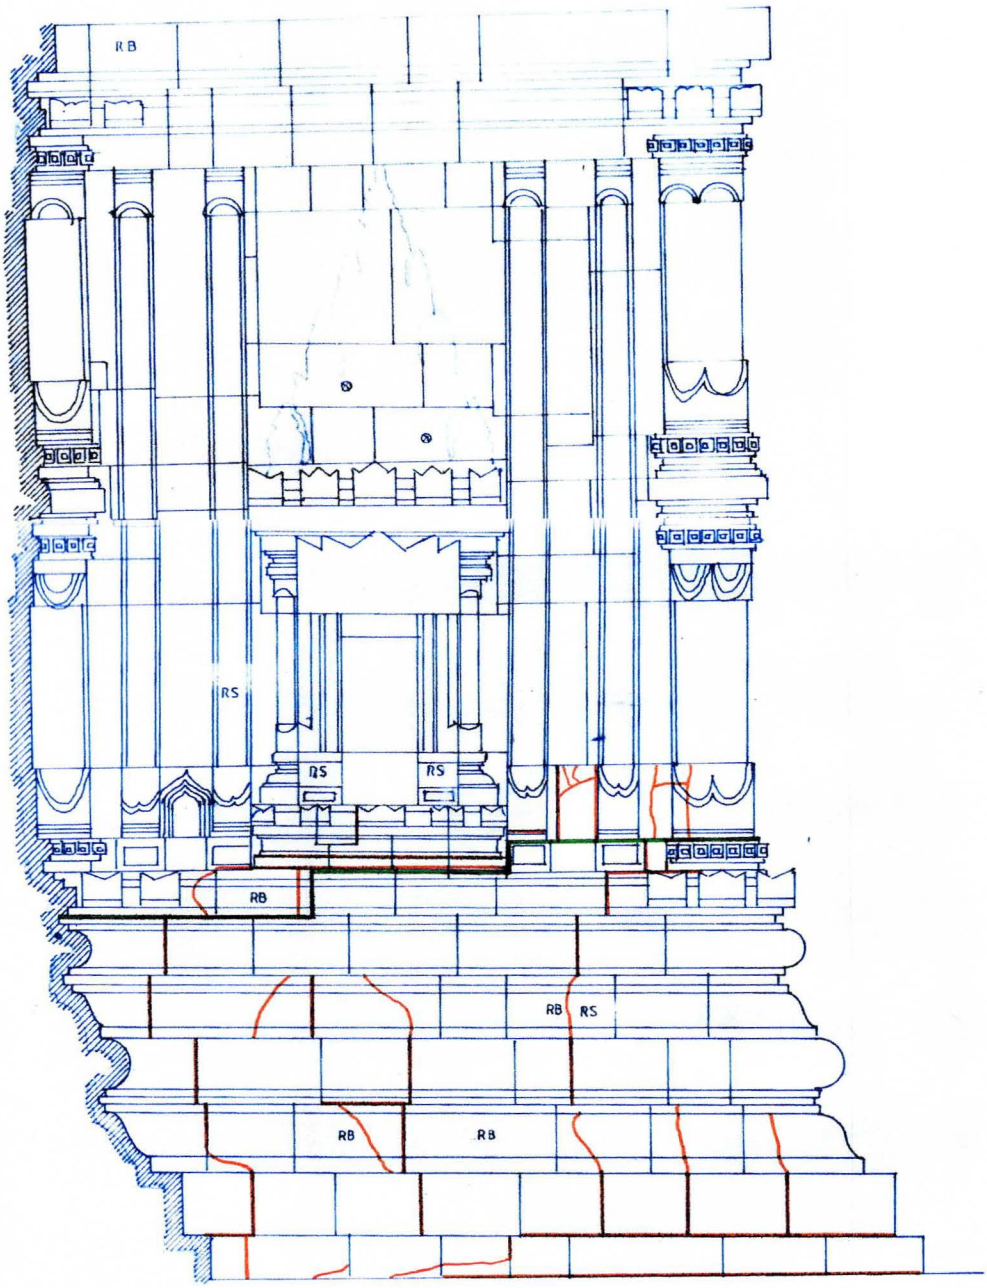
Area XVII

Craking and open joint stone

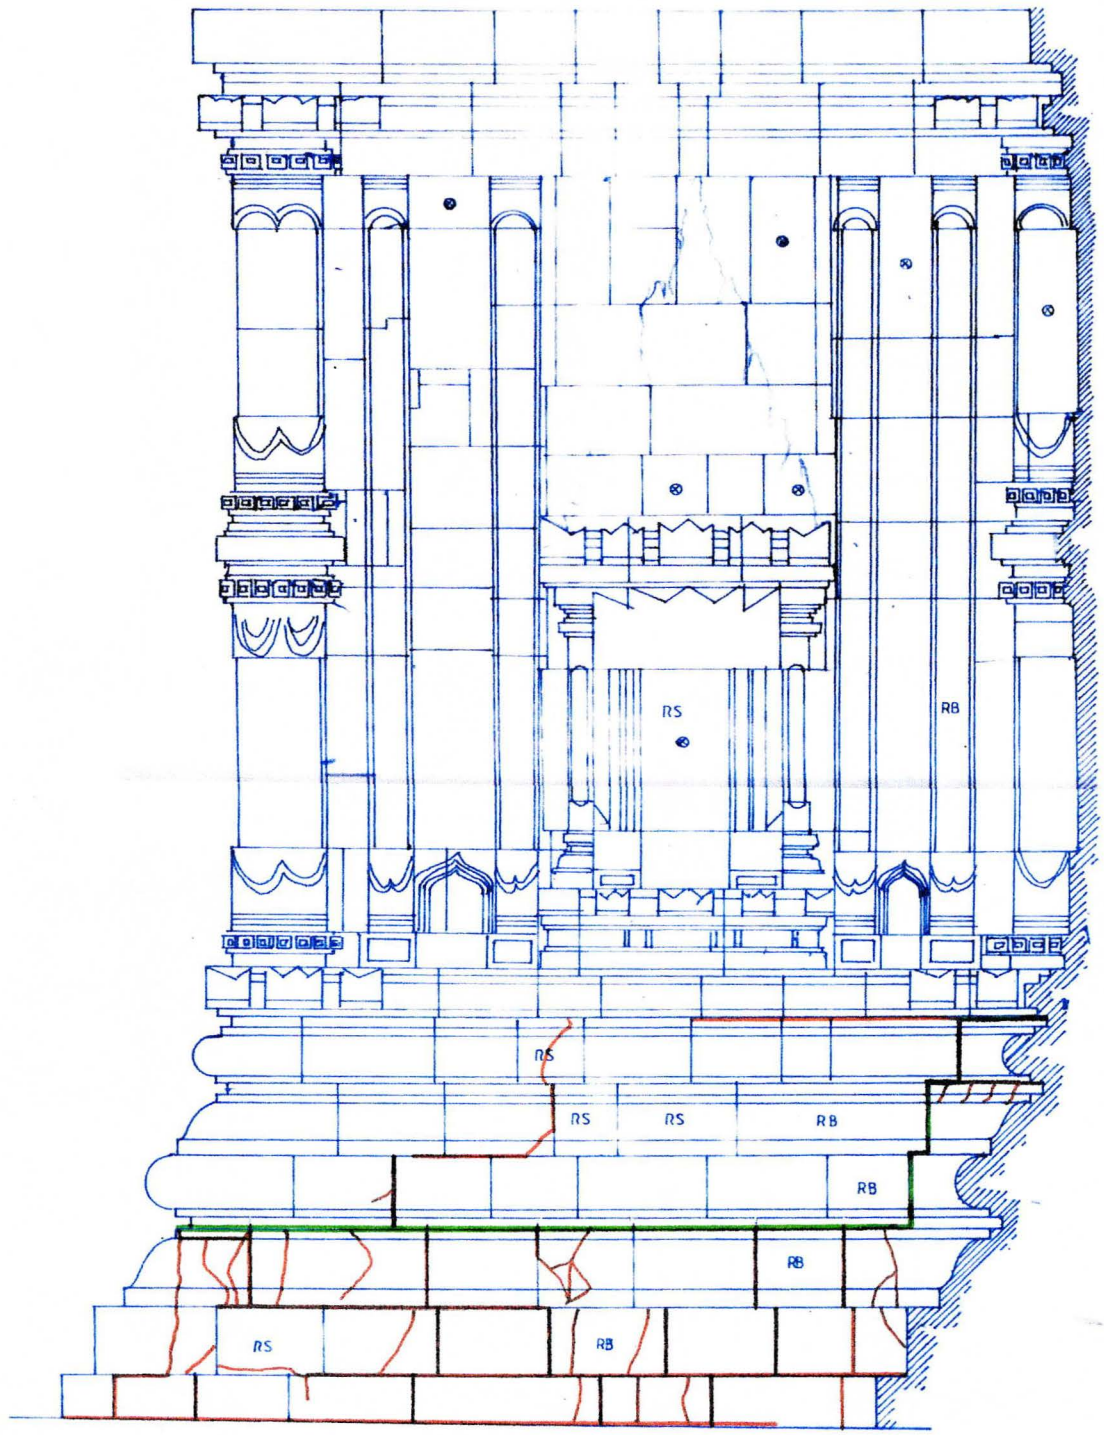
Siwa Temple
The Body, Level I

Craking and open joint stone

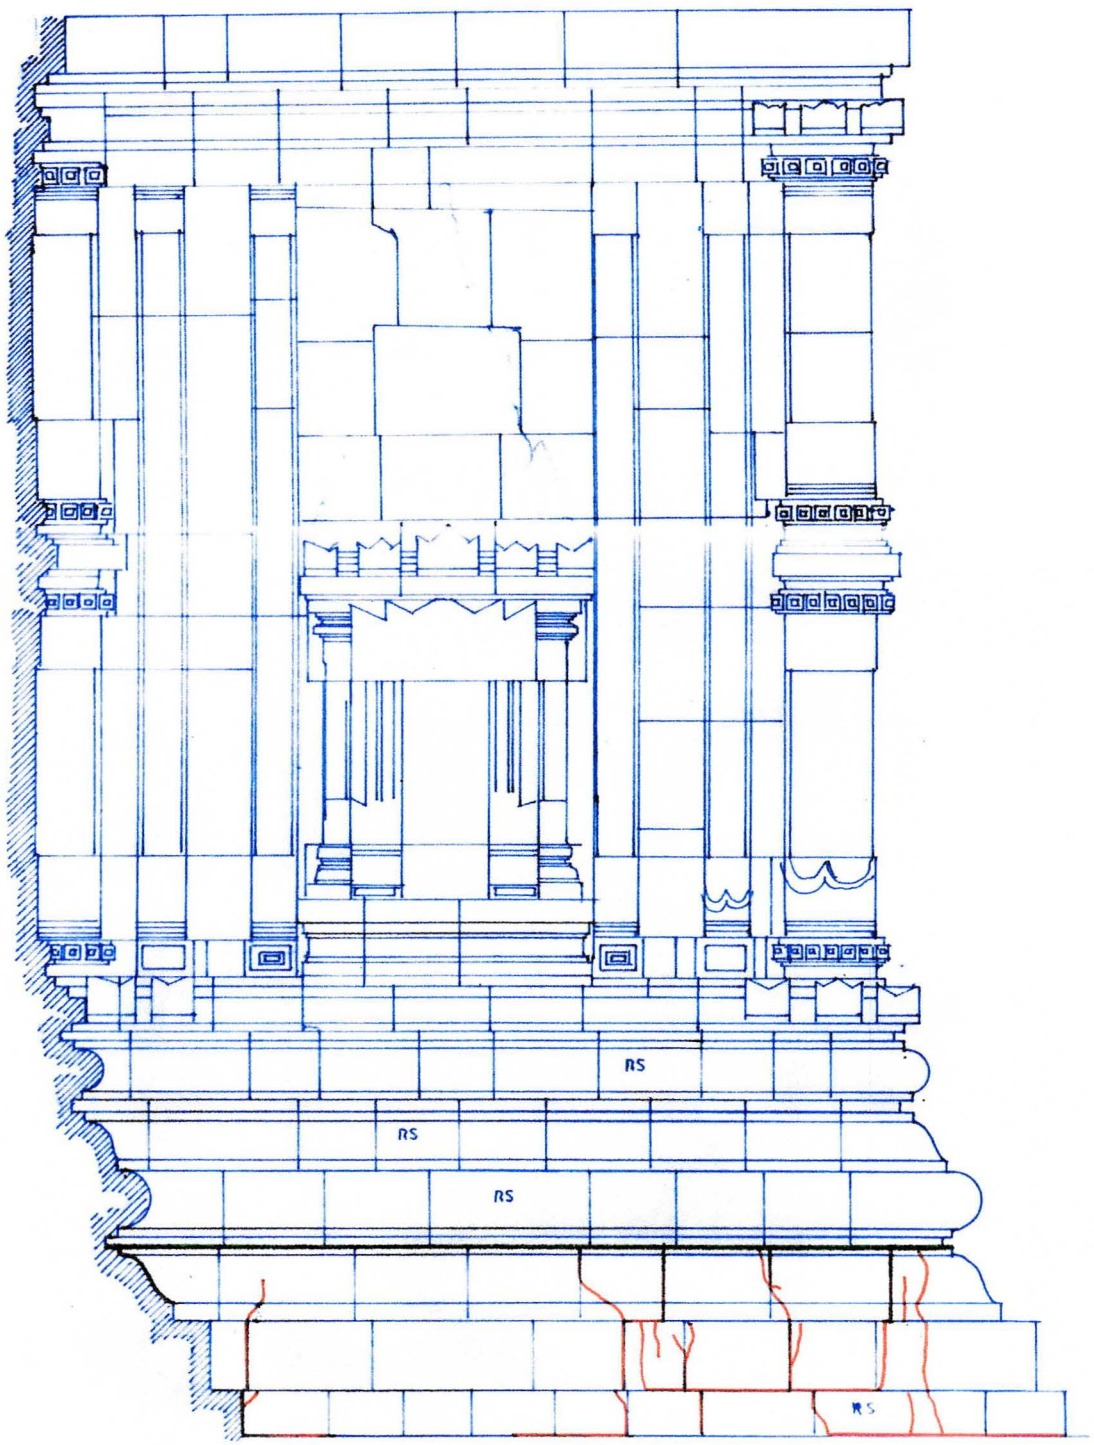
The Body, Level I

Craking and open joint stone

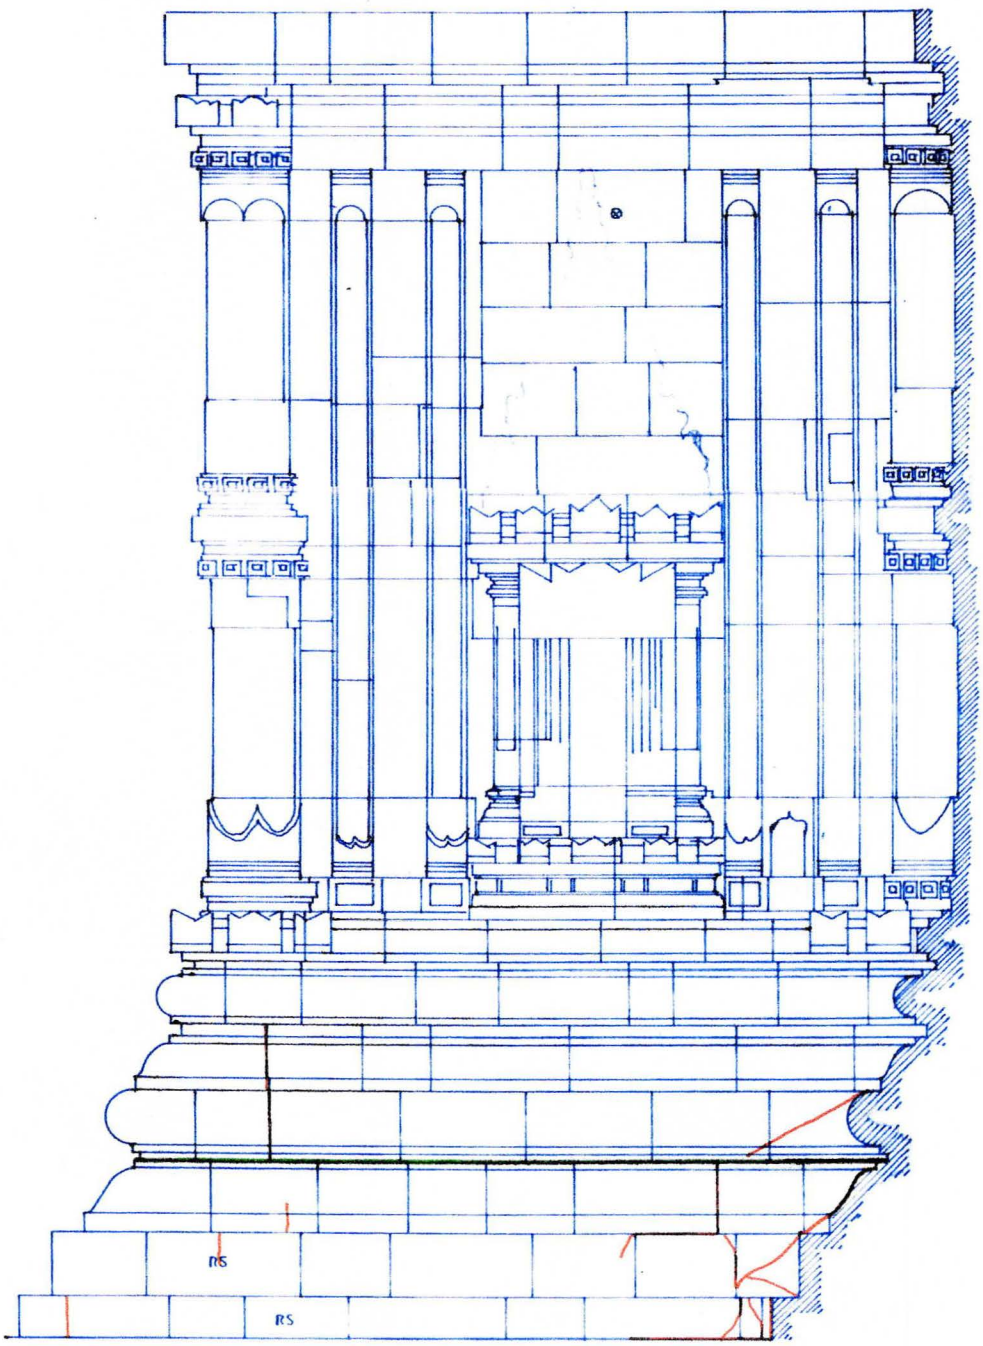
The Body, Level I

Craking and open joint stone

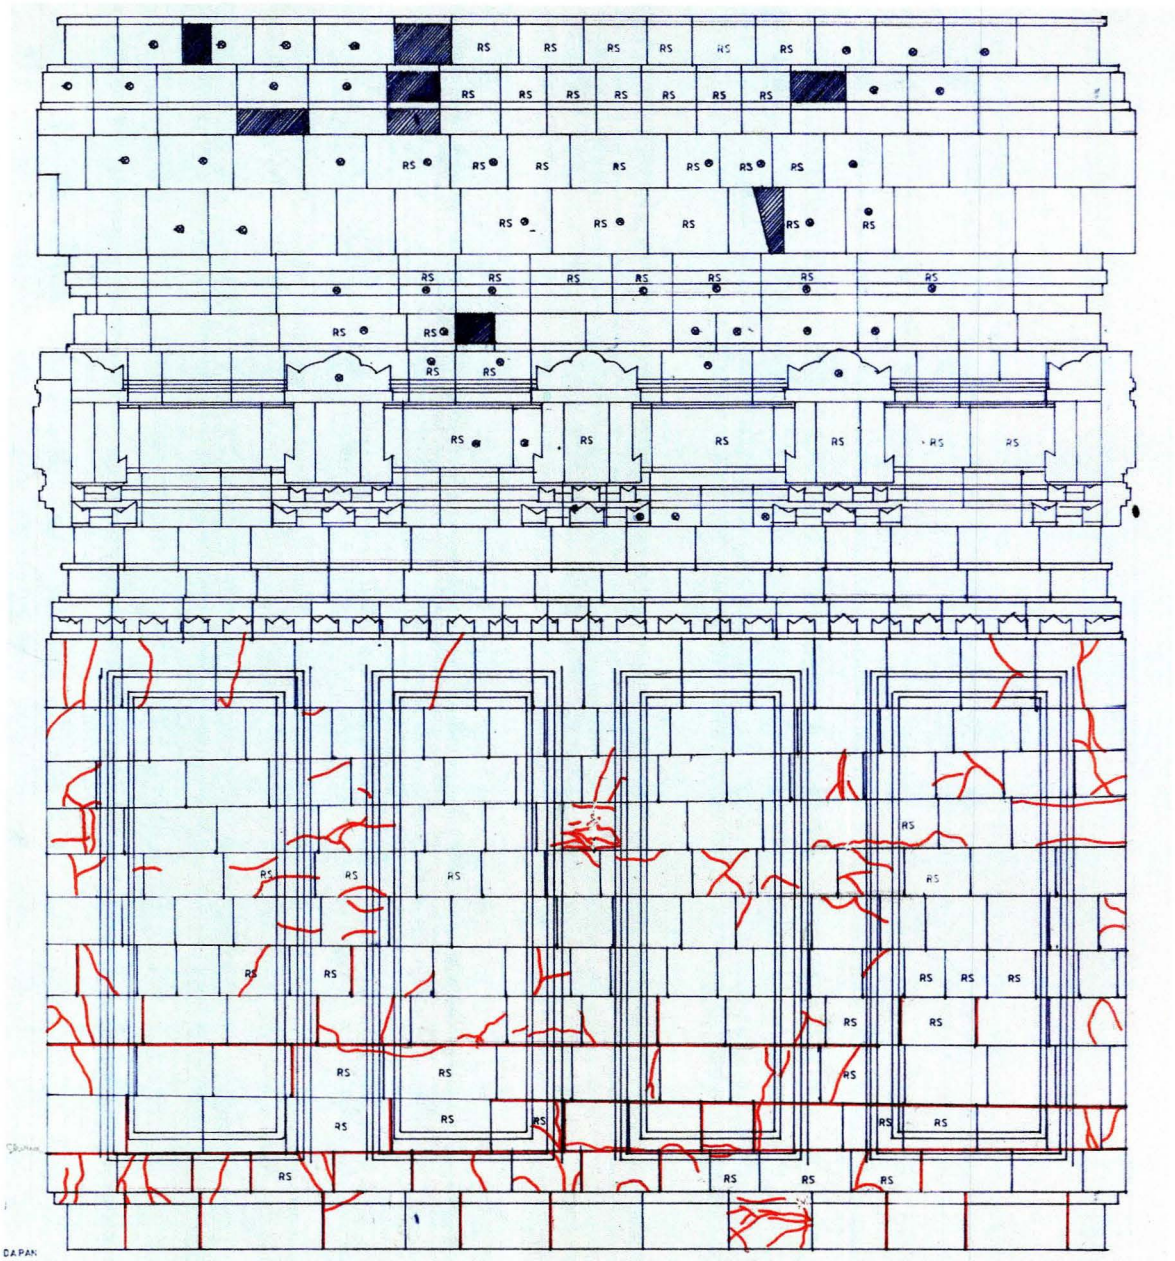
Dinding Utara
(North wall)

Candi Siwa
Bilik Utama
(Main chamber of Siwa temple)

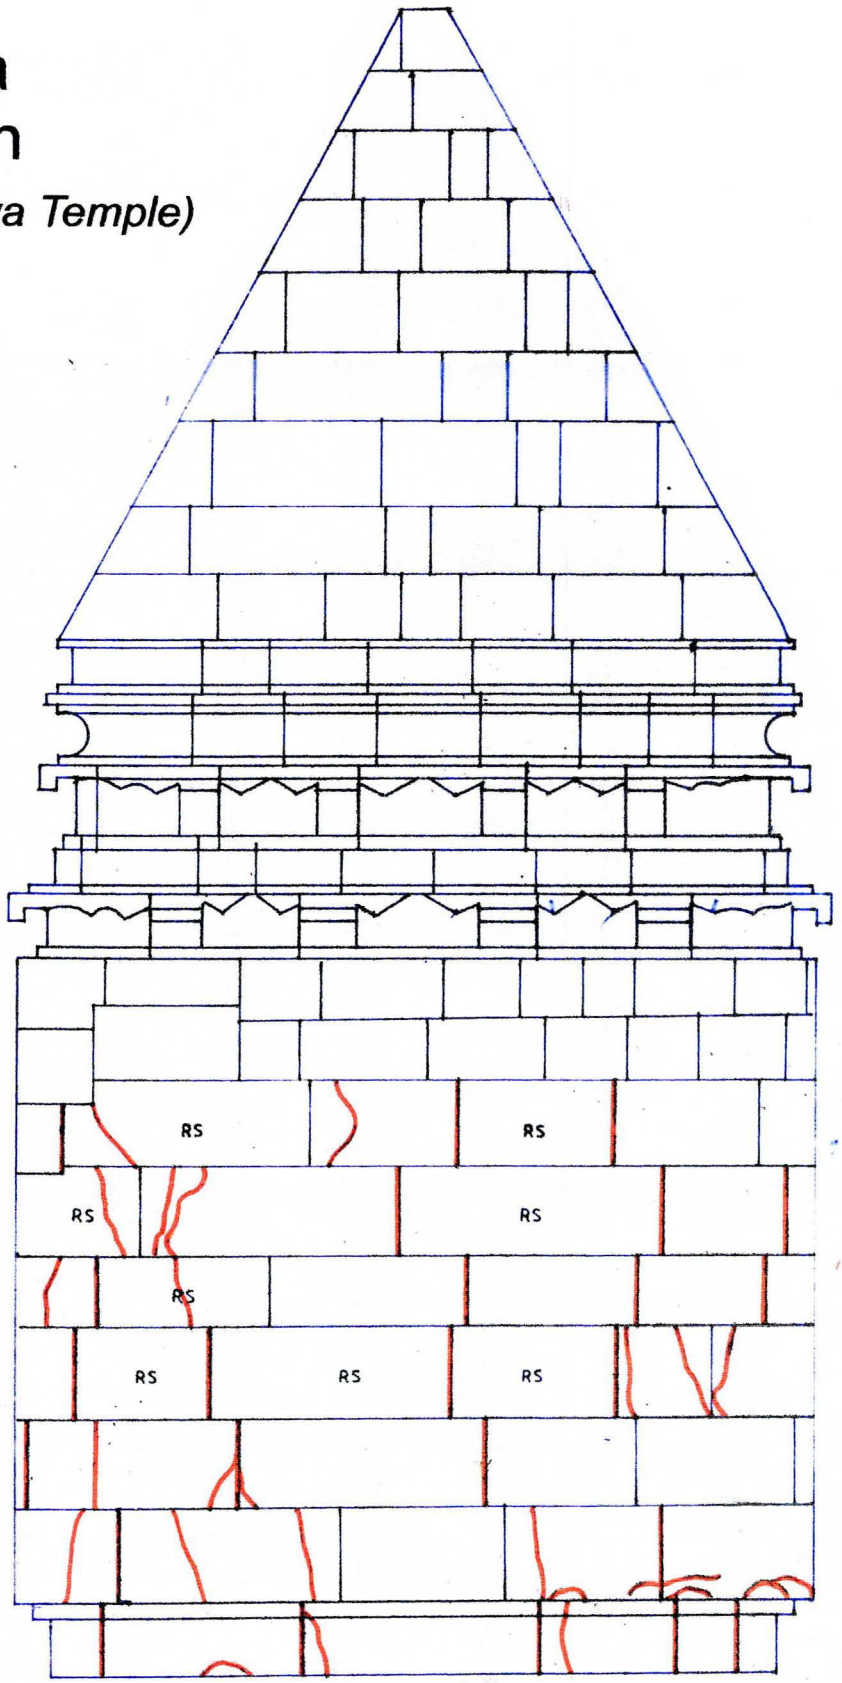
DINDING TIMUR

Candi Siwa
Bilik Selatan

(South chamber of Siwa Temple)

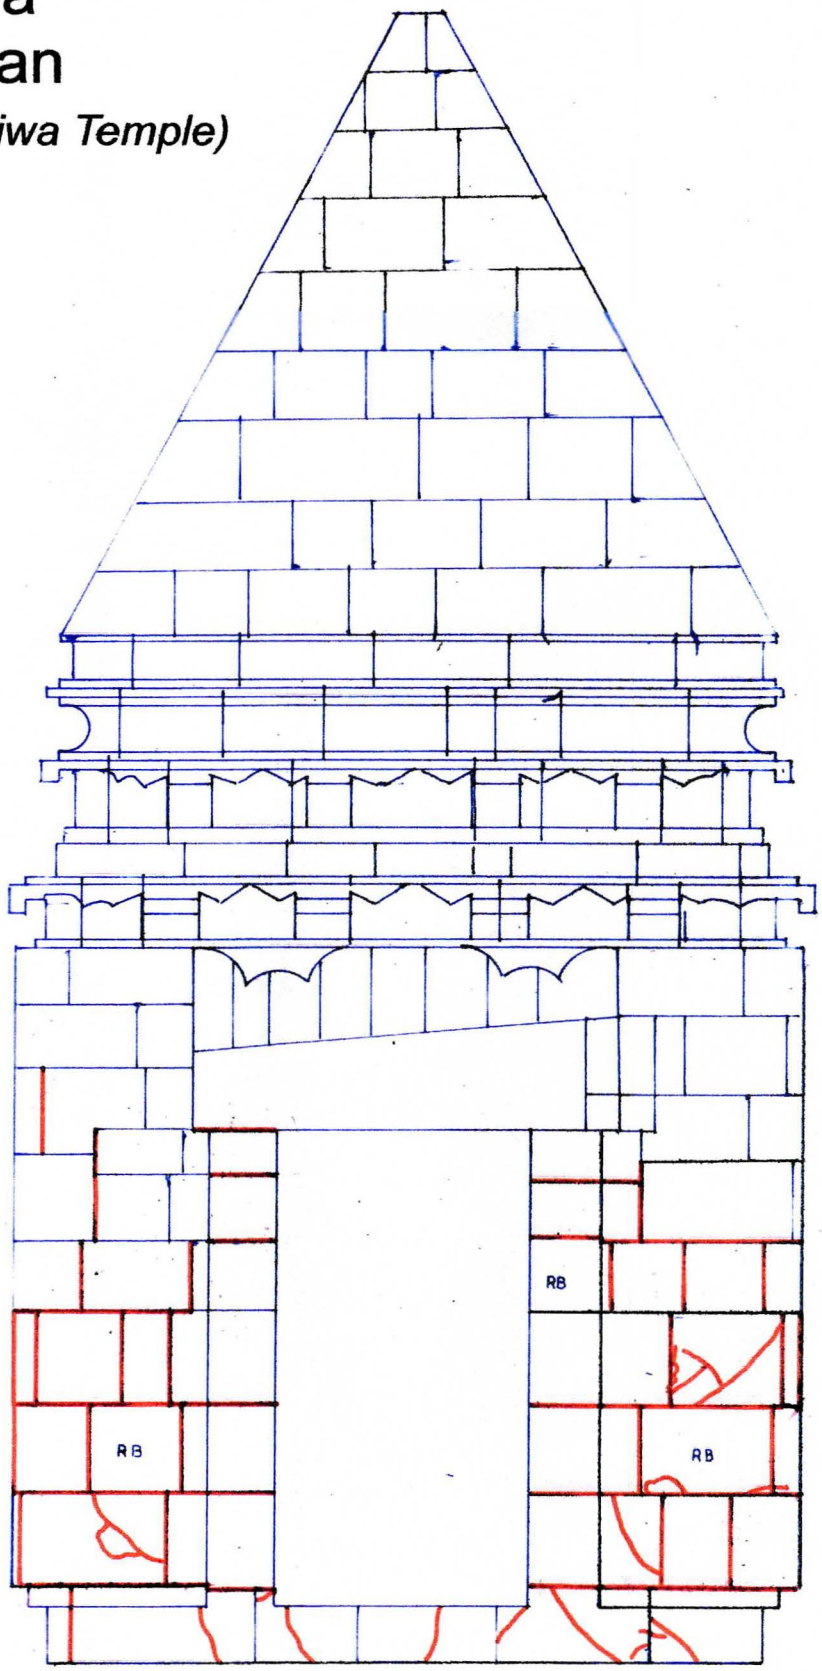
DINDING SELATAN

Candi Siwa
Bilik Selatan

(South chamber of Siwa Temple)

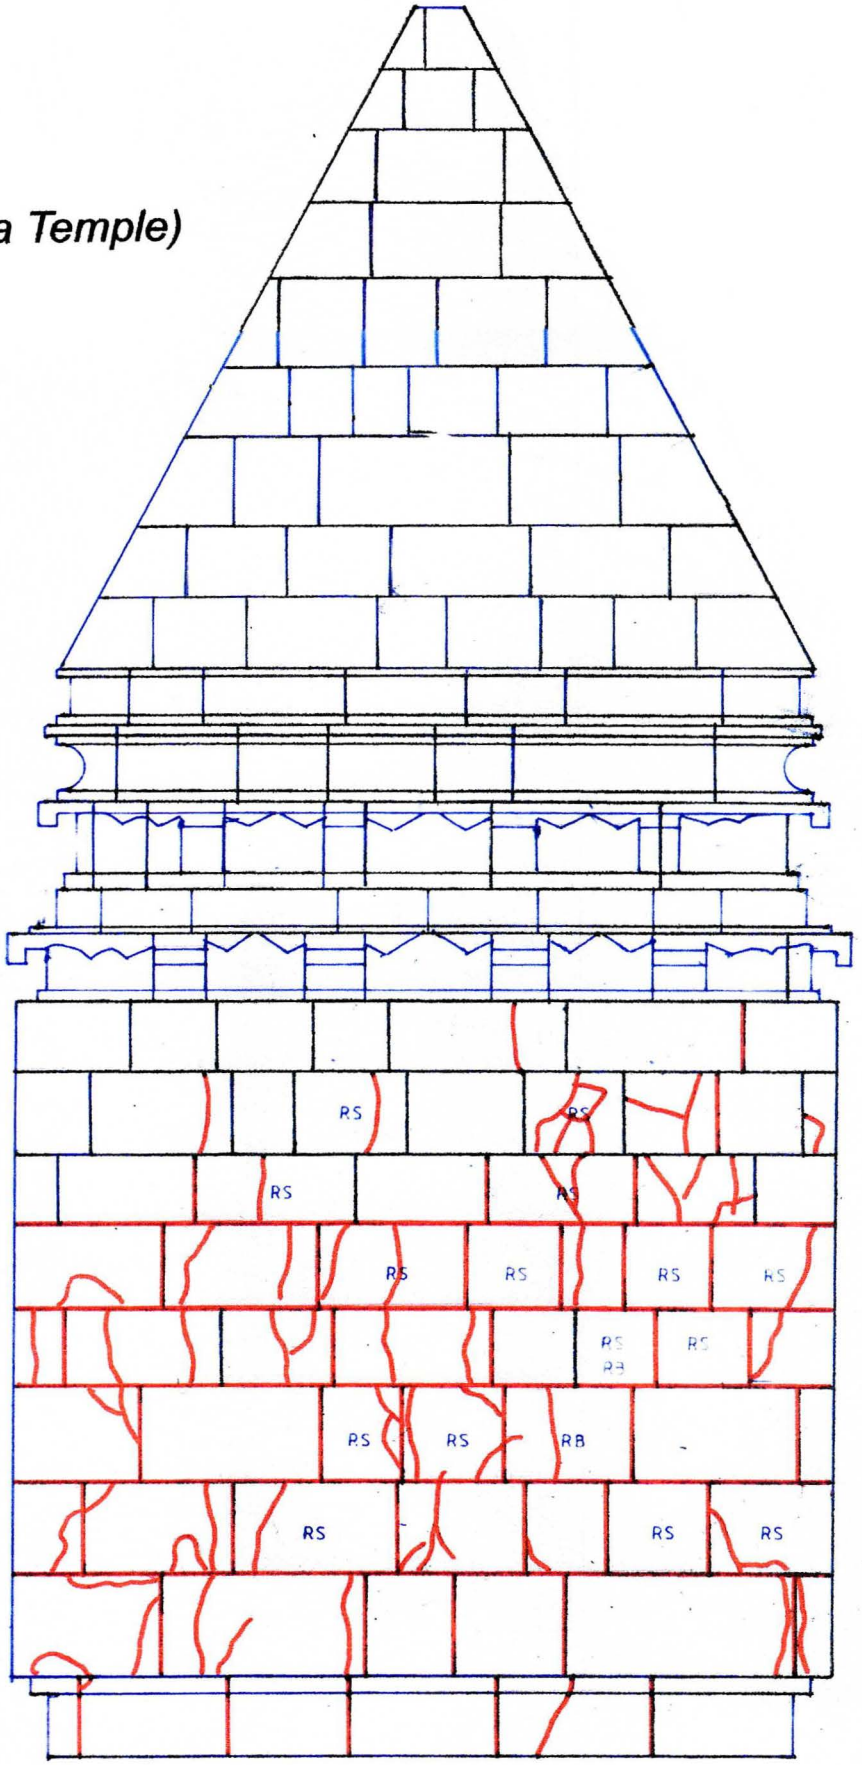
DINDING BARAT

Candi Siwa
Bilik Selatan

(South chamber of Siwa Temple)

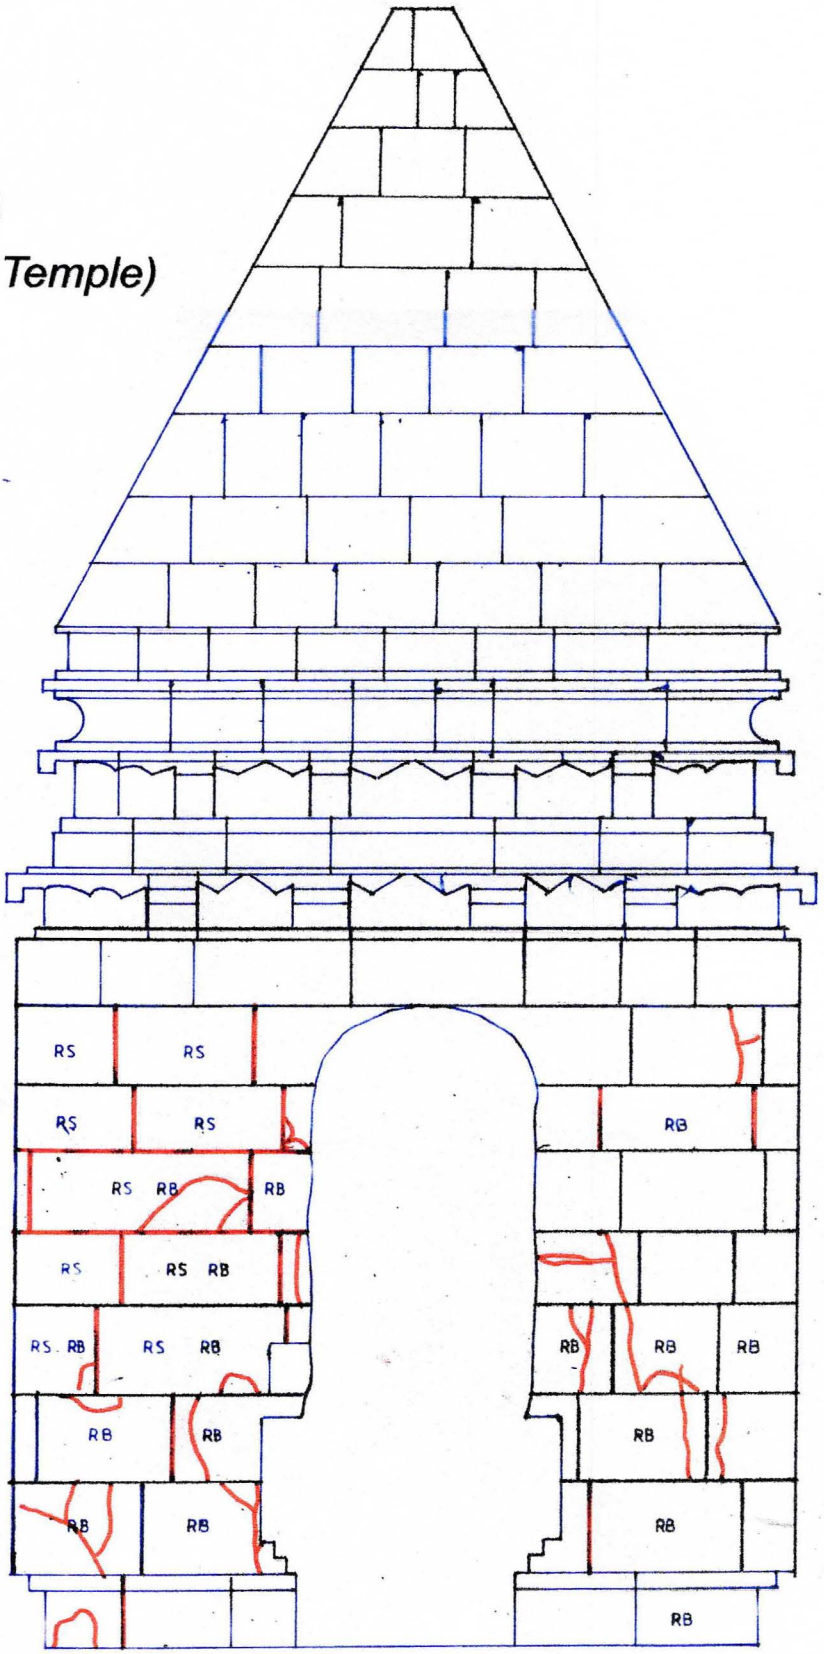
DINDING UTARA

Candi Siwa
Bilik Selatan

(South chamber of Siwa Temple)

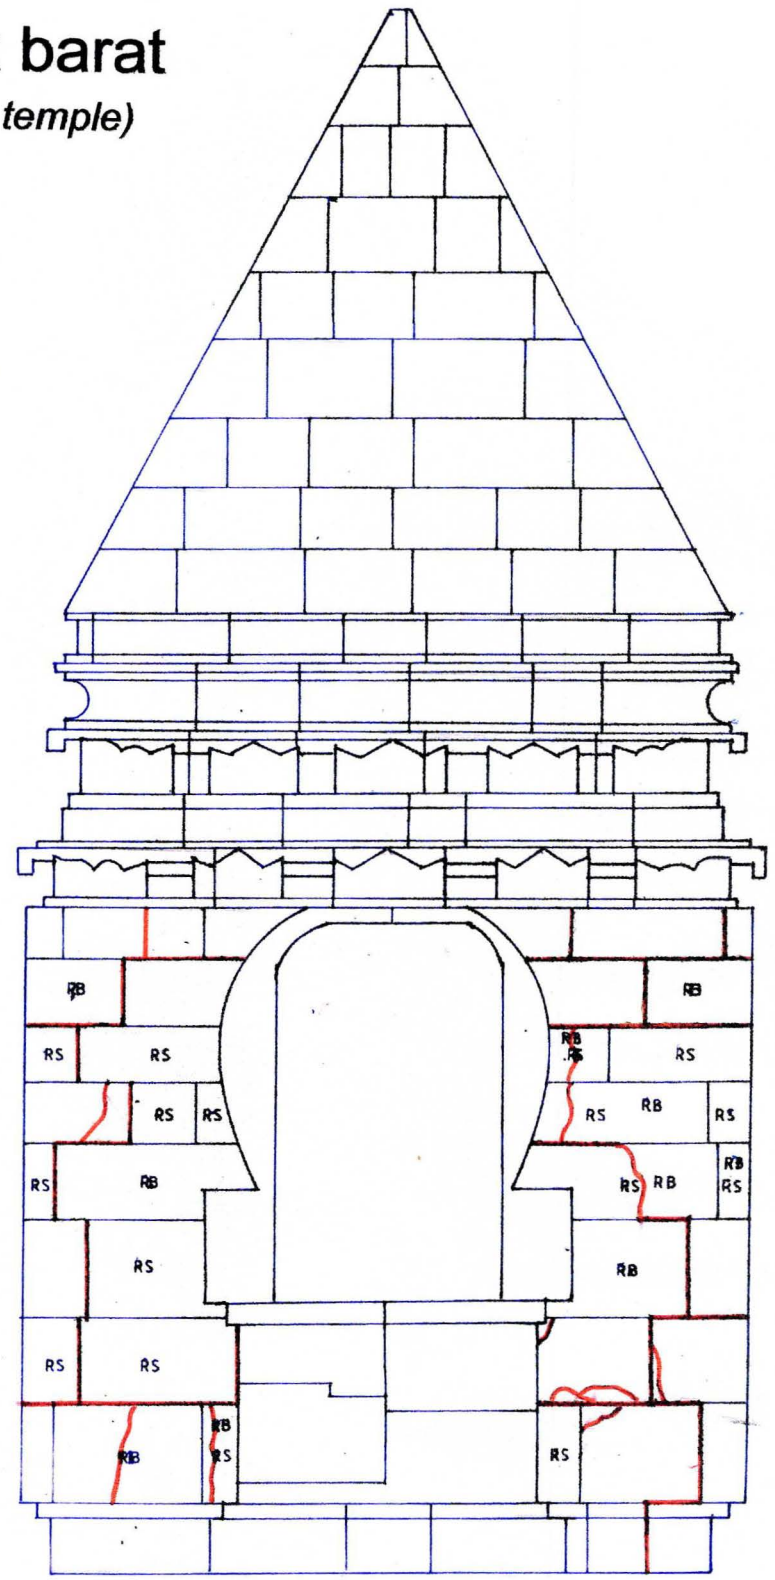
Candi Siwa bilik barat

(West chamber of Siwa temple)

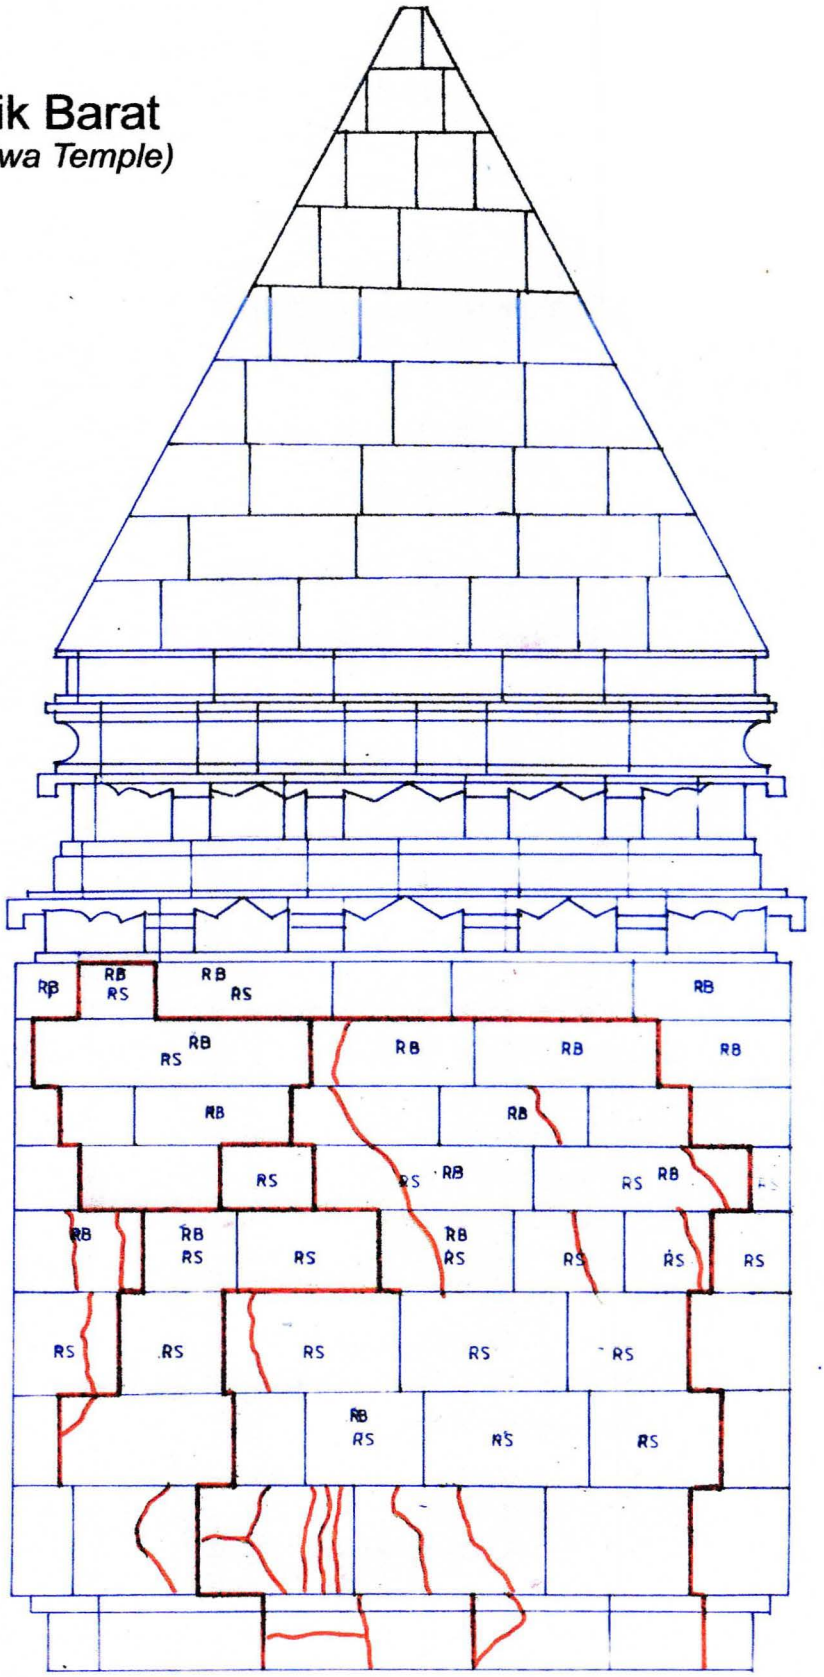
Dinding Selatan

Candi Siwa Bilik Barat

(West chamber of Siwa Temple)
