TECHNICAL STUDY

FOR REHABILITATION ON PRAMBANAN TEMPLE COMPOUND AFTER EARTHQUAKE

BY
TECHNICAL STUDY TEAM
ARCHAEOLOGICAL OFFICE OF YOGYAKARTA

DEPARTMENT OF CULTURE AND TOURISM
2007

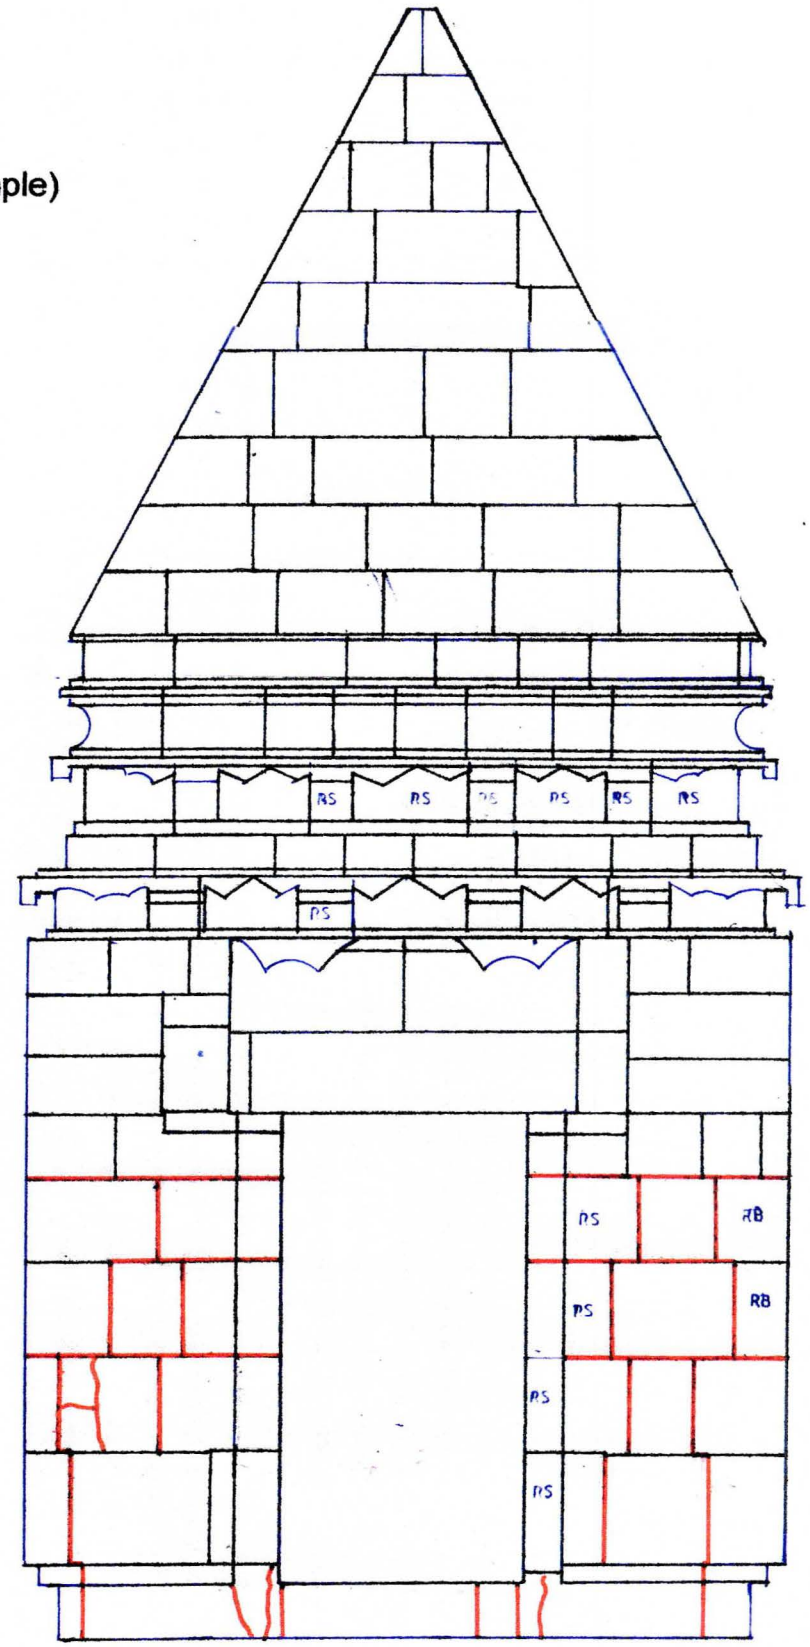
Dinding Barat
(West wall)

Candi Siwa
Bilik Barat

(West chamber of Siwa temple)

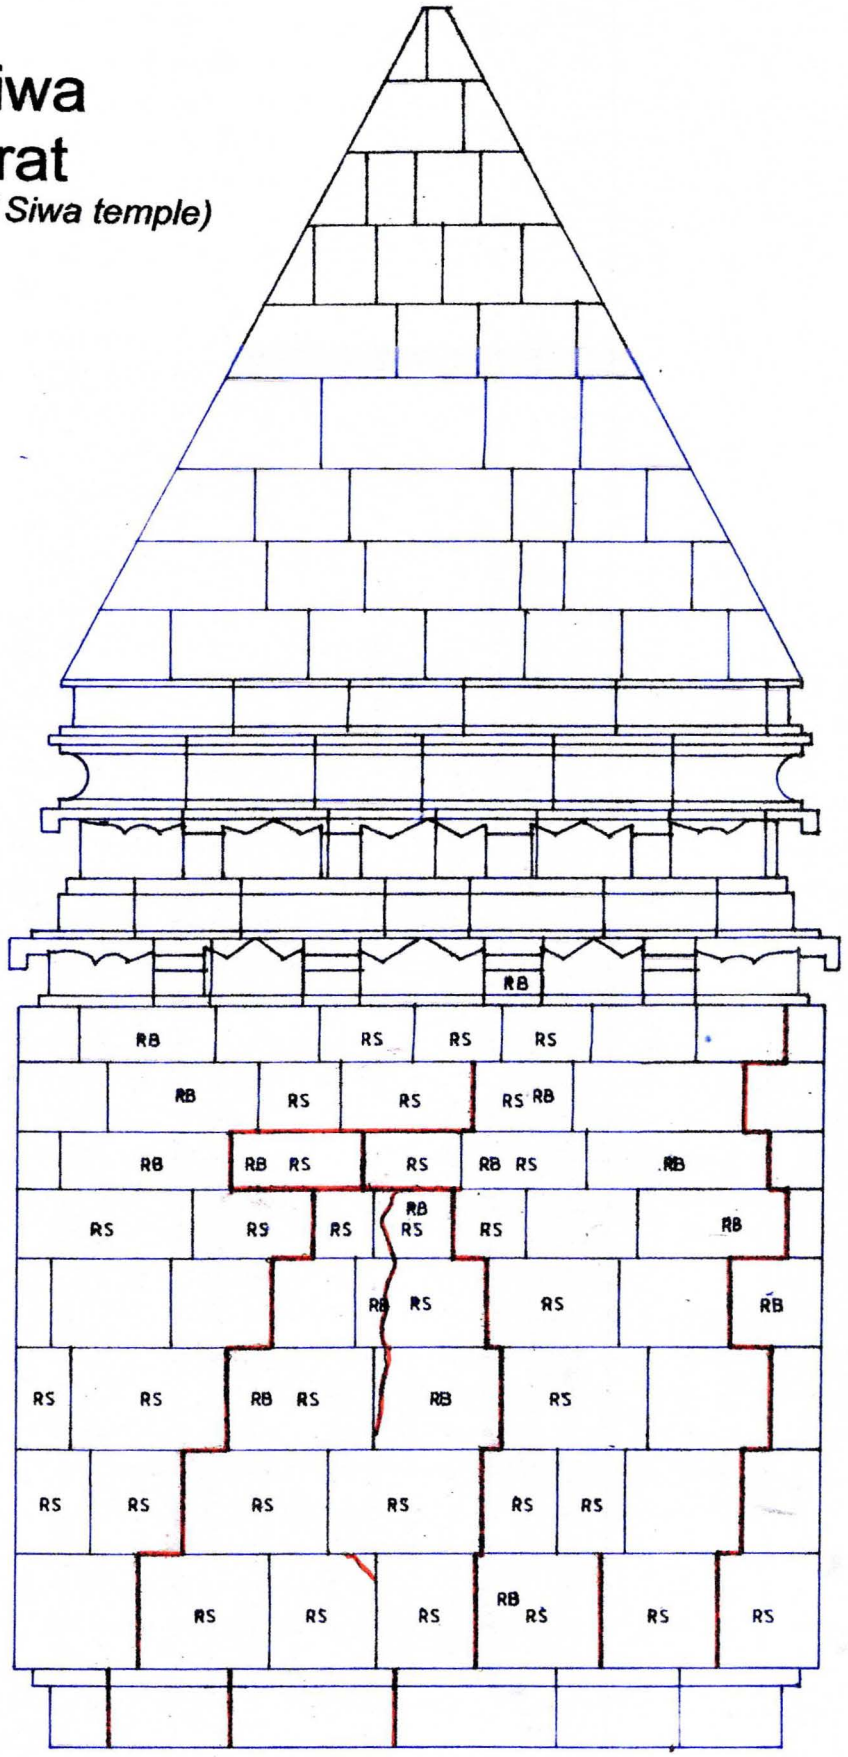
Dinding Utara
(North wall)

Candi Siwa
Bilik Barat
(West chamber of Siwa temple)

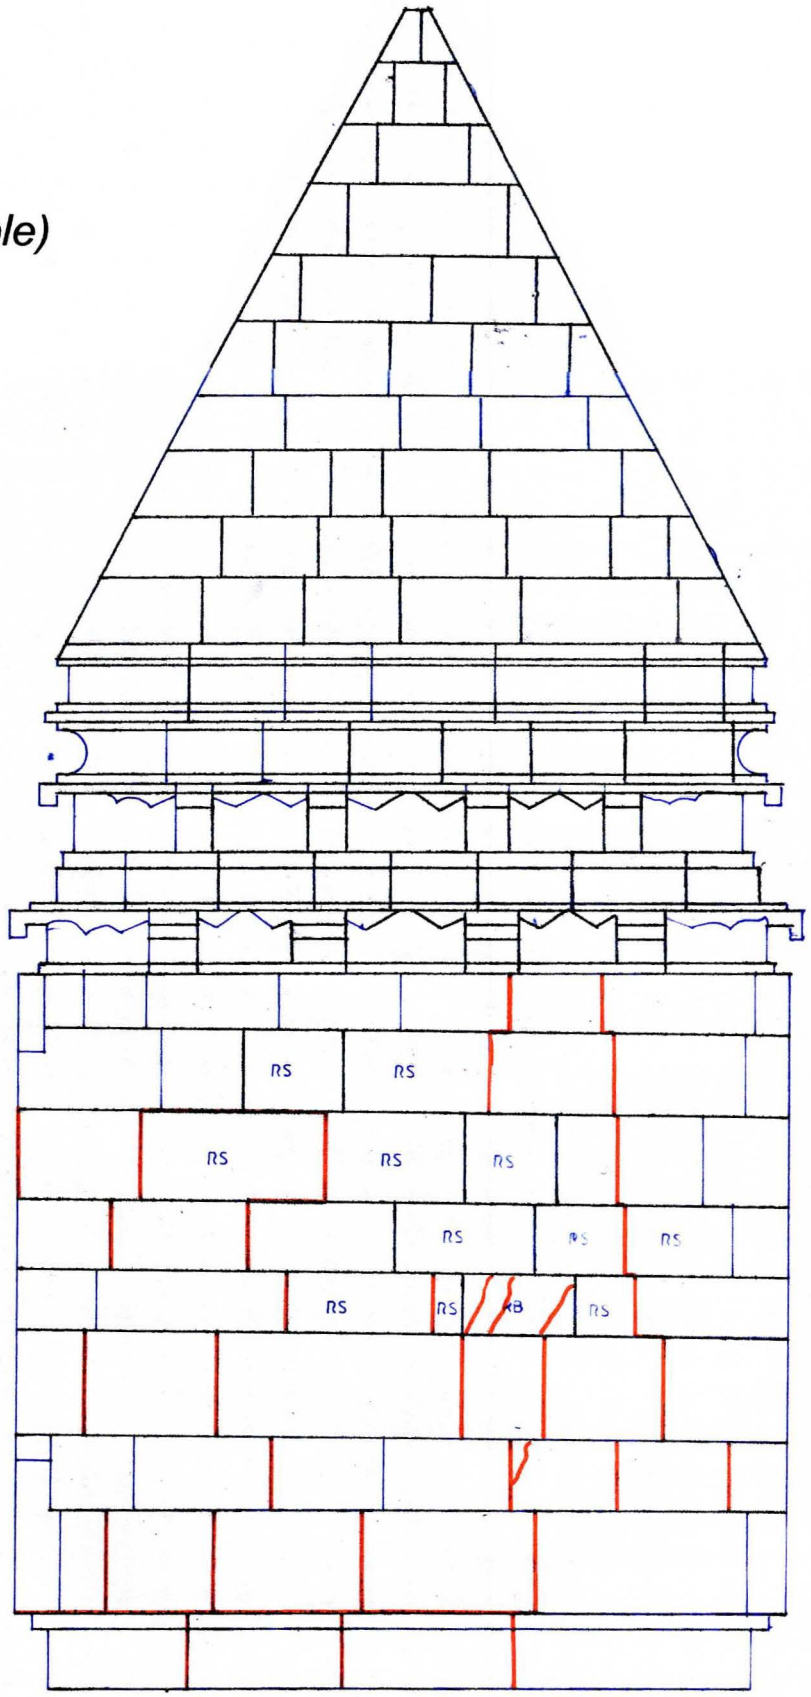
DINDING TIMUR

Candi Siwa
Bilik Utara

(North chamber of Siwa Temple)

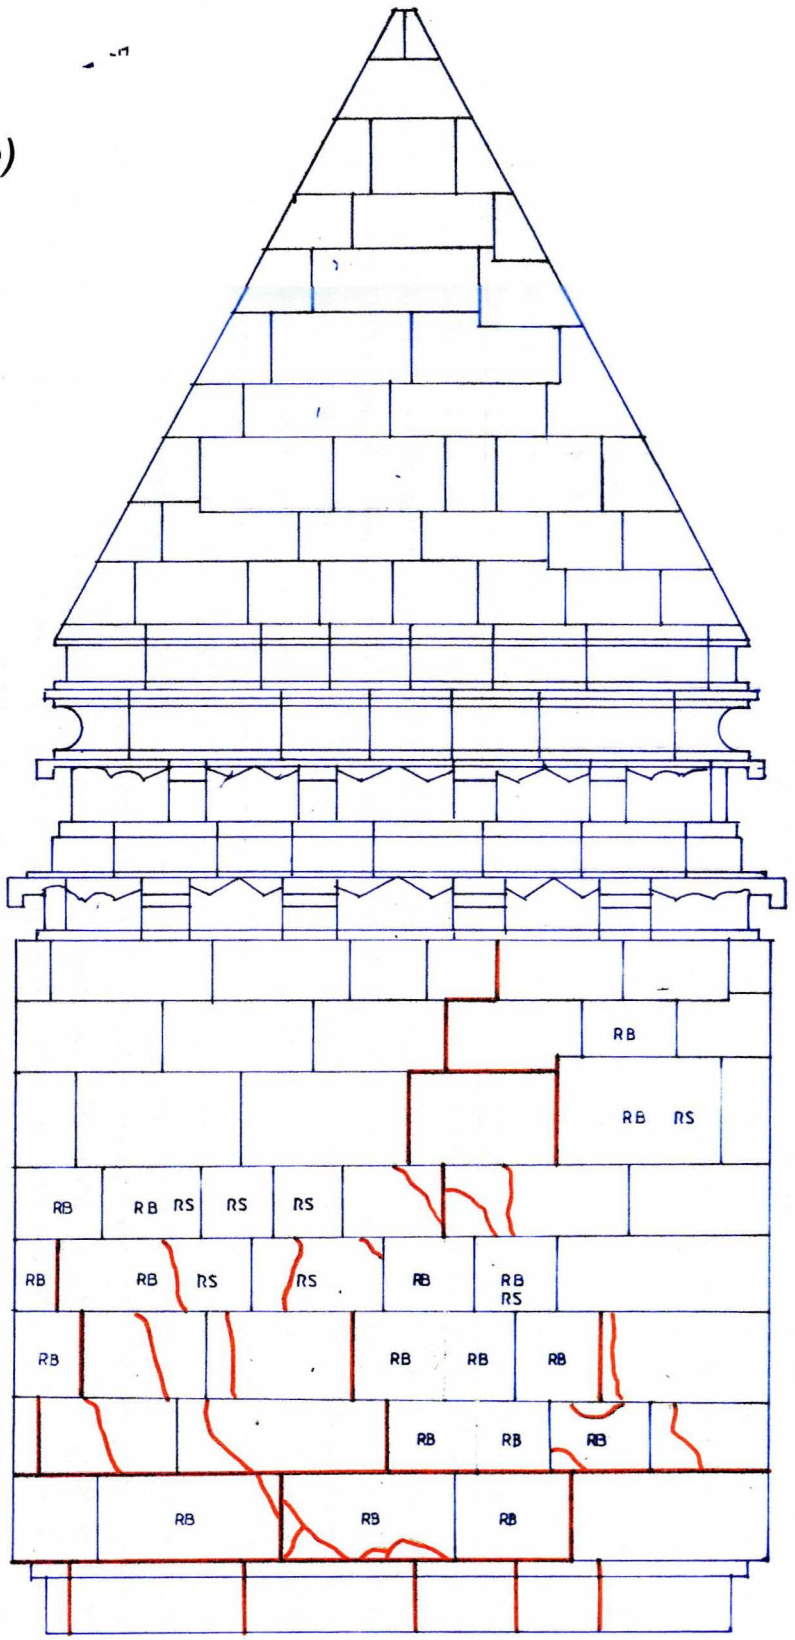
Dinding Barat

Candi Siwa
Bilik Utara

(North chamber of Siwa Temple)
